## **New GIS Tools for Mapping Ohio's Lake Erie Coastal Erosion Areas**

By James McDonald<sup>1</sup>, Paul Harbulak<sup>2</sup>, and Scudder D. Mackey<sup>3</sup>

Every ten years, the Ohio Department of Natural Resources (ODNR), Division of Geological Survey identifies and maps coastal erosion areas along Ohio's 262-mile Lake Erie shore. Coastal erosion areas are those likely to erode over the next 30 years if no additional shore protection is emplaced. Historically, eroding bluffs and shores have caused considerable economic damage to property, buildings, and public infrastructure. The objective of the Coastal Erosion Area (CEA) Program is to minimize economic losses by ensuring that new development along the Ohio shore is adequately protected from coastal erosion.

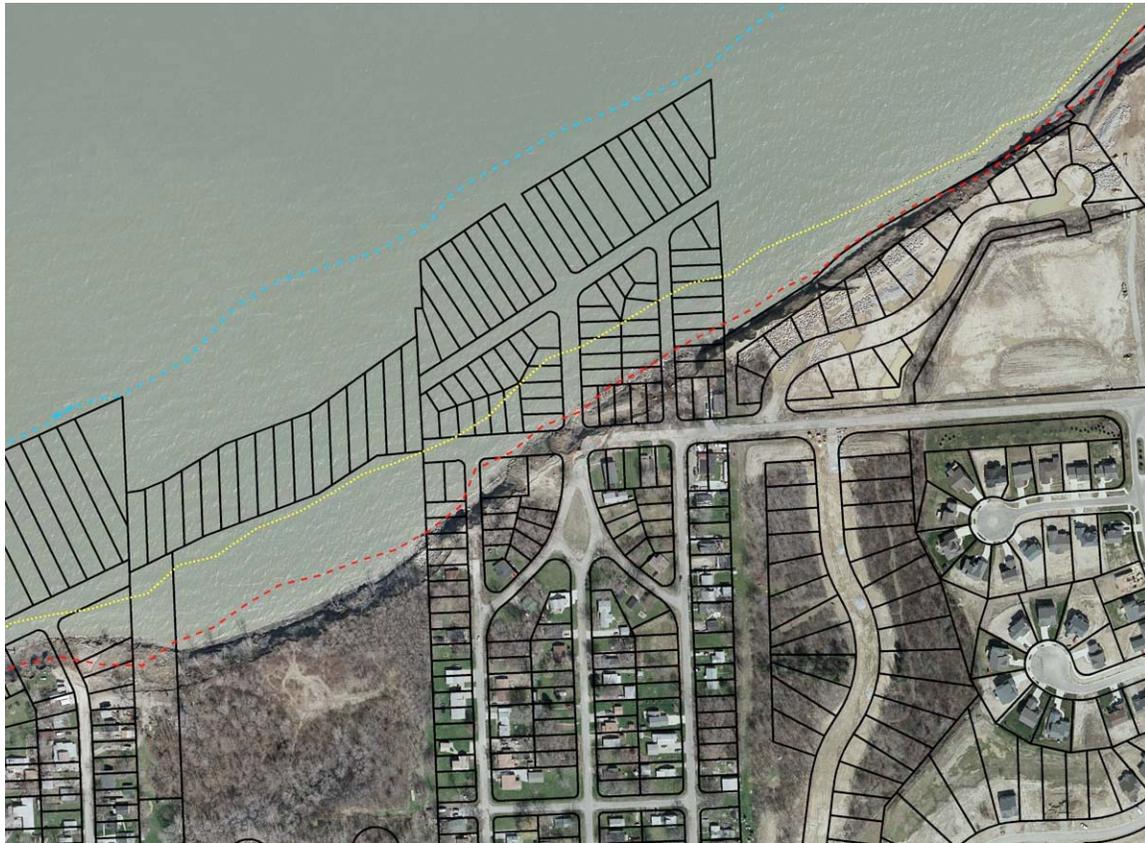
Figure 1. An area of the Lake Erie coast near Painesville, Ohio, that has undergone up to 207 feet of recession during the 17-year period. The blue dashed line indicates the 1876 shoreline; the yellow identifies the 1973 shoreline; and the dashed red line represents the 1990 shoreline. Aerial photo was taken in 2004. The black outlines are parcel boundaries. As can be seen, parcels have been lost due to coastal erosion.

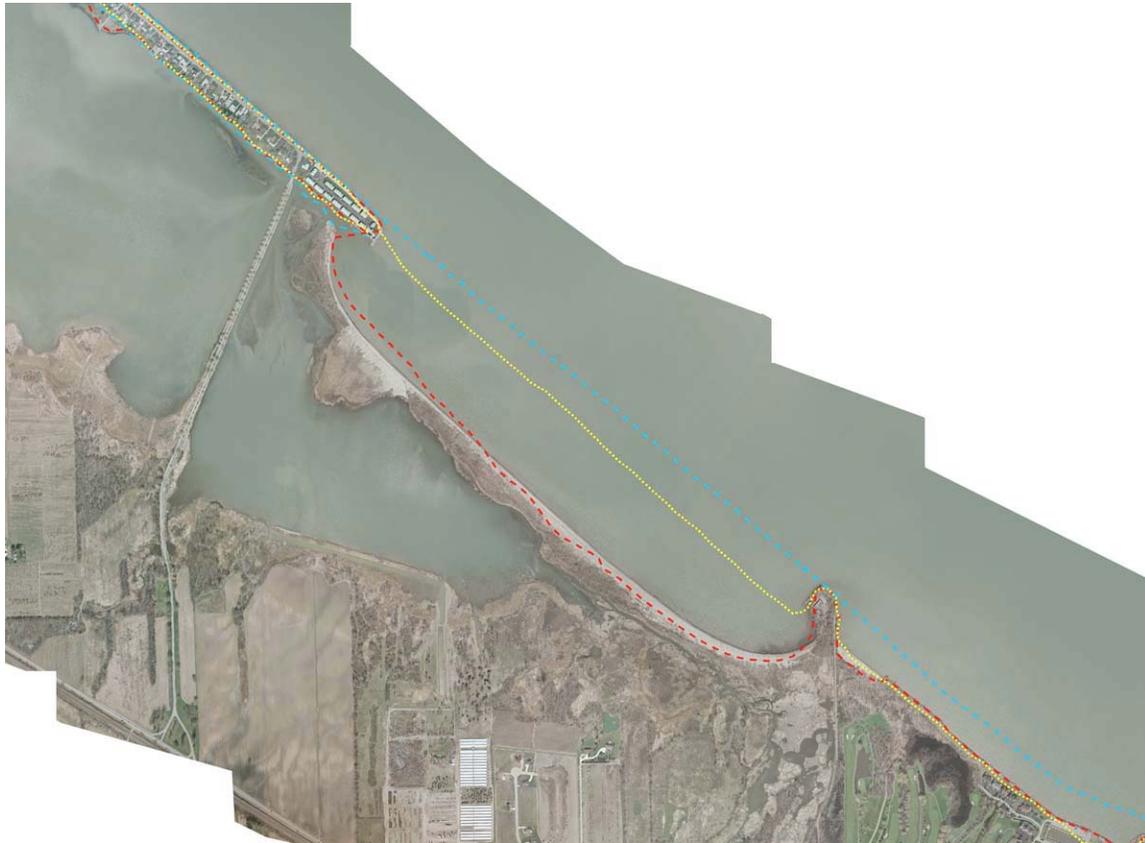
Figure 2. The Sheldon Marsh barrier island, which was eroded and moved landward during the great November 1972 storm, has been retreating at a rate between 15 and 56 feet per year.

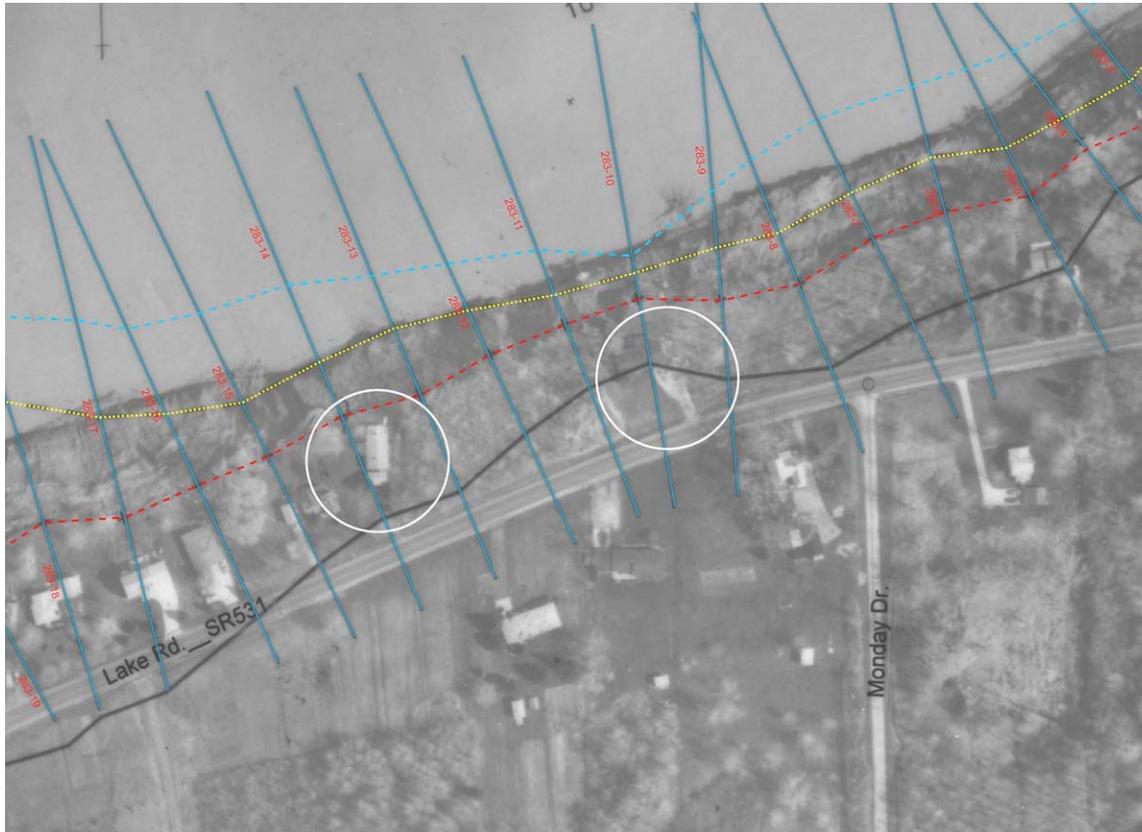
Figure 3a. Properties can be lost to coastal erosion. This 1990 aerial image shows two houses that will be lost to coastal erosion. The blue dashed line indicates the 1876 shoreline; the yellow identifies the 1973 shoreline; and the dashed red line represents the 1990 shoreline. The black line represents the coastal erosion area designation line. The houses are circled in WHITE.

Shore erosion along Lake Erie can be either dramatic or relatively steady in nature. Between 1973 and 1990, the average shore recession rate was 1.41 feet per year, or approximately 24 feet over the 17-year period. Recession rates along the coast range from 0 feet per year to up to 56 feet per year along certain reaches of the coast. Large-scale changes can also occur. Near Painesville, Ohio, the coast has undergone between 34 and 207 feet of recession from 1973 and 1990 (Figure 1). The Sheldon Marsh barrier beach, which was overwashed and eroded during the great November 1972 storm (Carter, 1973), has undergone between 268 and 953 feet of recession over the 17-year time period (Figure 2). While these large-scale changes are very dramatic, relatively steady erosion rates along the coast are also a hazard, eroding bluffs and damaging properties. As a bluff recedes, buildings are lost by either falling into the lake, or being torn down before they are destroyed, or moved back from the bluff (Figures 3a and 3b).

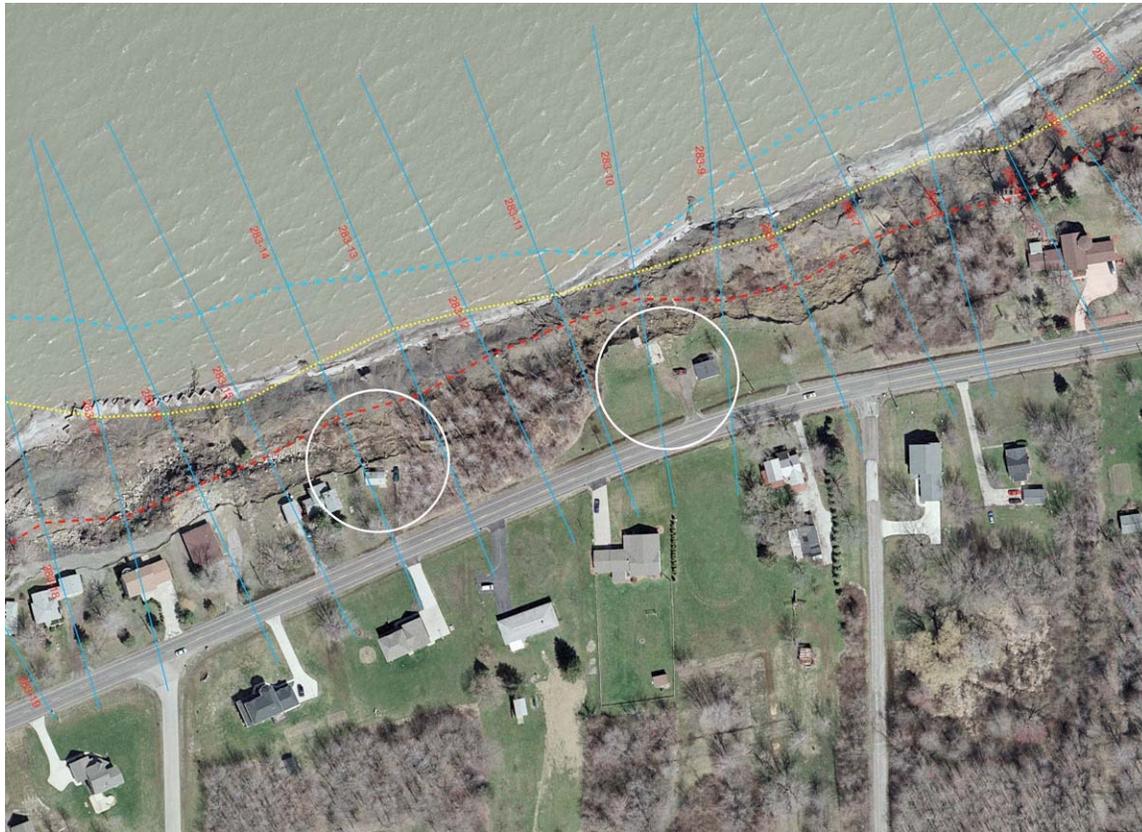
Figure 3b. By 2004, the two houses have been lost to coastal erosion. The location of the former houses are circled in WHITE.

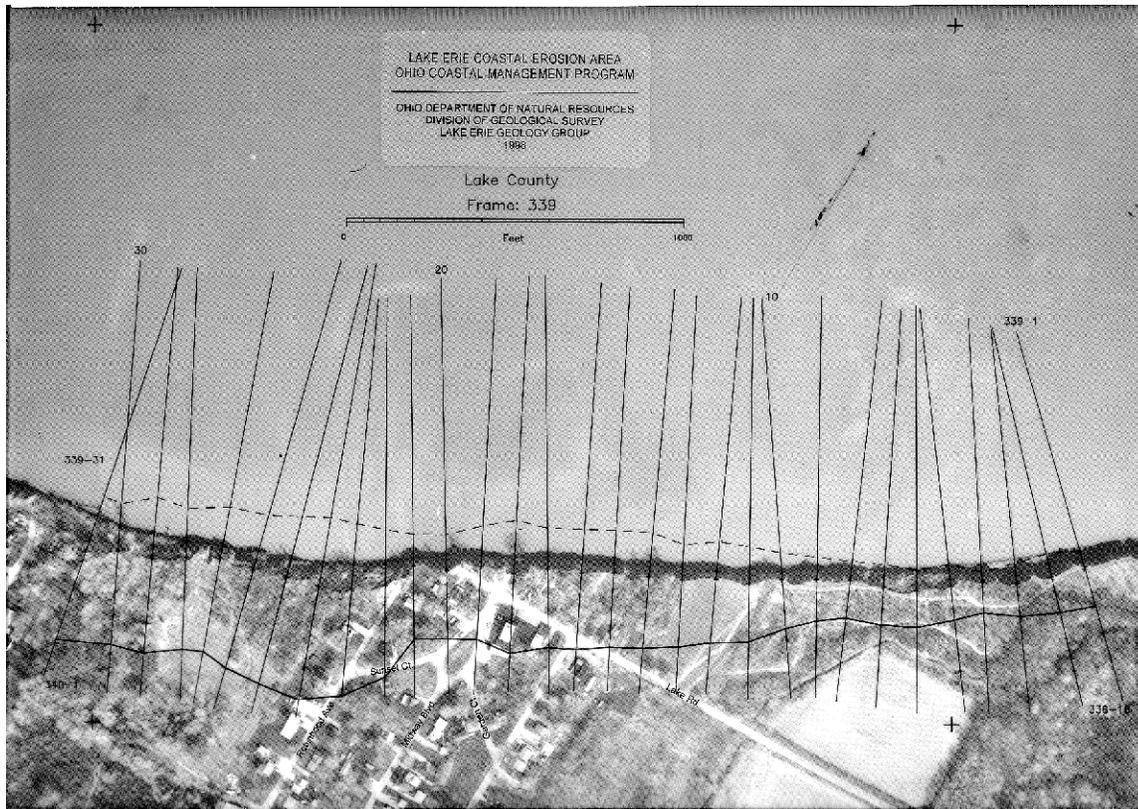
Figure 4. Example of a 1998 coastal erosion area mapbook page for section of Lake Erie coast in Painesville, Ohio.

The transects, the 1973 and 1990 shoreline intersections, and the 1990 toe of the bluff were digitized using SigmaScan<sup>®</sup> software, with each 1990 aerial-photo image having its own relative coordinate system. Once digitized, the vector data was then used as input into a FORTRAN 77 program that calculated (1) the recession distance and recession rate between 1973 and 1990, and (2) a smoothed 30-year average recession distance, i.e., where the shoreline is projected to be in 2020. The 30-year recession (or coastal erosion area) distance was then plotted back onto the 1990 imagery (Mackey and others, 1996; Guy, 1999). The preliminary coastal erosion area maps were released to the public in 1996. After an extensive public notification and review process, the final coastal erosion area maps were approved by the ODNR Director in 1998 (Figure 4).

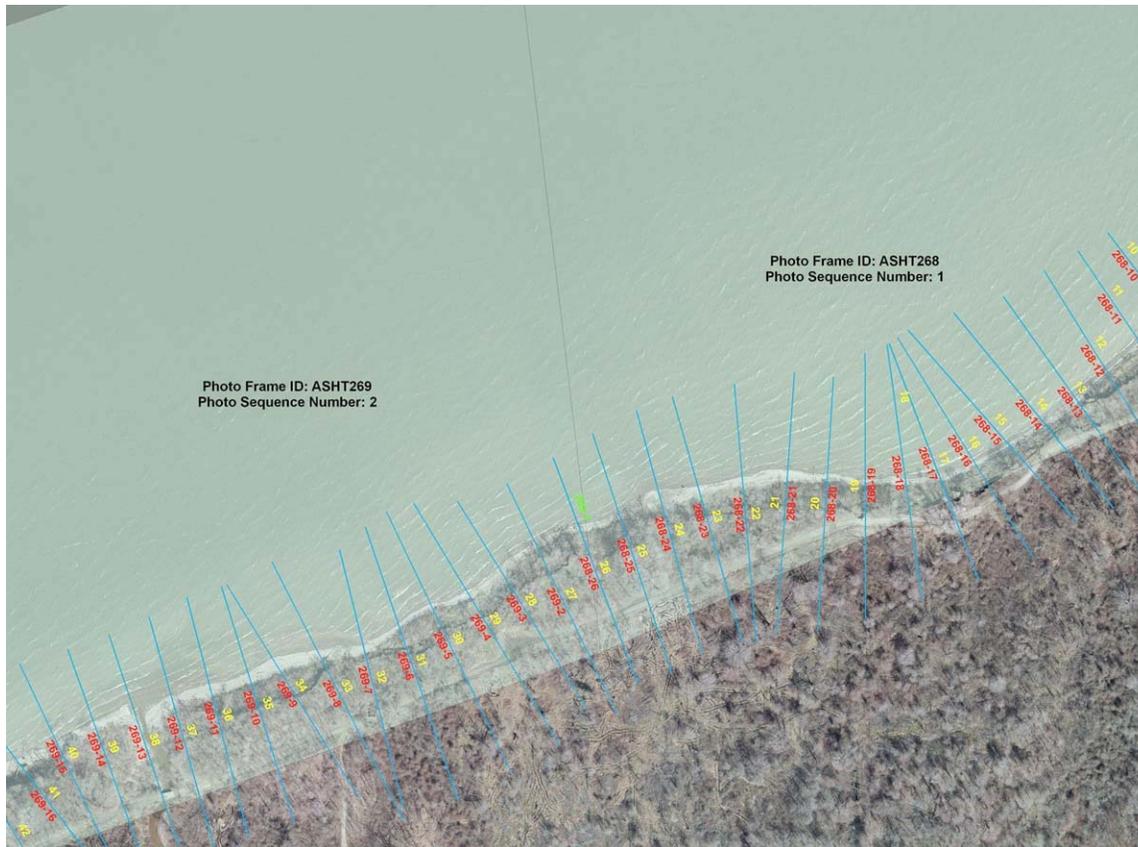
Figure 5. A portion of the Lake Erie coast near the Ohio-Pennsylvania border. The outlines of two 1990 aerial photo frames—frame 268 and frame 269—are shown. Also shown are the aerial-photo sequence numbers. The shore-normal transects (blue lines) are labeled with the original frame and transect identification (TID) numbers (in red). A tie transect (in green, along the boundary between photo frames) is the last transect in a 1990 aerial photo frame and also the first transect in the next frame. The new TIDs are in yellow. The new TID numbers are assigned to the 1870's, 1973, 1990, and 2004 datasets. Aerial photo was taken in 2004.

To assign the TIDs, we took advantage of the fact that the 1990 aerial photography was flown in an east-to-west sequence along the coast. Therefore, a sequence number was assigned to each air photo frame. During the 1998 coastal erosion area mapping, shore-normal transects were drawn on each 1990 aerial photo. These transects were uniquely numbered for each aerial photo; the numbers range from 1 to 72, depending in the width of the aerial photo. Using the aerial-photo sequence number and the sequential-transect numbers on each aerial photo, the application iteratively assigns the unique TIDs for the entire coastal dataset (Figure 5). The TIDs range from 1 at the Ohio-Pennsylvania border to 12,157 at the Ohio-Michigan border. The Lake Erie islands TIDs range from 12,158 to 14,164.

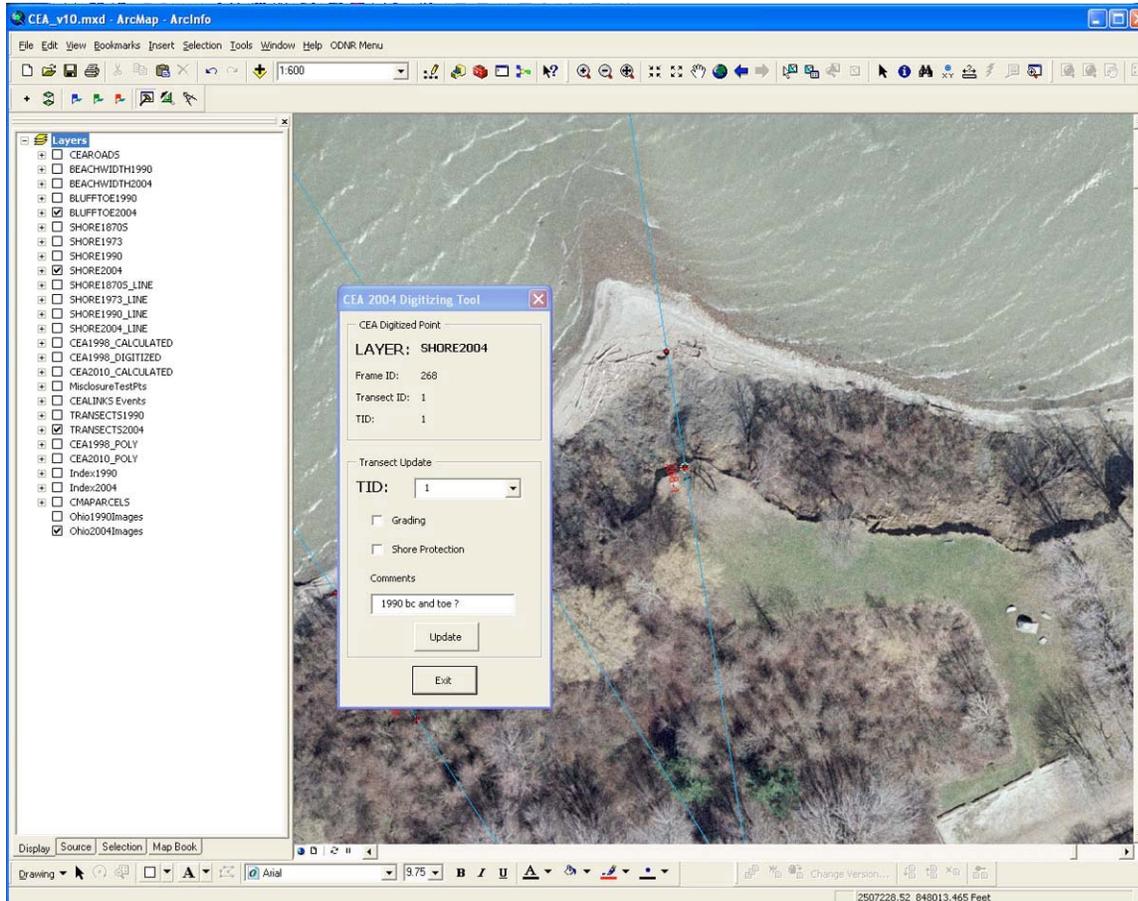
Figure 6. The CEA 2004 Digitizing Application. The VBA form displays the attributes being transferred from transects to the new points. The user has the ability to add attributes as to whether man-made grading has occurred to the bluff slope, whether shore protection has been installed, and other comments about the points which can be included in the dataset.

The CEA 2004 Digitizing Application is a simple, user-friendly application that allows for digitizing the toe of the bluff and the shoreline intersections (Figure 6). Once activated by the user, the application turns on the ArcMap Editor toolbar and sets the snapping tolerance (2 feet) for snapping to the shore-normal transect. The user is then prompted to first digitize the bluff toe (base of the bluff) and then the bluff crest (2004 shore) for each shore-normal transect. The application automatically switches between digitizing the bluff toe and the bluff crest (or other appropriate shore erosion reference feature) for each shore-normal transect. Attributes, such as the TID, the 1990 aerial photo frame number, and the original transect identification number, are automatically copied from the shore-normal transect and written to the newly digitized features in the geodatabase, thereby removing all keyboard entry errors. The application also identifies the user who digitized the feature, along with the date and time the feature was digitized. A user can also assign attributes to the shore-normal transect, including

presence or absence of shore protection and an offset to account for anthropogenic erosion (i.e., slope grading). By automating the process and significantly reducing keyboard entry errors, the Digitizing Tool application reduced the amount of time for GIS quality-control editing from approximately 160 hours to 8 hours.

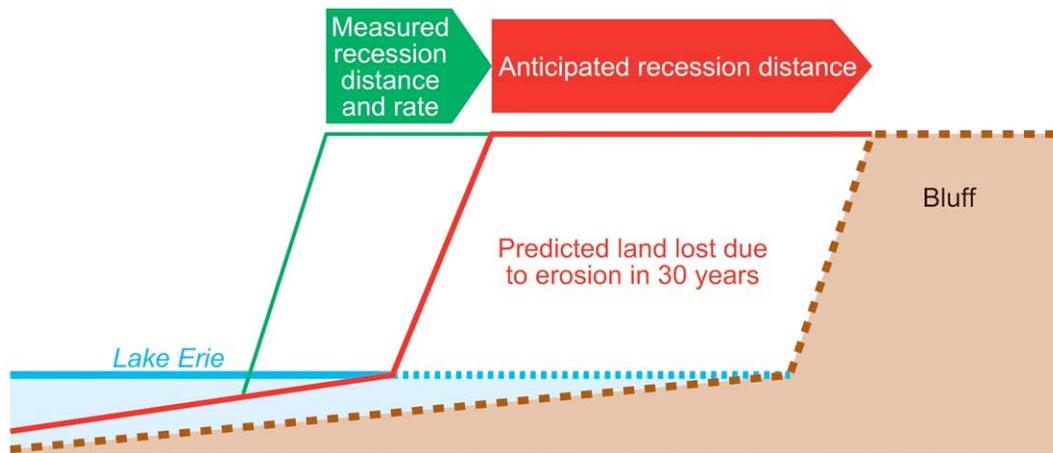
Figure 7. Sample cross section of the Lake Erie bluff showing the measured recession distance (i.e., between 1990 and 2004) and the projected 30-year recession distance

Coastal erosion area calculations are a multistep process (Ohio Department of Natural Resources, 1996). The first step is to calculate the recession distance, which is the distance along the shore-normal transects between the reference shoreline intersection and the older shoreline intersection. Next, the recession rate is calculated by dividing the recession distance by the time interval between the reference shoreline and the most recent shoreline (for example, the 14 years between 1990 and 2004 [Figure 7]). The 30-year recession distance is calculated by multiplying the recession rate by 30 years (see Figure 6). The 30-year recession distance is then

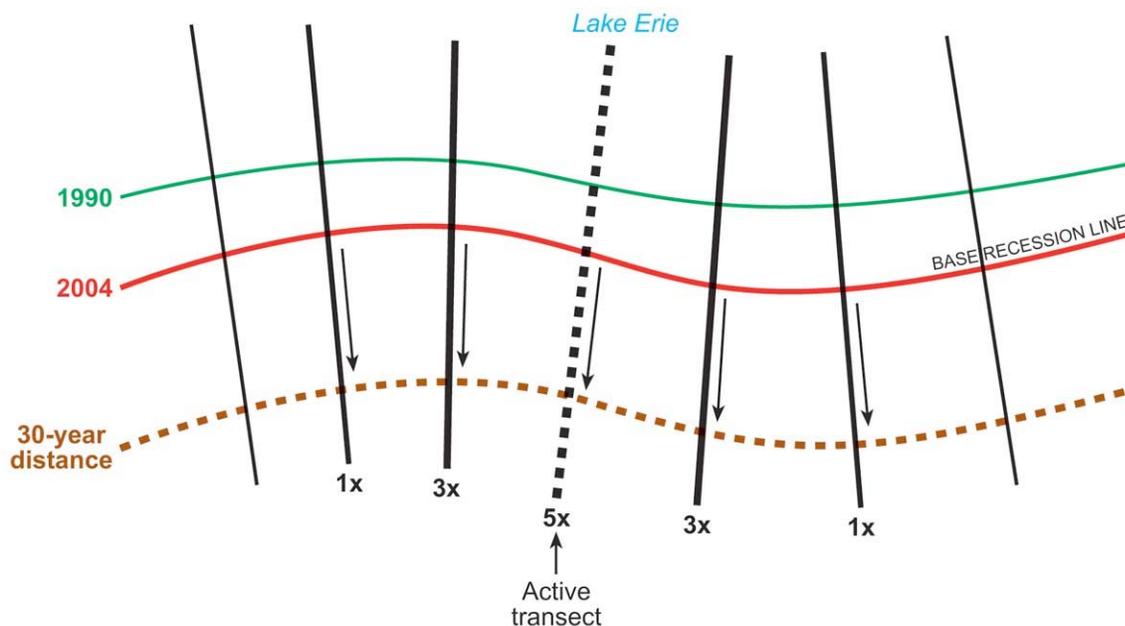
Figure 8. A five-point moving average is used to smooth the projected (30-year) shoreline.

smoothed using a five-point, center-weighted, moving-average filter (Figure 8). The five-point, center-weighted, moving-average filter is required because any small changes in the recession rate are magnified by a factor of 30 and the coastal erosion area designation would be a jagged line. The five-point, center-weighted, moving-average filter is calculated using the 30-year recession distance at a central transect and two transects on either side of the central transect. Weights of 5, 3, and 1 are applied to the five transects. The weighted values are summed and divided by 13 to produce the 30-year average recession (or coastal erosion area) distance at the central transect. The filter then shifts to the next adjacent transect and the process is repeated.

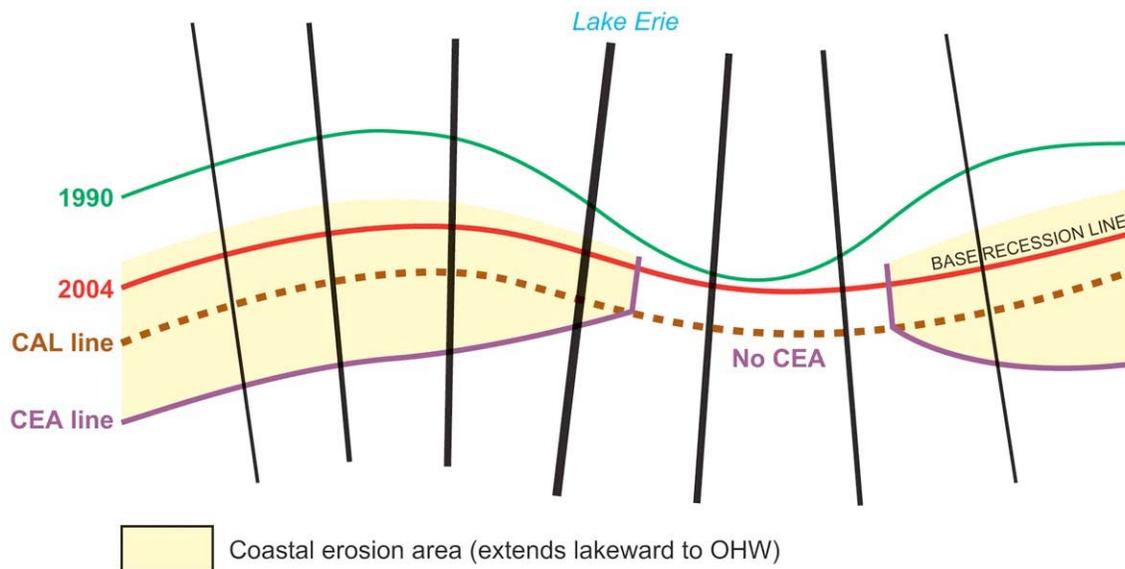
Figure 9. All the components either used or calculated during the Lake Erie coastal erosion area designation are shown here. The 1990 shoreline/bluff crest (green line) and 2004 shoreline (red line) are mapped using aerial photography. The black lines perpendicular to the shore are the shore-normal transects, which are used as reference lines for measuring shore recession. The Calculated Accuracy Limit (CAL; dashed, brown line) is created using the 2004 shoreline/bluff crest as the base recession line. Finally, coastal erosion area (CEA) lines (purple line) are calculated and plotted back into the GIS database using the CAL line and annual-recession distance projected 30 years into the future. The coastal erosion area (yellow shaded area) extends lakeward from the CEA line to the ordinary high-water (OHW) mark on the lake.

The final step is to plot the coastal erosion area designation line (Figure 9). The CEA designation is plotted when the 30-year average recession distance is greater than the Calculated Accuracy Limit (CAL). The CAL value provides a way to incorporate mapping uncertainty into coastal erosion areas. The administrative code (Ohio Department of Natural Resources, 1996) specifies the mapping uncertainty be set at 5 feet total error between the two different mapping epochs. The five-foot mapping error is divided by the interval in years and then multiplied by 30 to propagate 30 years into the future, creating the CAL. For the first coastal erosion area mapping in 1998, the CAL was computed to be 9 feet. For the upcoming remapping of coastal erosion areas, the CAL is computed to be 11 feet. The CAL acts as a minimum coastal erosion area distance. If the 30-year average recession distance is less than the CAL value, then a coastal erosion area is not designated. If the 30-year average recession distance is greater than the CAL value, then a coastal erosion area is designated.

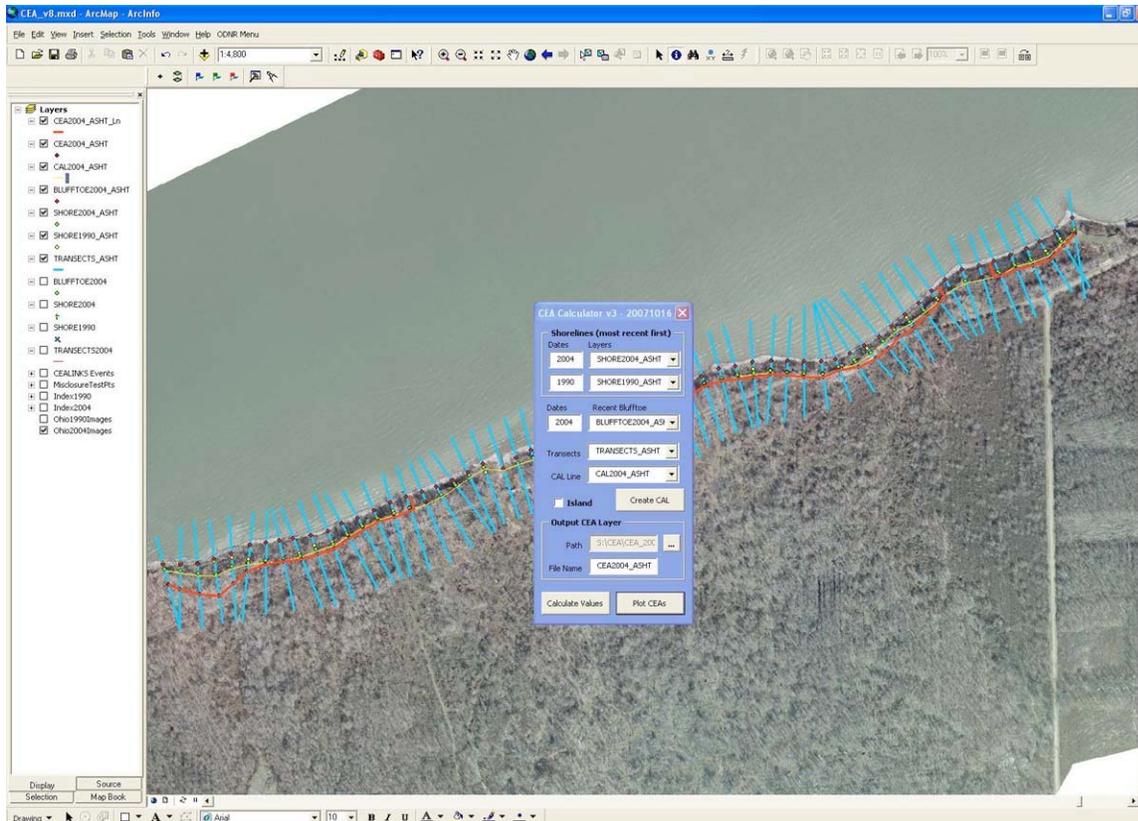
Figure 10. The CEA Calculator application.

The CEA Calculator incorporates all of the calculations described above into an easy-to-use application (Figure 10). The application requires four different GIS layers: the reference shoreline and the older shoreline, the toe of the bluff for the most recent year mapped, and the shore-normal transects. For the special case of coastal erosion areas being calculated for a Lake Erie island, a simple checkbox is provided to designate an island calculation.

Coastal erosion area calculations are a three step process. After selecting all the layers, the operator first creates the CAL line. Then, the operator calculates the recession distance, recession rate, and the 30-year average recession distance. These values are written into the attribute table of the shore-normal transects feature class. Finally, the coastal erosion area designation lines are plotted using the application. These three operations are performed using a simple selection of the three command buttons.

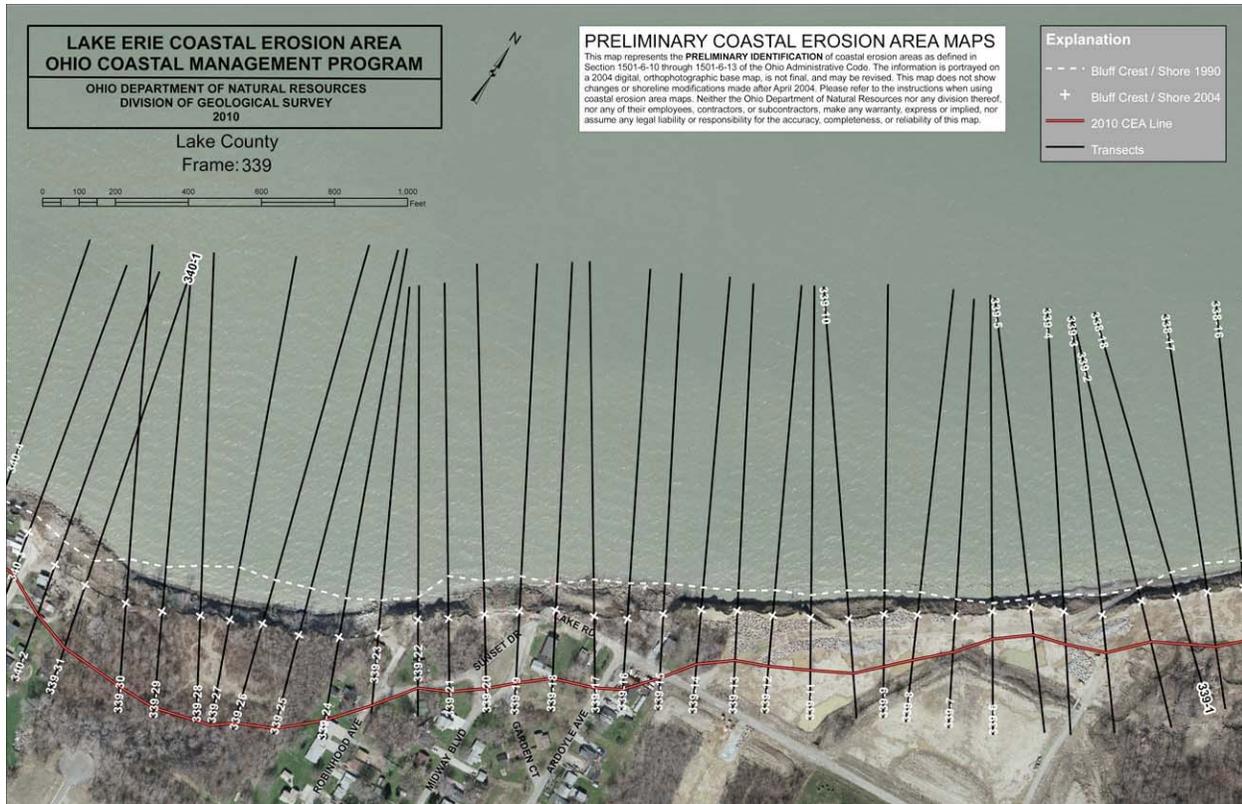
Figure 12. Example mapbook page (for a section of Lake Erie coast in Painesville, Ohio) from the coastal erosion area GIS dataset.

Now that the preliminary mapping is complete, additional products can be developed with the new GIS data. Traditional products created for the 1998 coastal erosion area mapping project included map books (Figure 12) and data table books. Similar products can be easily produced using the 2004 GIS dataset. The public is already familiar with these products, and these products can be rapidly generated and updated with ease. The maps will be made public via a web map application on the ODNR Web site, and hard copies will be made available at select repositories and public buildings along the coast.
