The following was presented at DMT'11
(May 22-25, 2011).

Mapping Abandoned Mines Using Imagery and LiDAR from the Ohio Statewide Imagery Program

James McDonald (jim.mcdonald@dnr.state.oh.us) • Ohio Department of Natural Resources, Division of Geological Survey • 2045 Morse Road, Bldg. C-1, Columbus, OH 43229-6693

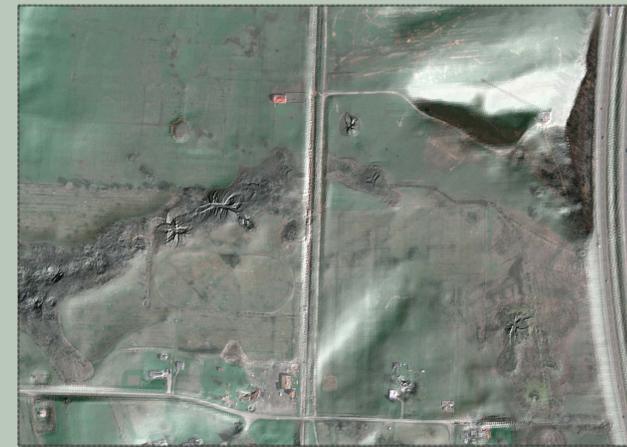
FIGURE 2c.—Hill shade overlay of the gridded LiDAR dataset. Some of the pit subsidence features can be easily identified, especially if the pit subsidence feature has a vertical resolution of greater than the LiDAR accuracy.

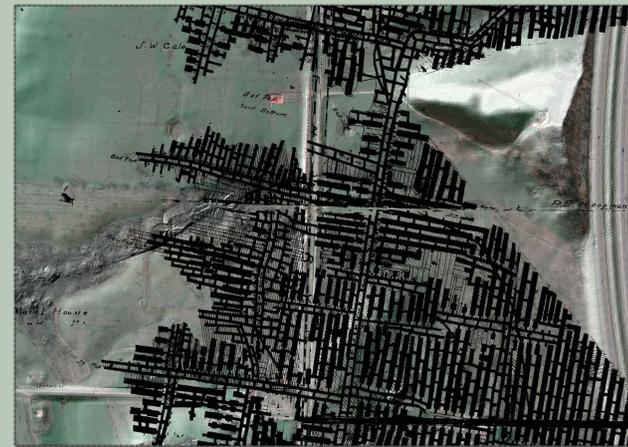
FIGURE 2d.—Overlay of the detailed abandoned mine map. Some of the pit subsidence features lie outside of the mapped mine workings, possibly indicating that the detailed mine map does not completely show the full extent of the mine workings.

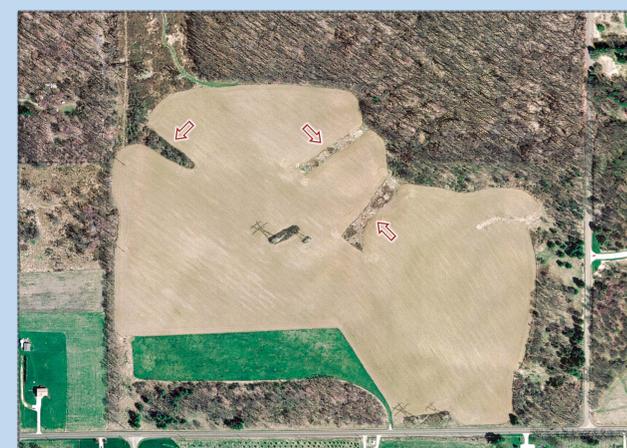
FIGURE 4a.—Silver Creek Metro Park, near Wadsworth, Ohio. The high-resolution imagery shows some unusual patterns (red arrows) within the mowed field.

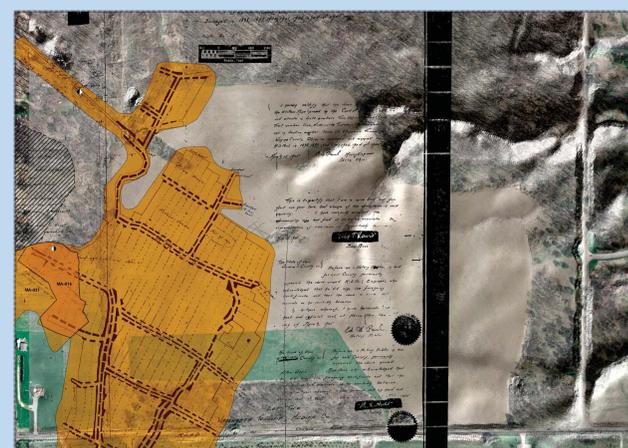
FIGURE 4b.—Overlay of the abandoned-mine map and the gridded LiDAR hill shade. The overlay clearly shows that the unusual pattern on the left side of the figure is due to slope entry to the mine. The other unusual patterns in the center of the figure may be caused by collapse of unmapped entries from an extension of the abandoned-underground mine. Further field work is necessary to confirm or refute this hypothesis.

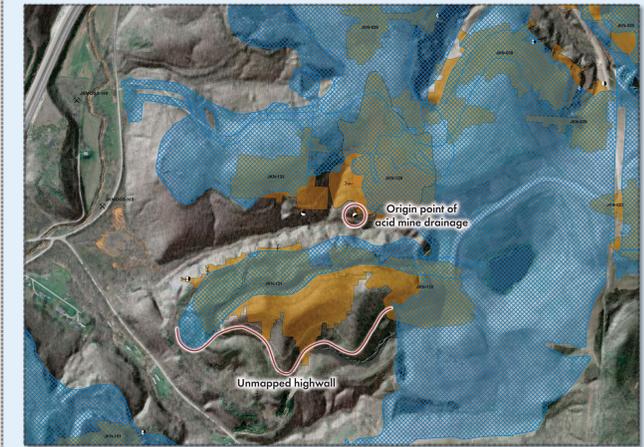
FIGURE 3b.—Overlay of the outlines of the abandoned-underground mines (brown) and abandoned-surface mines (blue hachure pattern). The origin point for the acid mine drainage can now be identified as coming from either the drift entry or the air shaft of the abandoned-underground mine. In addition, the LiDAR hill shade easily identifies an unreclaimed highwall from an unmapped surface mine.
