The following was presented at DMT'08 (May 18-21, 2008).

EXAMPLES OF SHORE EROSION

THE CEA PROGRAM

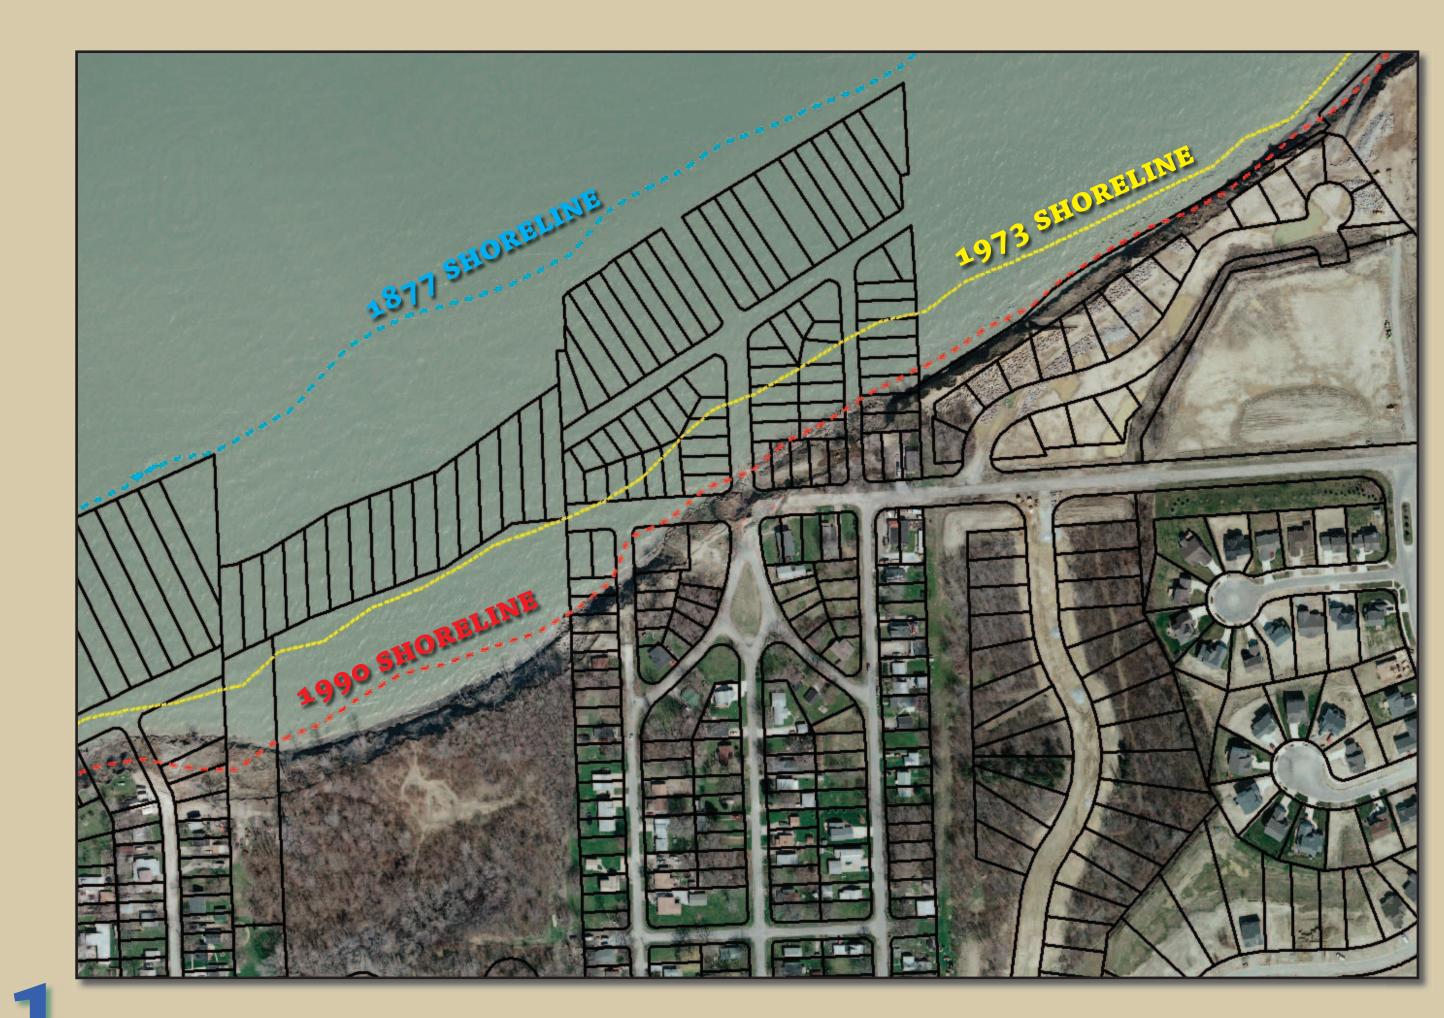
Erosion along the Lake Erie shoreline of Ohio is a major geologic hazard. Between 1973 and 1990, the average shoreline recession was 1.41 feet per year, which indicates that the shoreline receded approximately 24 feet during the 17-year period. This figure shows an area of the coast near Painesville, Ohio, that has undergone up to 207 feet of recession during the 17-year period.

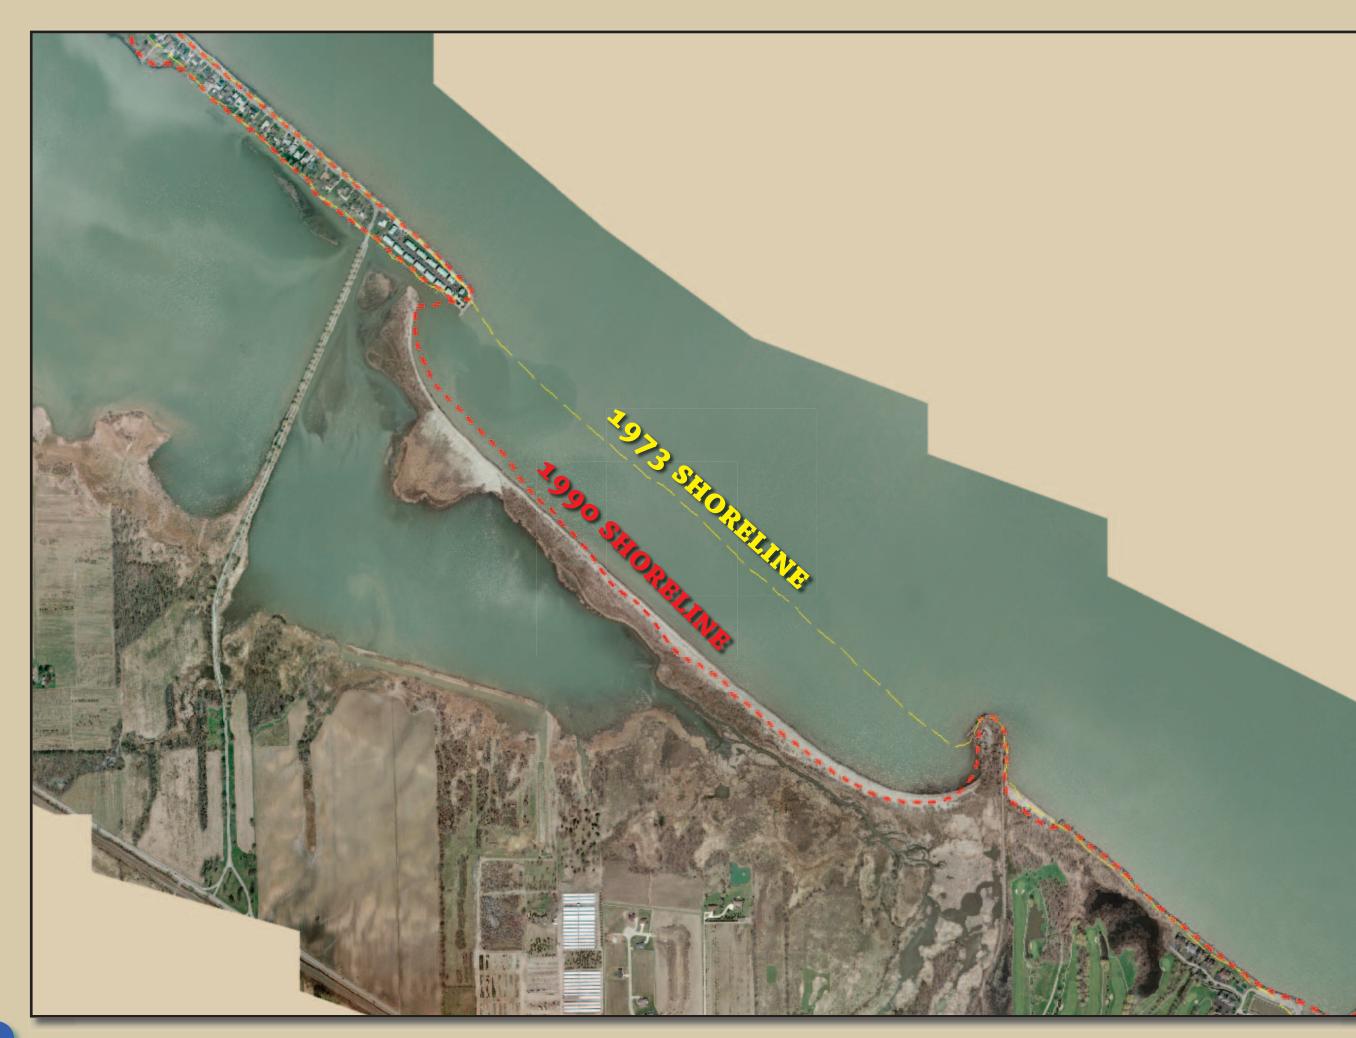
The Lake Erie coastline of Ohio is very dynamic and can undergo large-scale changes. The Sheldon Marsh barrier island, which was blown out during the great November 1972 storm, has been retreating at a rate between 15 to 56 feet per year.

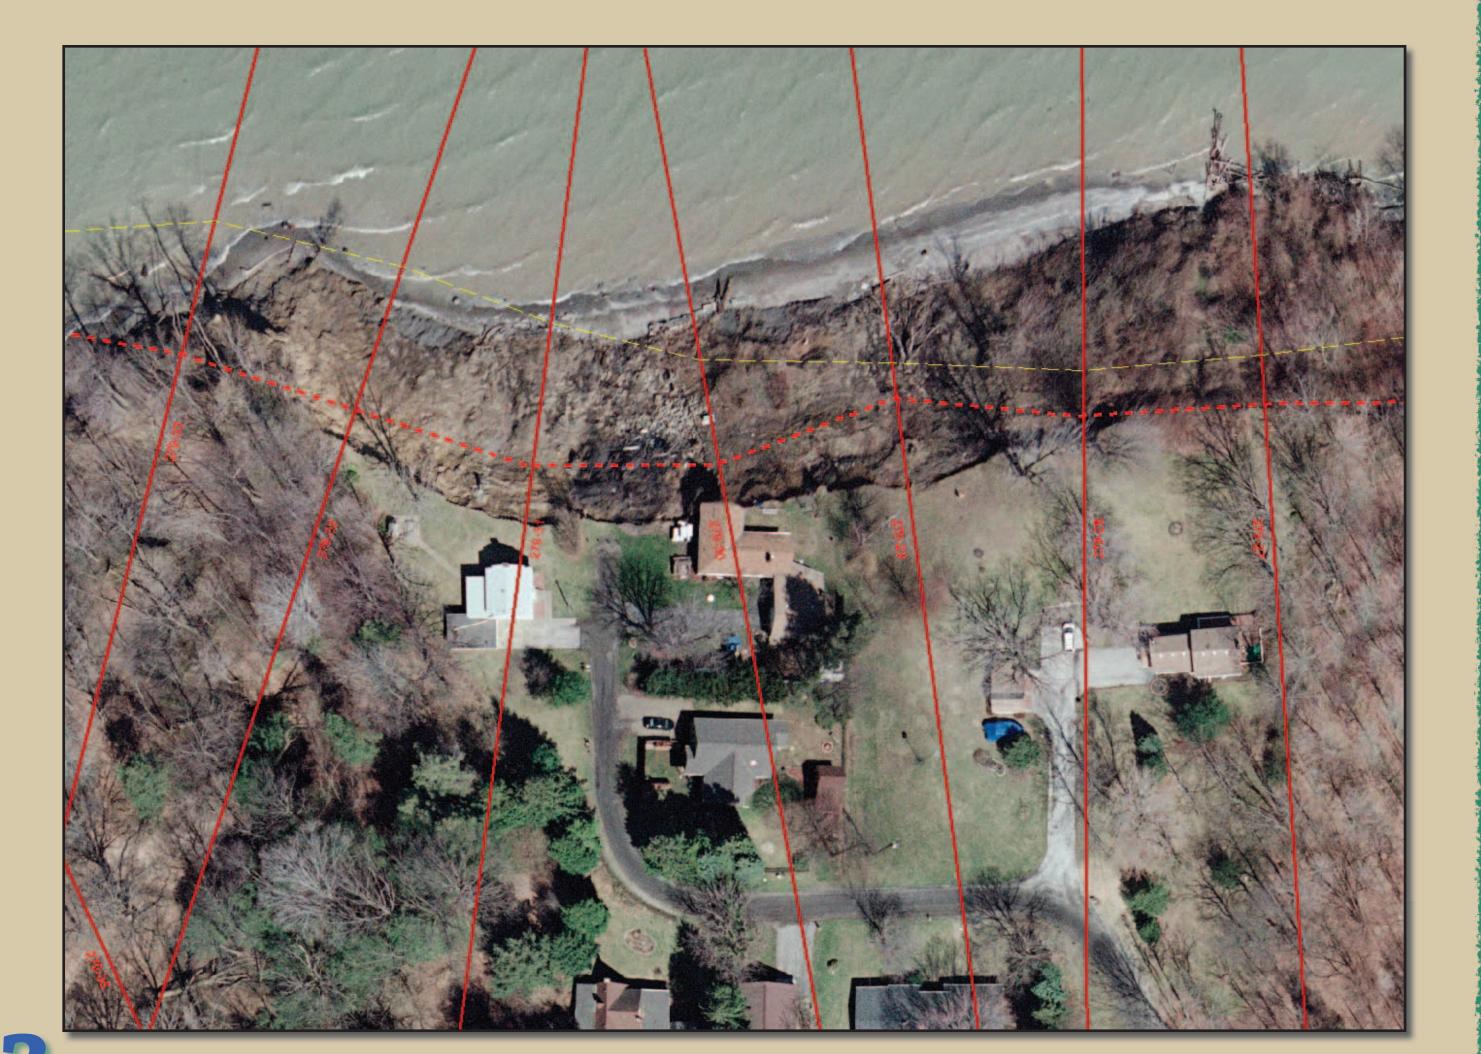
Properties can be lost to coastal erosion. This is a house that is about to fall off of a bluff due to erosion.

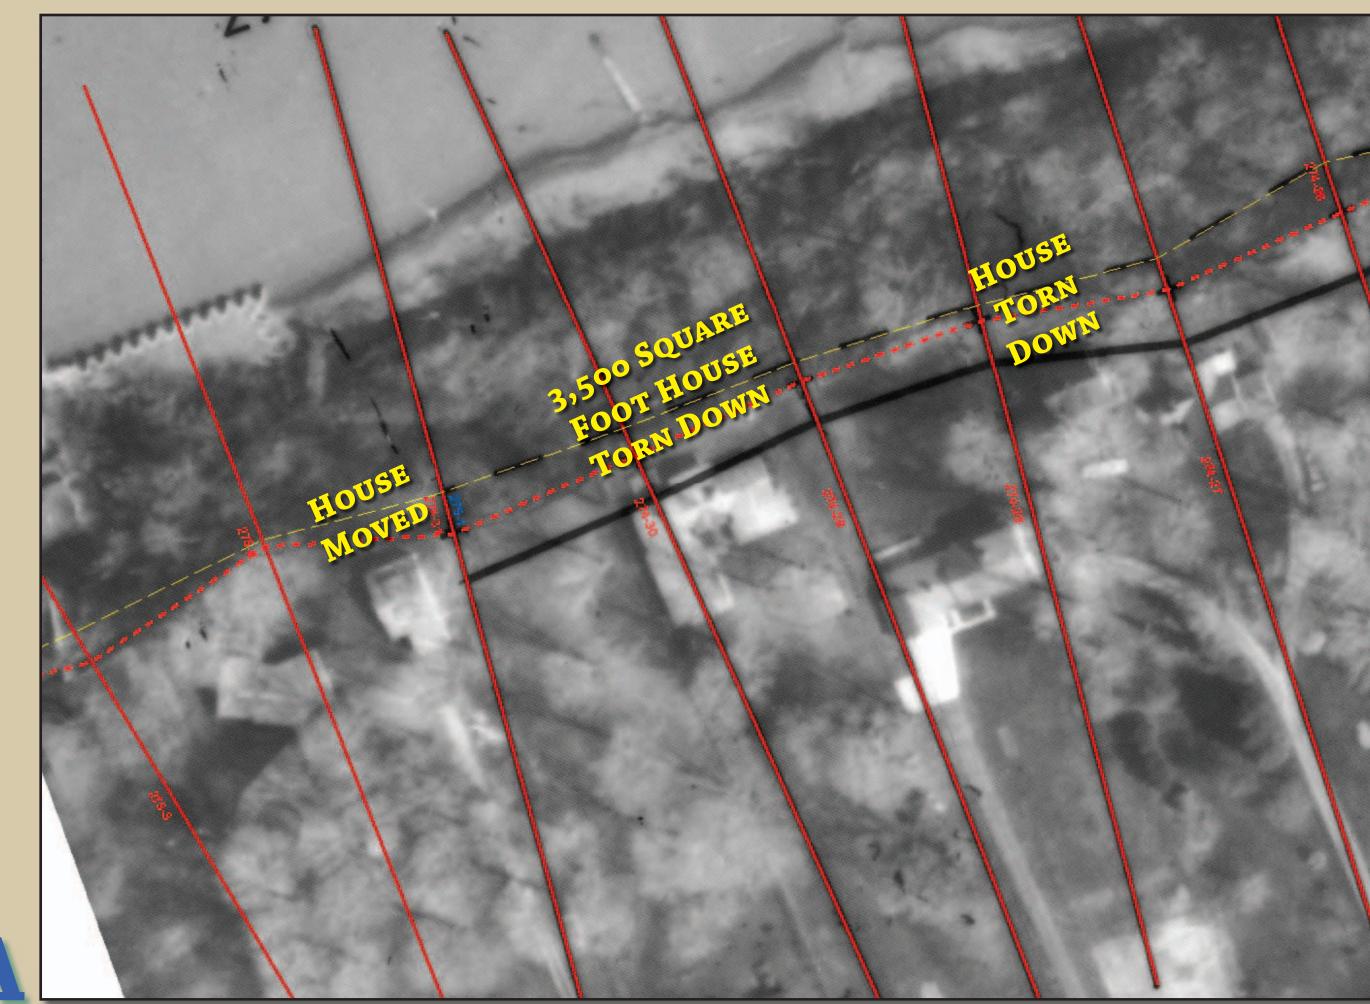
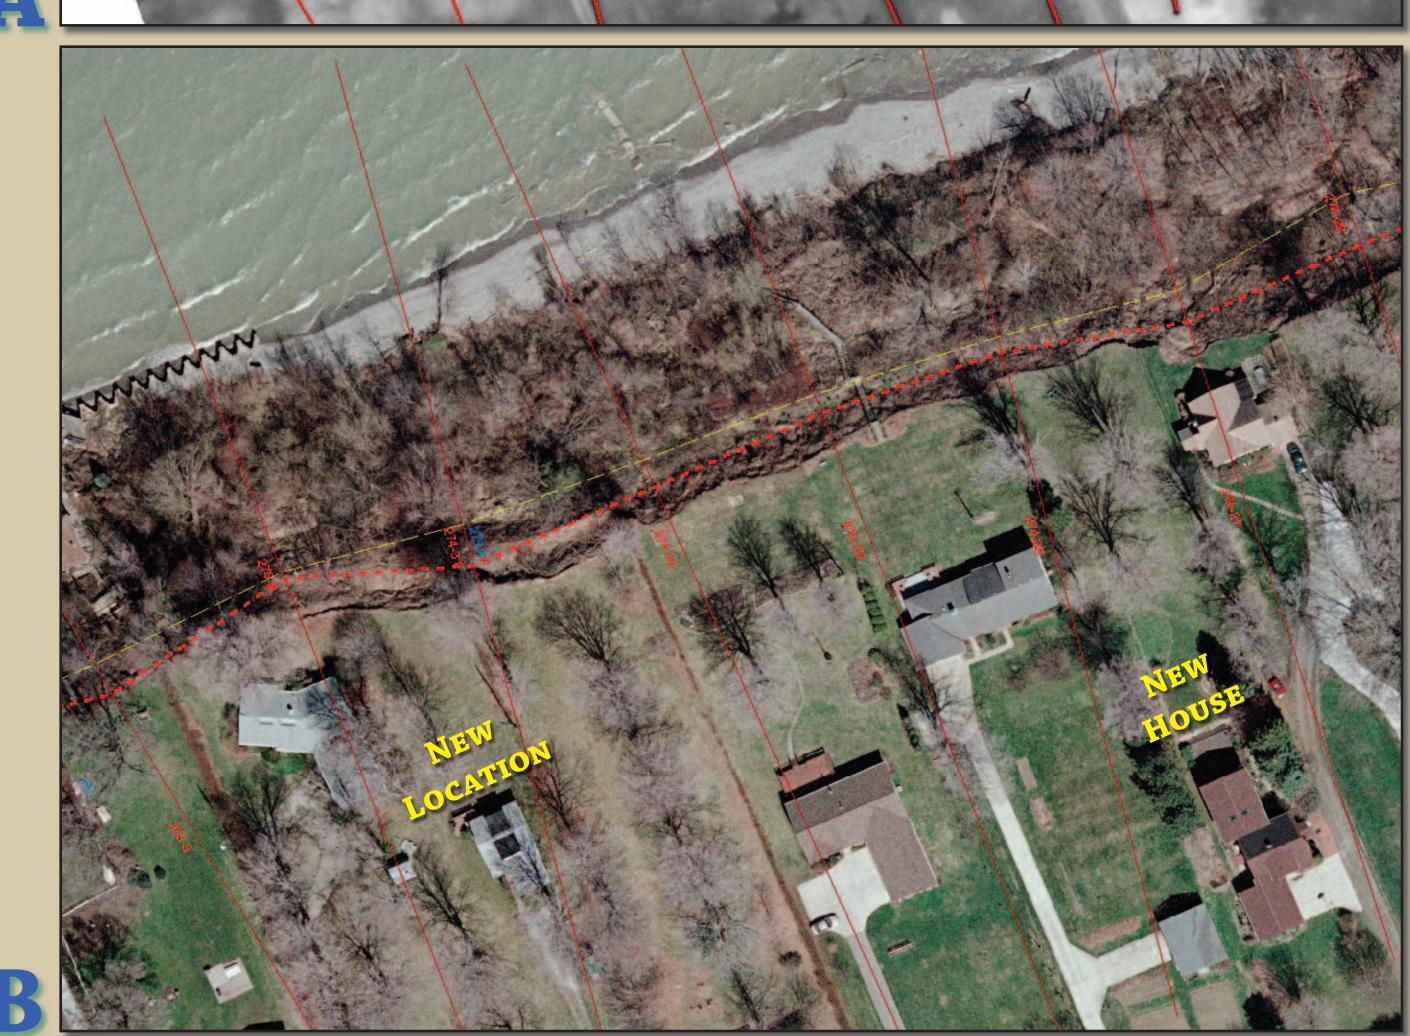
As a bluff recedes, buildings can be destroyed from the erosion, torn down before they are destroyed, or physically moved back from the bluff. Here two houses have disappeared, one of which is a 3,500 square foot house. In addition, a house has been moved back from the bluff edge.

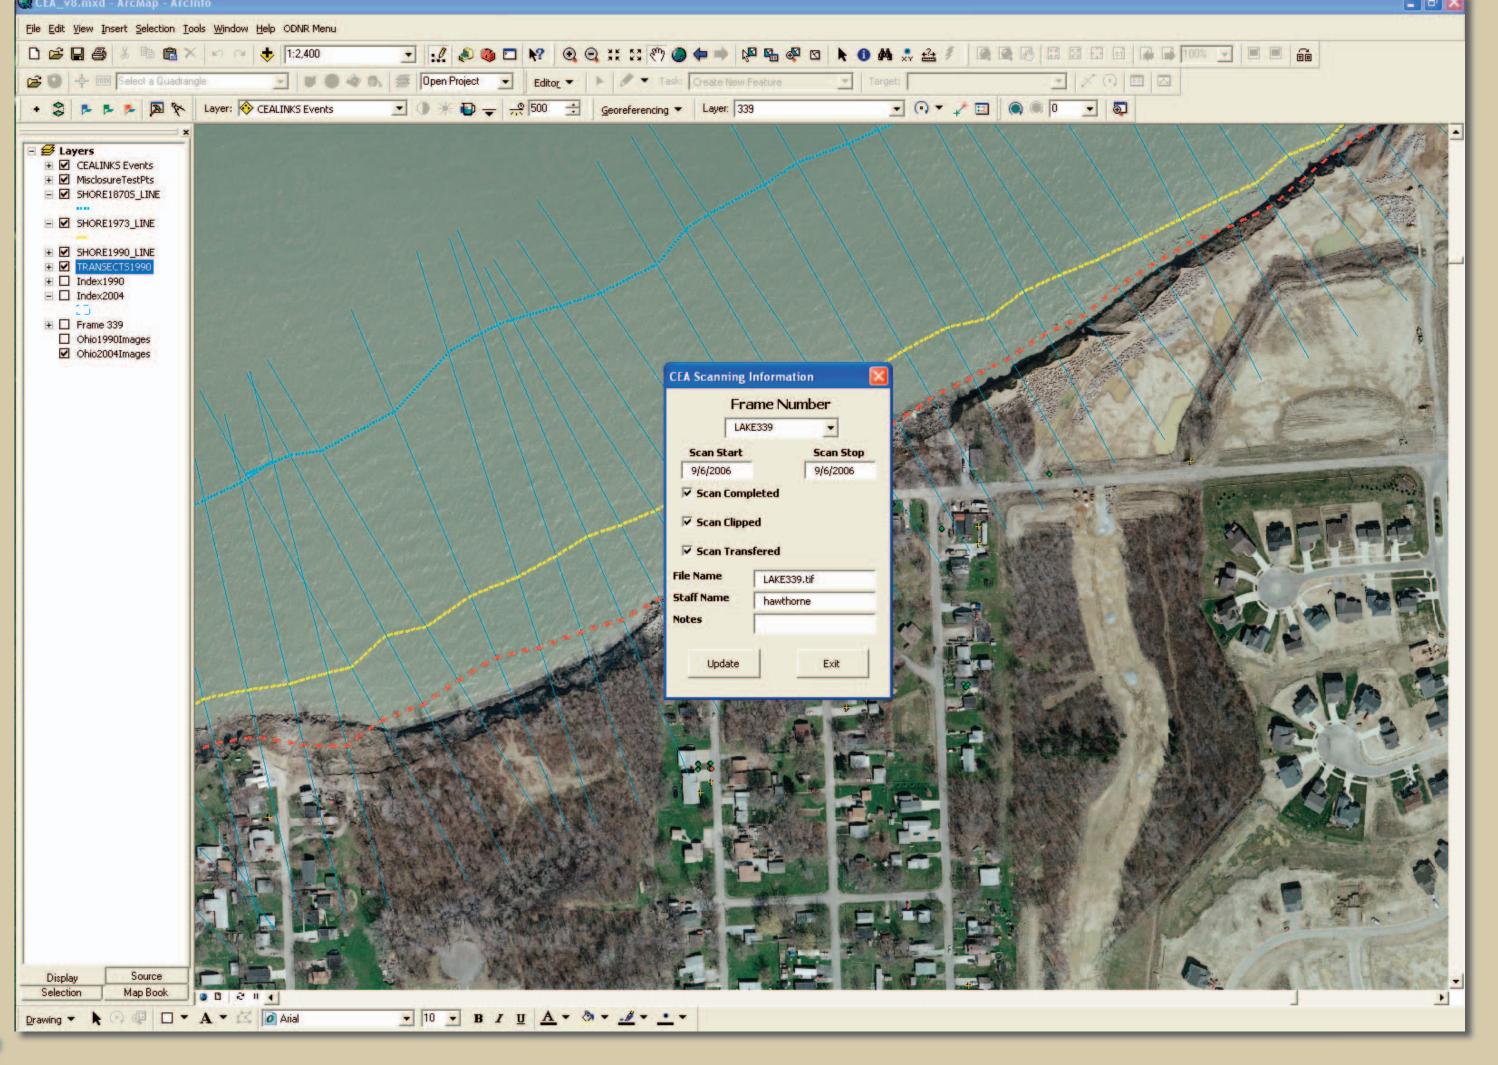
A VBA form used for tracking the progress of scanning the mylar photos. The VBA form allows information to be recorded about when the mylar photo was scanned, who did the scanning, and when the scanned image was transferred from the scanning PC to the network.

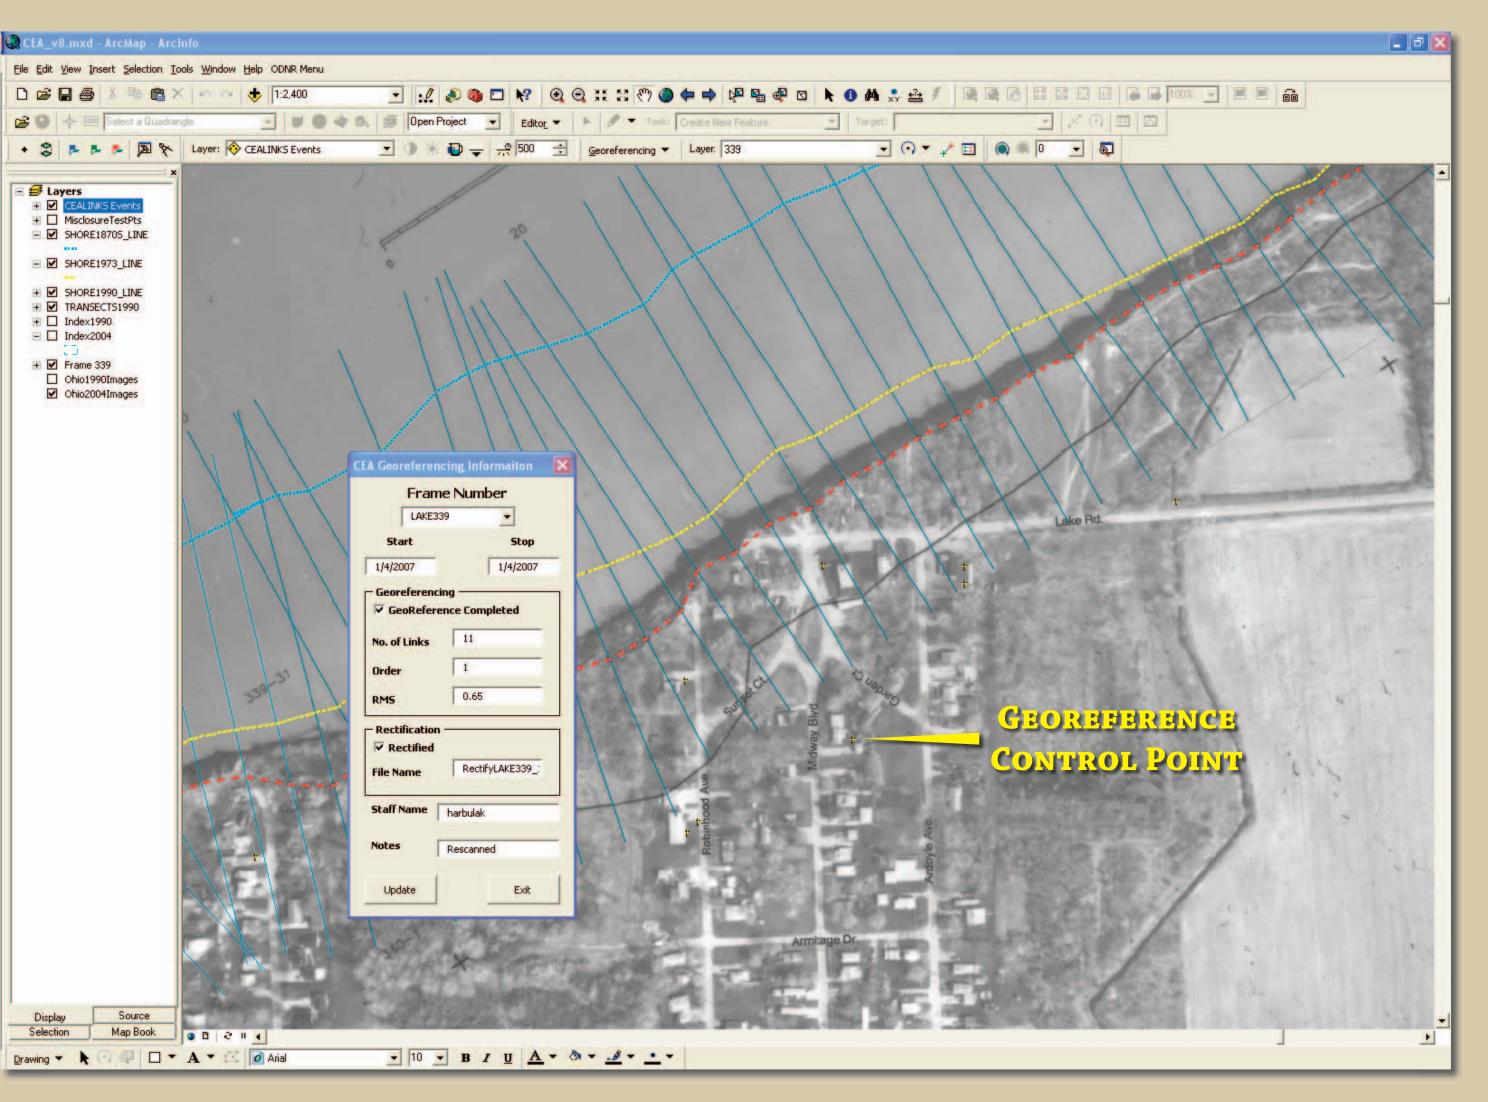
This is a VBA form for tracking the progress of georeferencing the mylar images. The form allows information to be recorded about the date started and stopped; georeferencing parameters, such as number of control points, georeferencing order, and RMS results; and the name of the rectified file and its location.

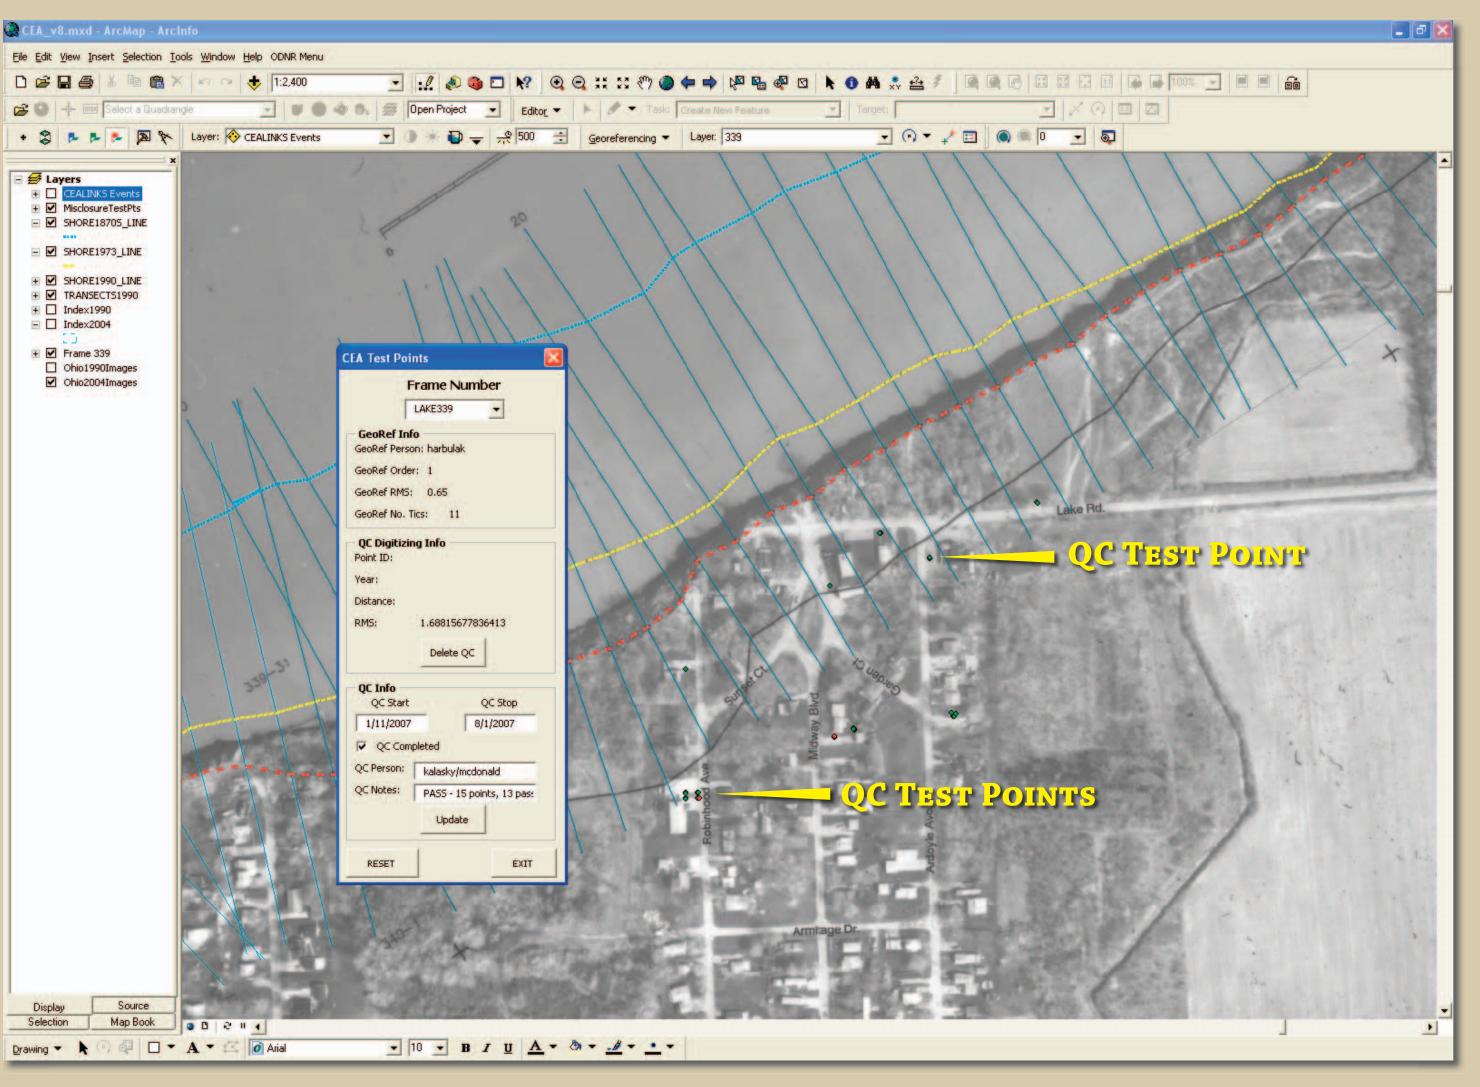
In order to check the accuracy of the georeferencing, a tool was created that would allow accuracy points to be digitized. These points were saved as a feature class in the GIS database. Part of the tool's function is to calculate the misclosure between a higher accuracy reference point and a corresponding test point on the newly created georeferenced image. The misclosure is recorded in the feature class attribute table and the points are symbolized as to whether they pass or fail the quality control check. Our initial project threshold was a misclosure of 2.5 feet between a 2004 reference point and a corresponding test point on the 1990 mylar image. The staff assigned to the project were instructed to digitize ten or more test points in order to perform a quality control test on a newly georeferenced 1990 image. If the number of passing points (misclosure < 2.5 feet) for the image comprised less than 80% of the test points, then staff were required to georeference the image again.

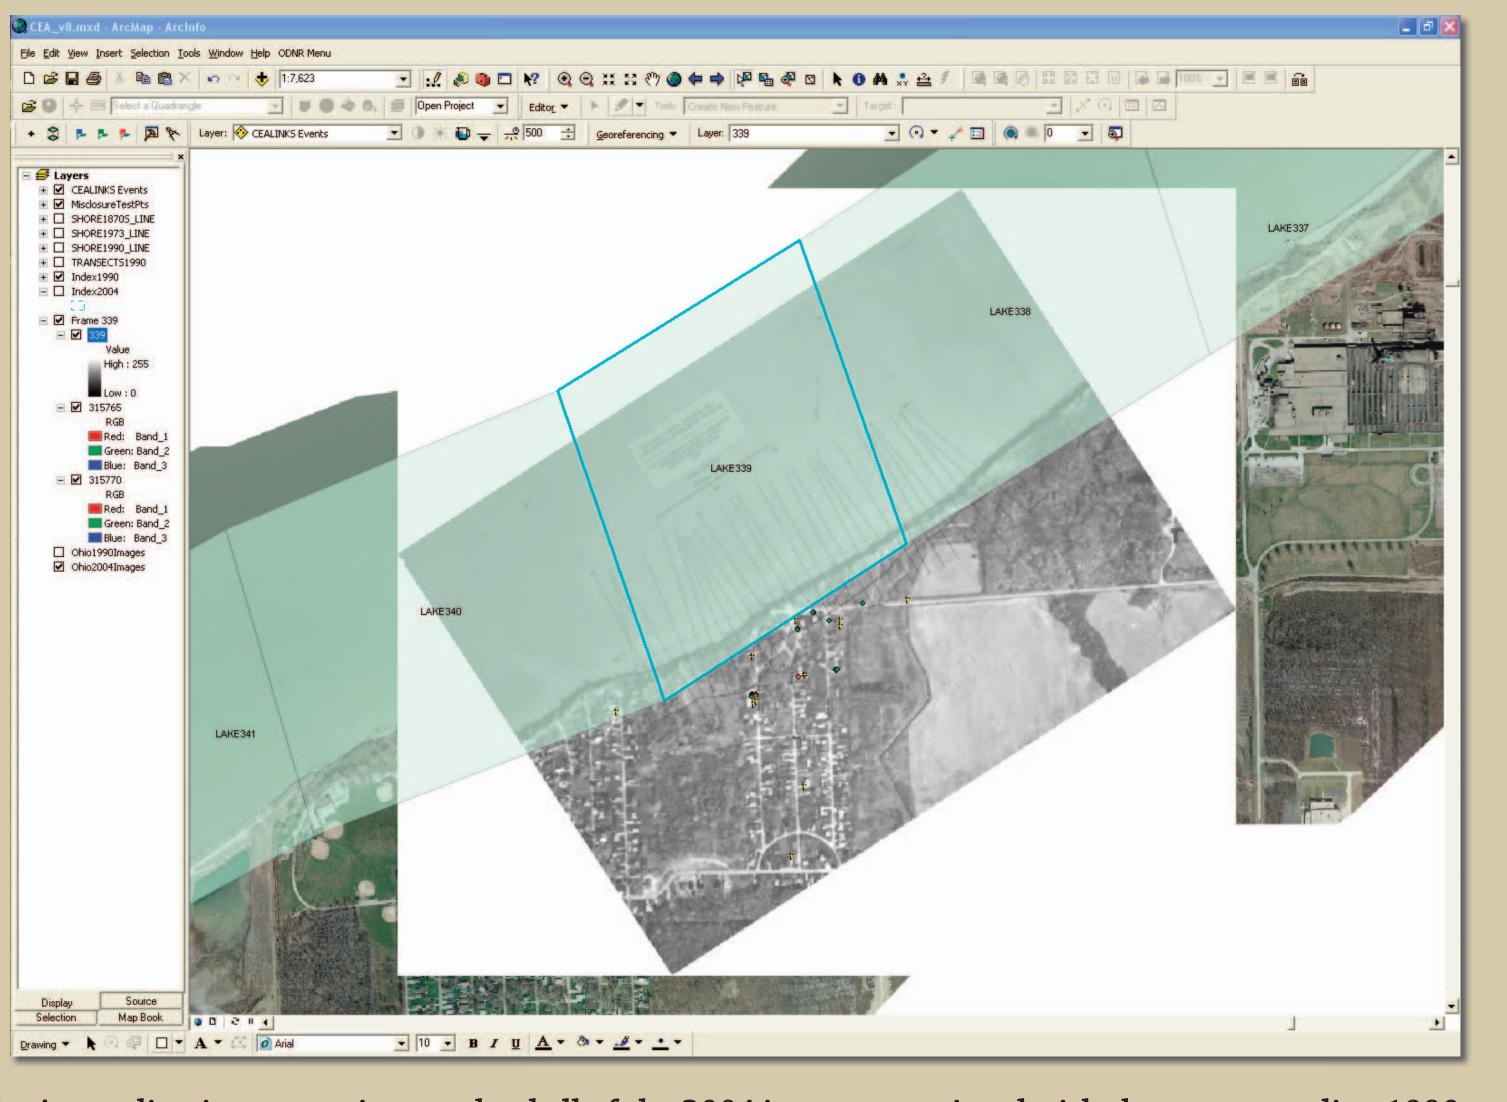
An application was written to load all of the 2004 images associated with the corresponding 1990 image. A GIS operator selects the 1990 index polygon, activates the application on a toolbar, and then all of the aerial-photo images are loaded for that area. In addition, all of the images are grouped together in the ArcMap Table of Contents, and the group layer is placed at the bottom of the Table of Contents. This application saves GIS operators time because they no longer have to hunt to find the images on the PC.

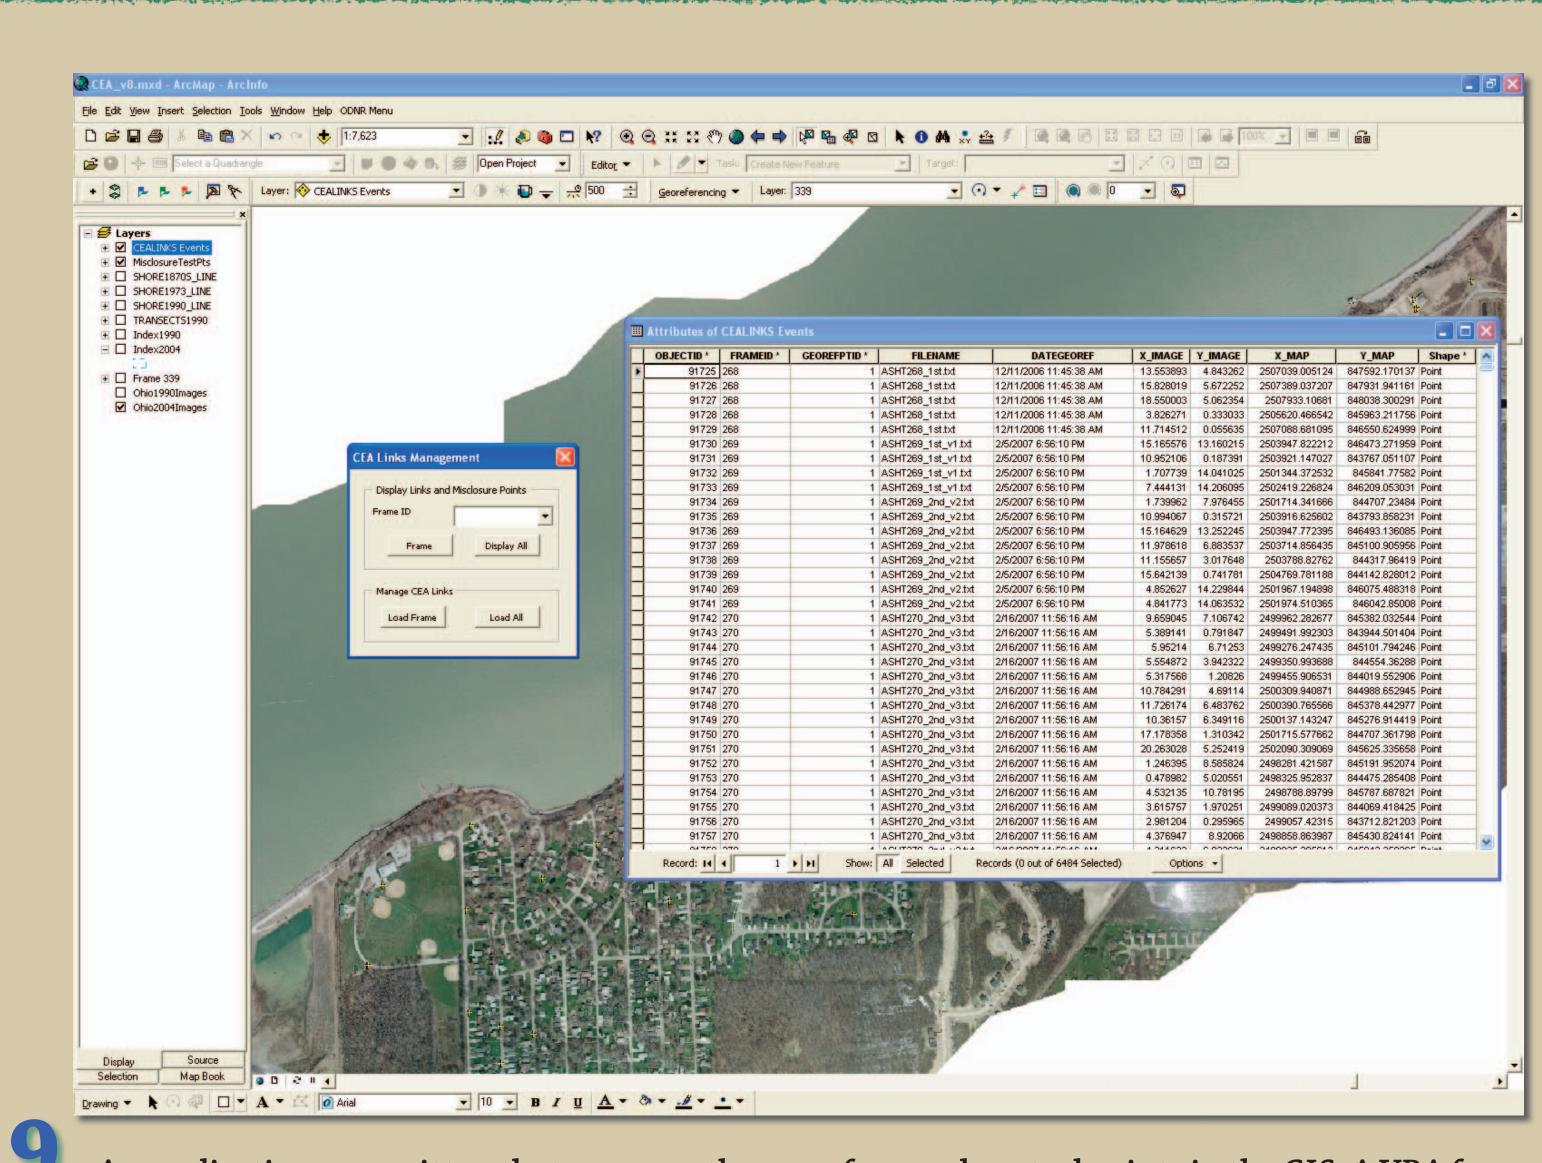
An application was written that manages the georeferenced control points in the GIS. A VBA form was created that provides access to four different tools. The two buttons grouped together on the bottom of the form, Load Frame and Load All, will load the georeferenced control-point text files into an attribute table in the GIS database. The attribute table is shown on the right. Either a single text file can be loaded or an entire directory of georeferenced control-point text files can be loaded. Two other buttons, at the top of the VBA form, control the display of the georeferenced control points and the misclosure test points. If a 1990 index frame is selected and the button Frame is selected, the ArcMap will zoom into the location of the selected 1990 image and hide all of the control points and misclosure points not associated with the selected image. This tool allows the user to examine either the control points or the misclosure points for a single image. The other button, Display All, will zoom out to the entire extent of the data and display all the points.
