Landslide Mapping Using LiDAR Data Technology

Prepared by:
State of Oregon
Department of Geology and Mineral Industries
Vicki S. McConnell, State Geologist
800 NE Oregon St., Ste. 965
Portland, Oregon 97232
(971) 673-1555
<http://www.oregongeology.com/>

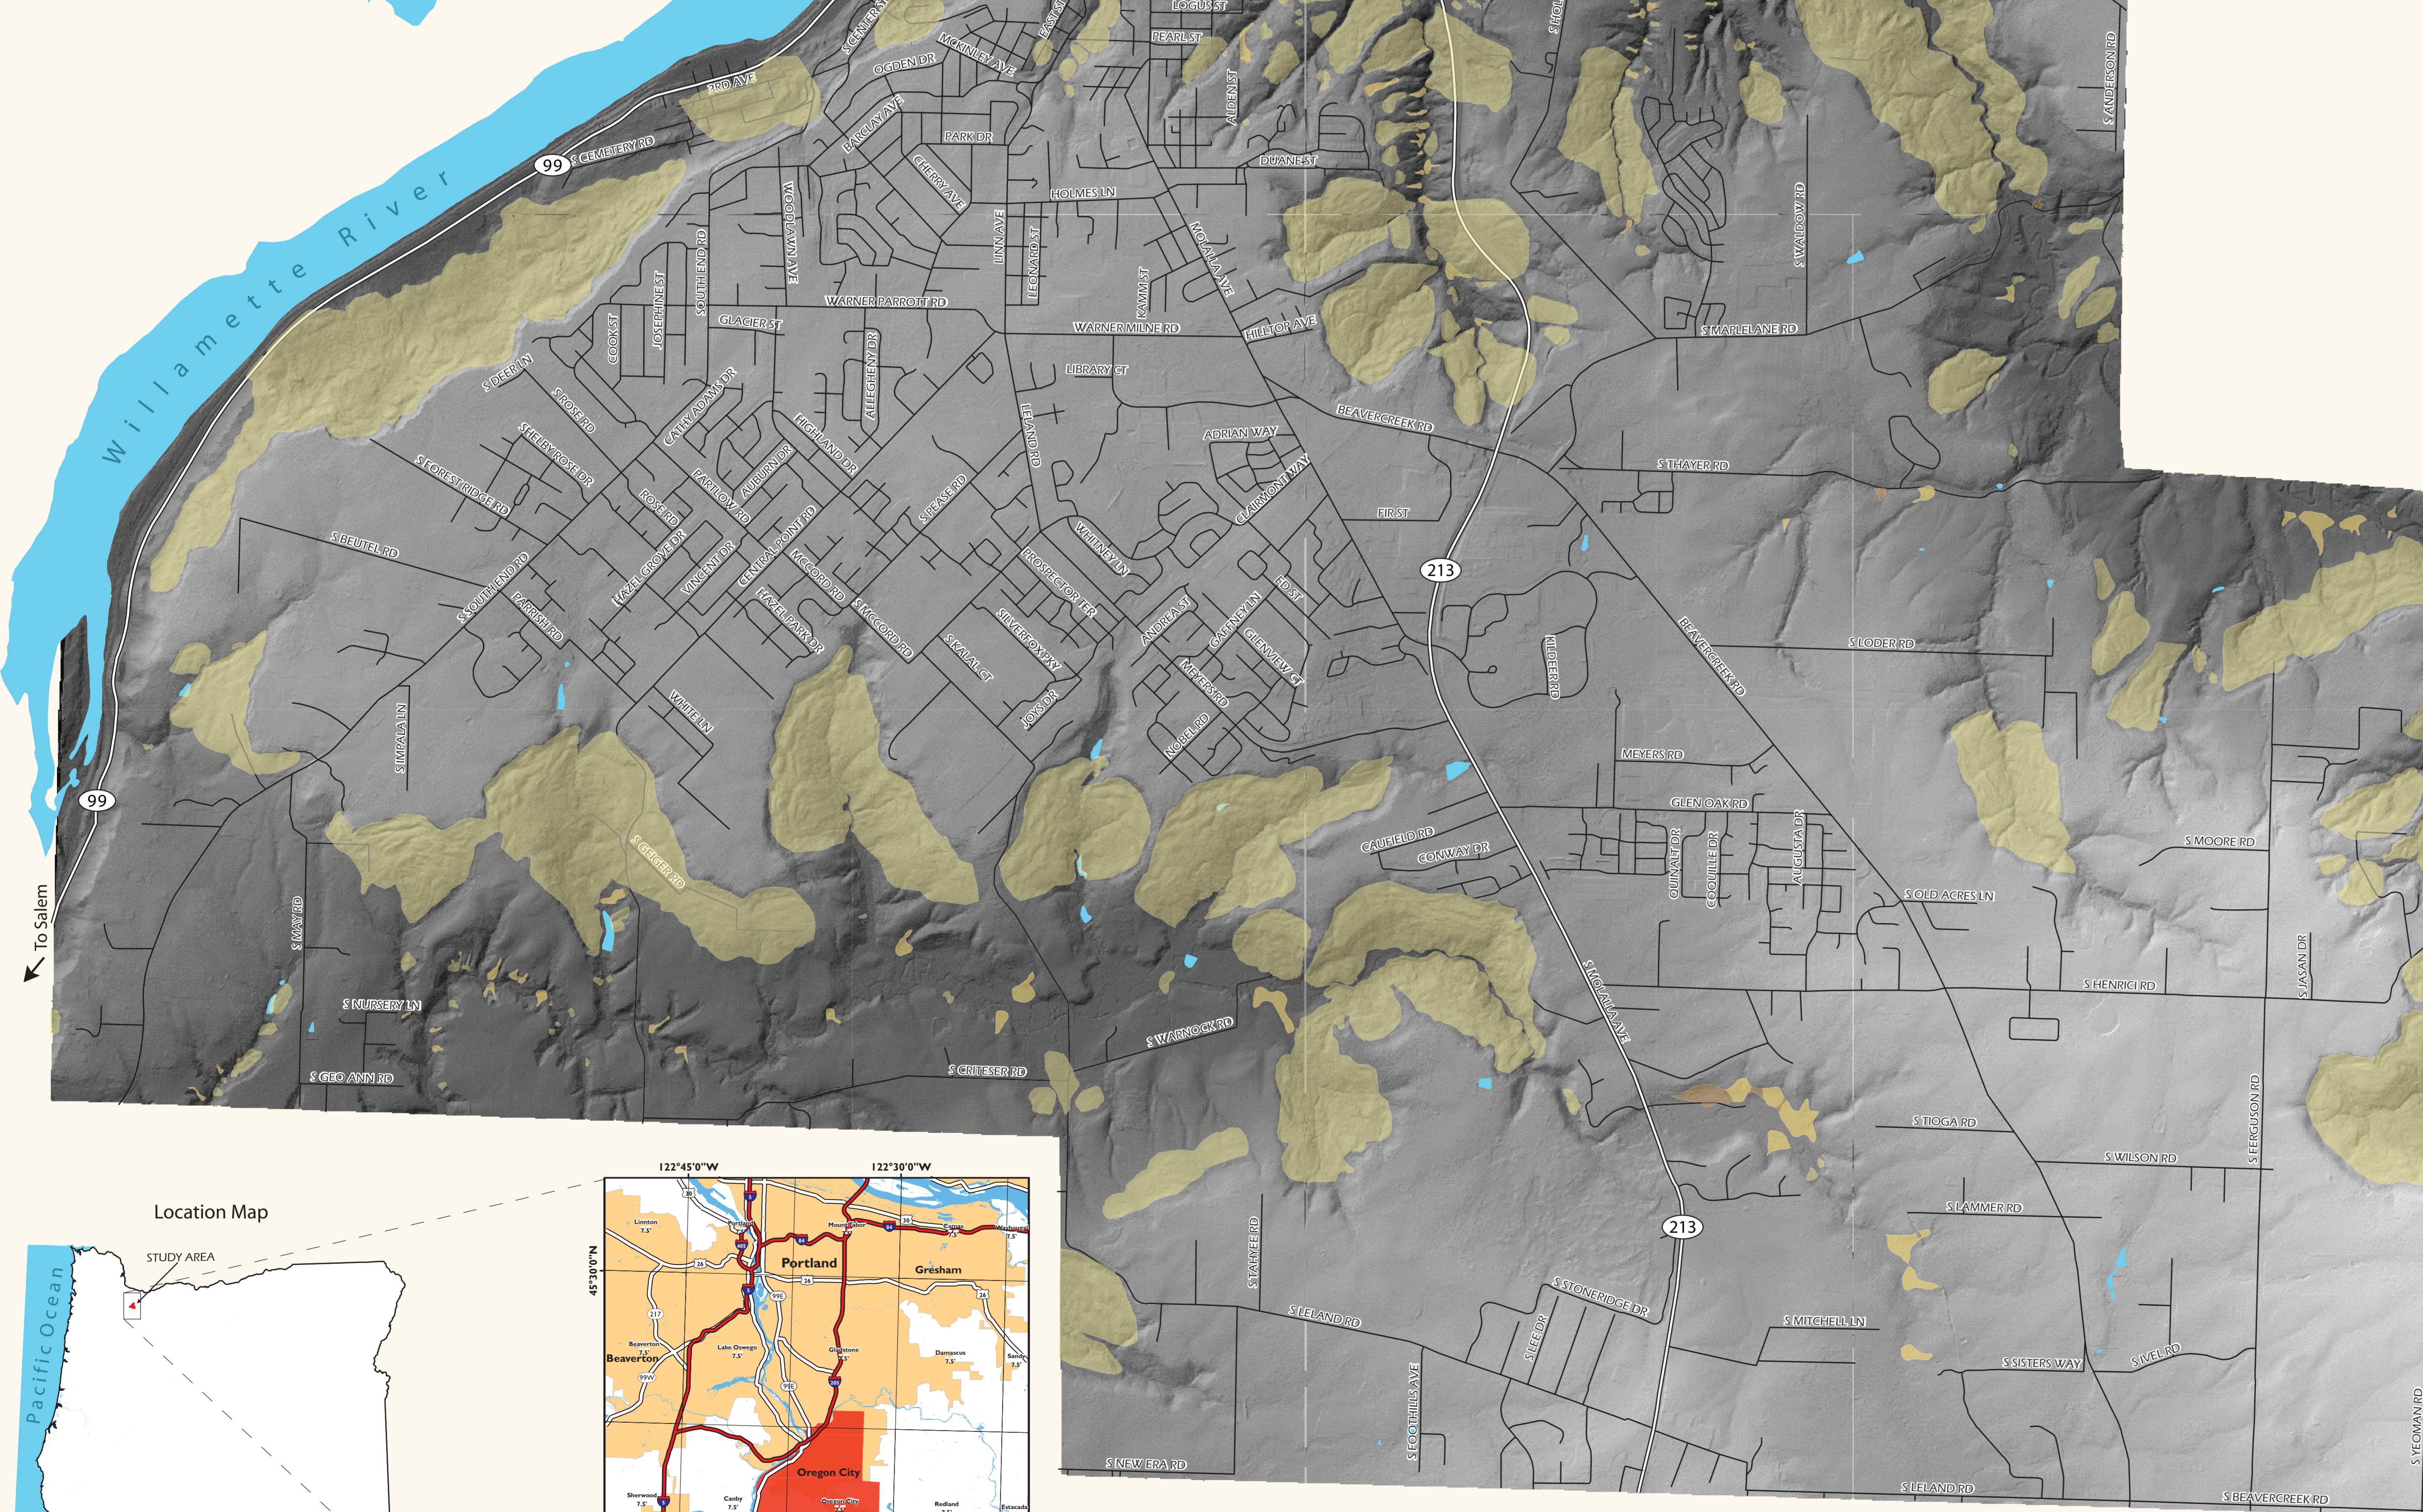
USGS 10m DEM	City of Portland Data	Stereo-Pair Aerial Photograph -1973	LIDAR Data
All four data sets mapped by one geologist				
Smallest landslide found(m ²)	106,988	5,330	2,019	80
Largest landslide found(m ²)	7,208,710	7,216,927	6,048,897	5,993,277
Landslides found hours spent average landslides found per hour	11 6 1.8	34 10 3.4	31 21 1.5	211 37 5.7
Each data set mapped by a different geologist				
Smallest landslide found(m ²)	34,693	1,694	8,111	28
Largest landslide found(m ²)	309,185	3,050,746	959,016	92,640
Landslides found hours spent average landslides found per hour	6 8 0.8	69 11 6.3	18 10 1.8	151 39 3.9
Average (all mappers)				
Landslides found hours spent landslides found per hour	8.5 7 1.2	51.5 10.5 4.9	24.5 15.5 1.6	181 38 4.8

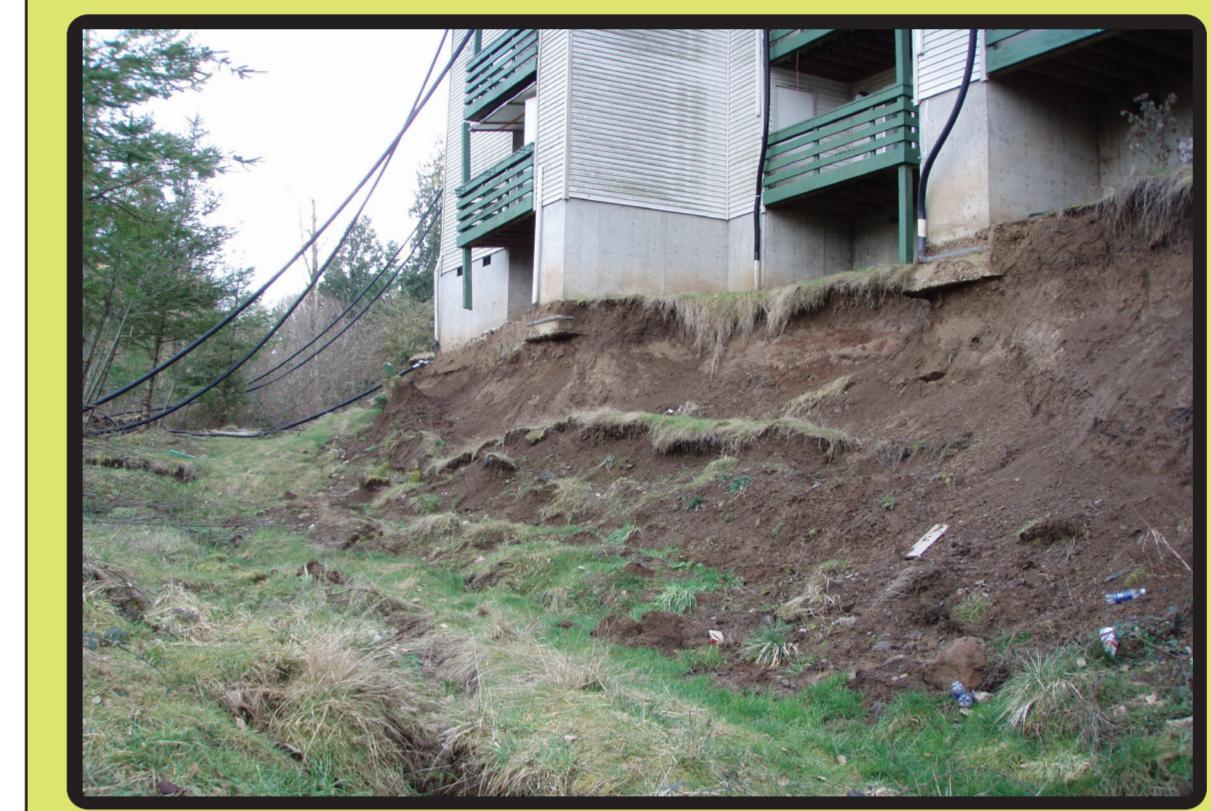
Photograph depicting scars along the crest of the toe of the large Newell Creek Apartments landslide - 2007.

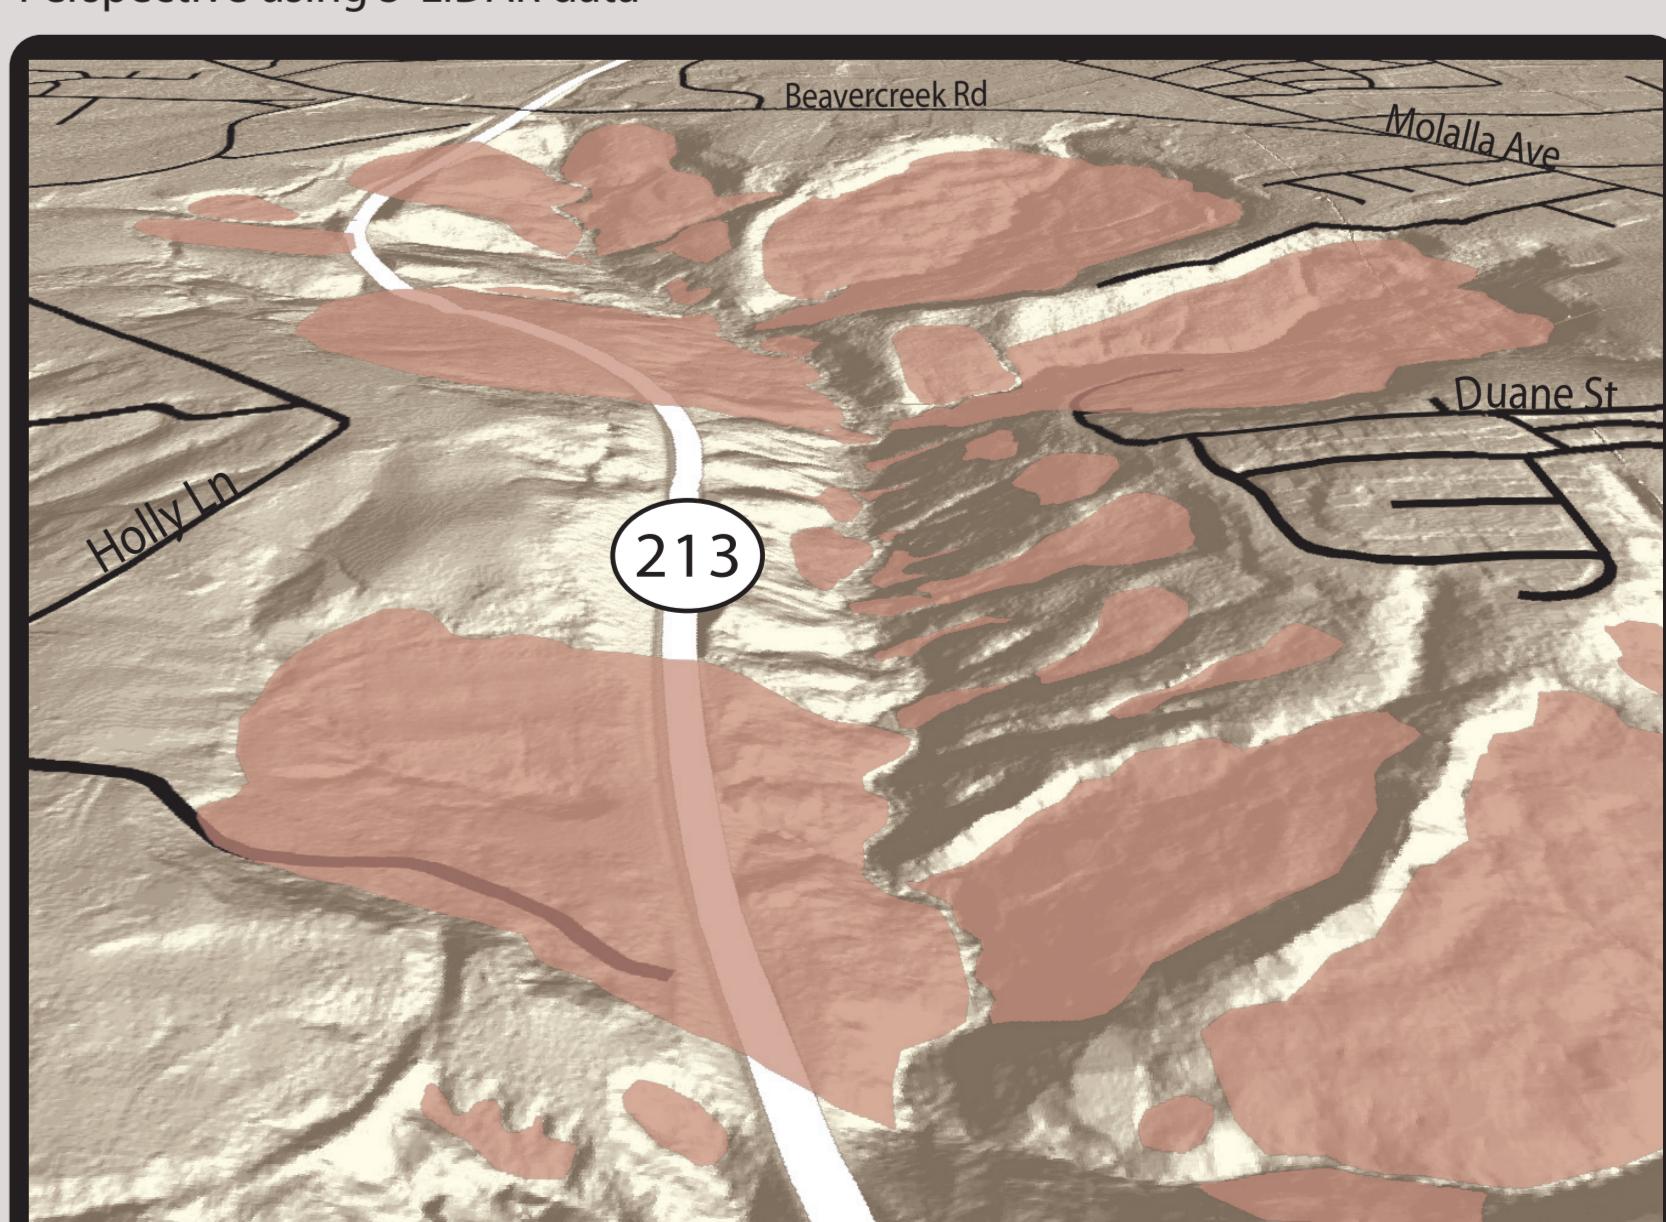
Perspective using 5' LiDAR data

LiDAR is an inexpensive, fast and better way to obtain superior details of the true shape of the Earth's surface, as compared with existing decades-old topographic maps and the digital elevation models (DEMs) derived from them. DOGAMI uses LiDAR DEMs as an accurate and precise base for detailed geologic mapping and to radically improve our landslide, earthquake, coastal change and tsunami inundation hazard assessment maps. Current efforts in identifying hazardous areas are, by default, "blurry" as the underlying topographic resolution itself is poor. Existing topographic maps were interpreted manually from aerial photos taken decades ago. They are outdated and there are myriad errors, especially in highly forested areas where the map makers could not see through the forest canopy. As a result, slopes are smoothed out and stream gradient detail is absent. This existing topographic base is frequently incomplete, artificial and simply wrong. High quality hazard assessment maps cannot be generated from low quality topographic data. With accurate, precise and high resolution DEMs, such as those based on LiDAR data, we achieve superb hazard assessment. When combined with wise planning, we sharpen the focus on truly dangerous locations for landslides, floods, coastal erosion, tsunami inundation and seismic activity. The following are examples of varying datasets throughout the years available to geologists and engineers for the detection of geohazards. LiDAR data detected landslides are symbolized by transparent red polygons.

Initial processing of the Oregon City LiDAR data-points produced a DEM (Oregon State Plane N, 1983) with 5 ft by 5 ft cells, in addition enhancing that DEM with both relief shading and slope maps to highlight subtle topography. Also produced were elevation contours at 2 foot intervals to help visualize the data. We then digitized the areas of landslide topography directly from LiDAR imagery at a scale of 1:2,400, again using topographic evidence such as scars, hummocky terrain, and lobate toes. An additional advantage of the LiDAR data was that we could instantly produce topographic cross sections along a suspect slope. With the LiDAR data it was also possible to see subtle fan deposits at the mouths of small canyons that be interpreted as debris flow or earth flow deposits.
