# New GIS Tools for Mapping Ohio's Lake Erie Coastal Erosion Areas

James McDonald  
Ohio Department of Natural Resources,  
Division of Geological Survey

## SHORE EROSION ALONG THE COAST OF LAKE ERIE

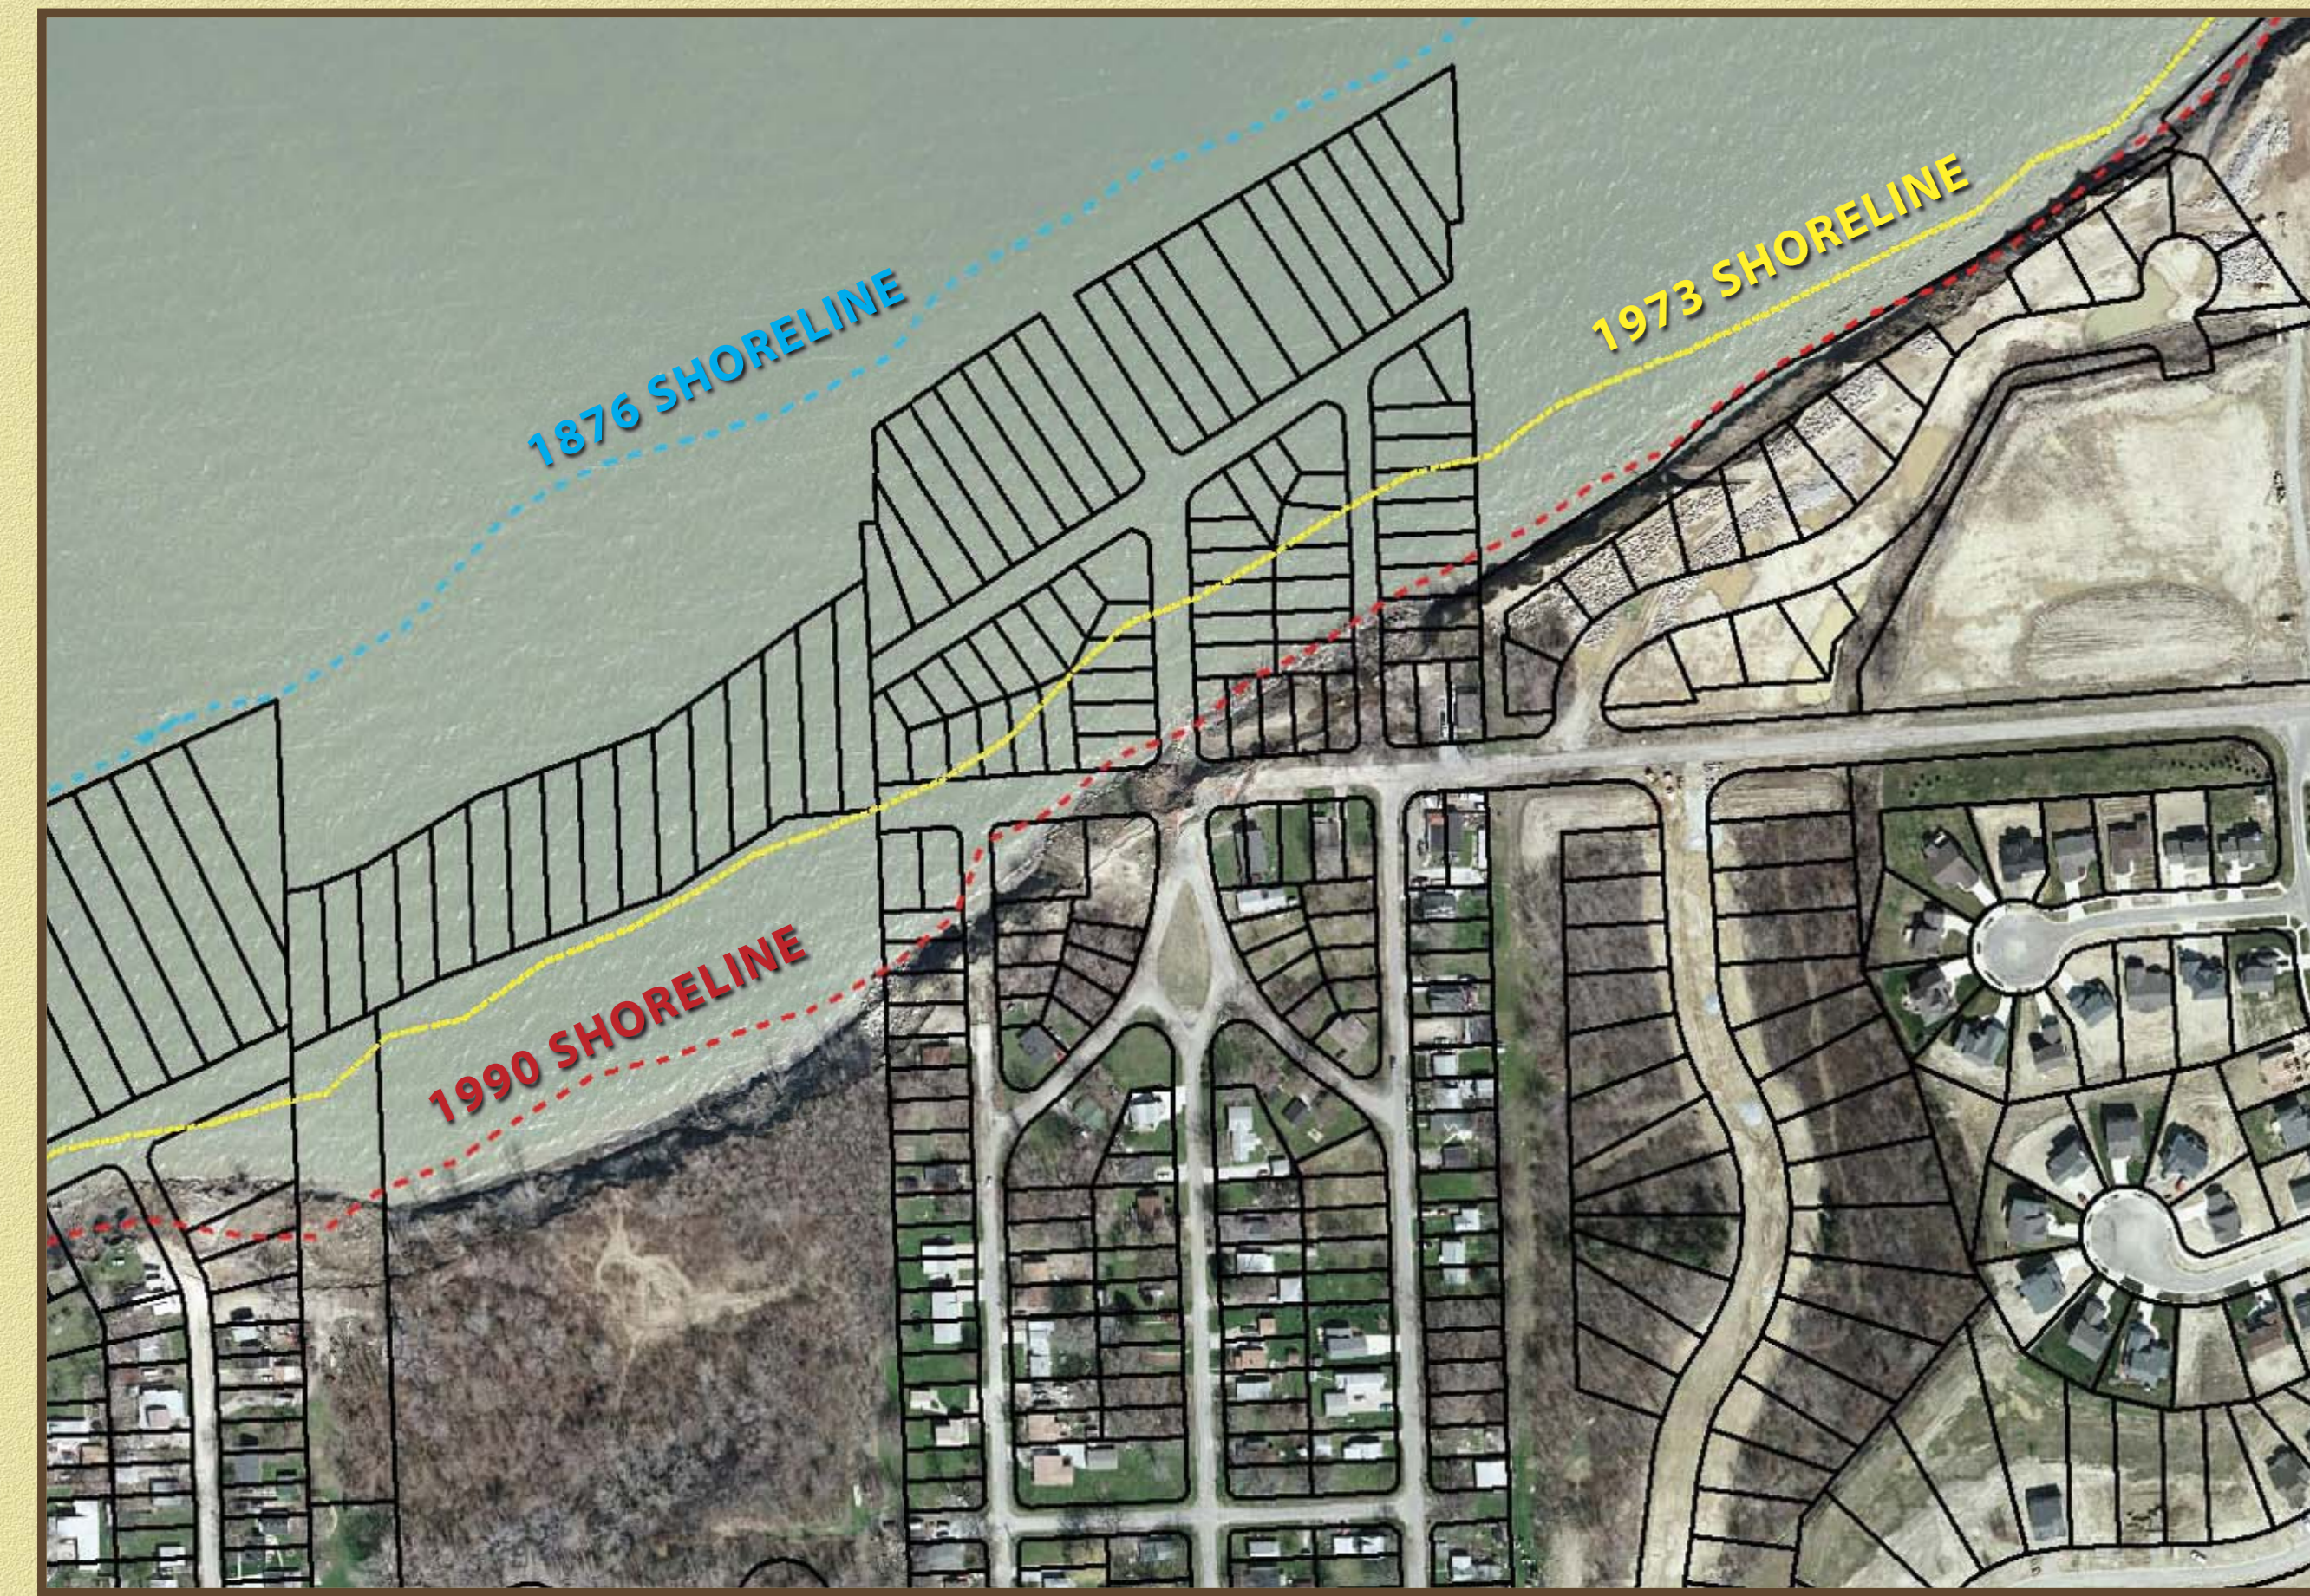
FIGURE 1.—Between 1973 and 1990, Ohio's shoreline receded approximately 24 feet. This area near Painesville experienced up to 207 feet of recession. Numerous parcels (black outlines) have been lost to coastal erosion.

Erosion along Ohio's Lake Erie shoreline is a major geologic hazard. The coastline undergoes large- and small-scale changes. Figures 1 and 2 highlight some large-scale changes. Figure 1 shows an area near Painesville that has undergone between 34 and 207 feet of recession over a 17-year period, while the Sheldon Marsh barrier island has undergone between 268 and 953 feet of recession during that same period (fig. 2).

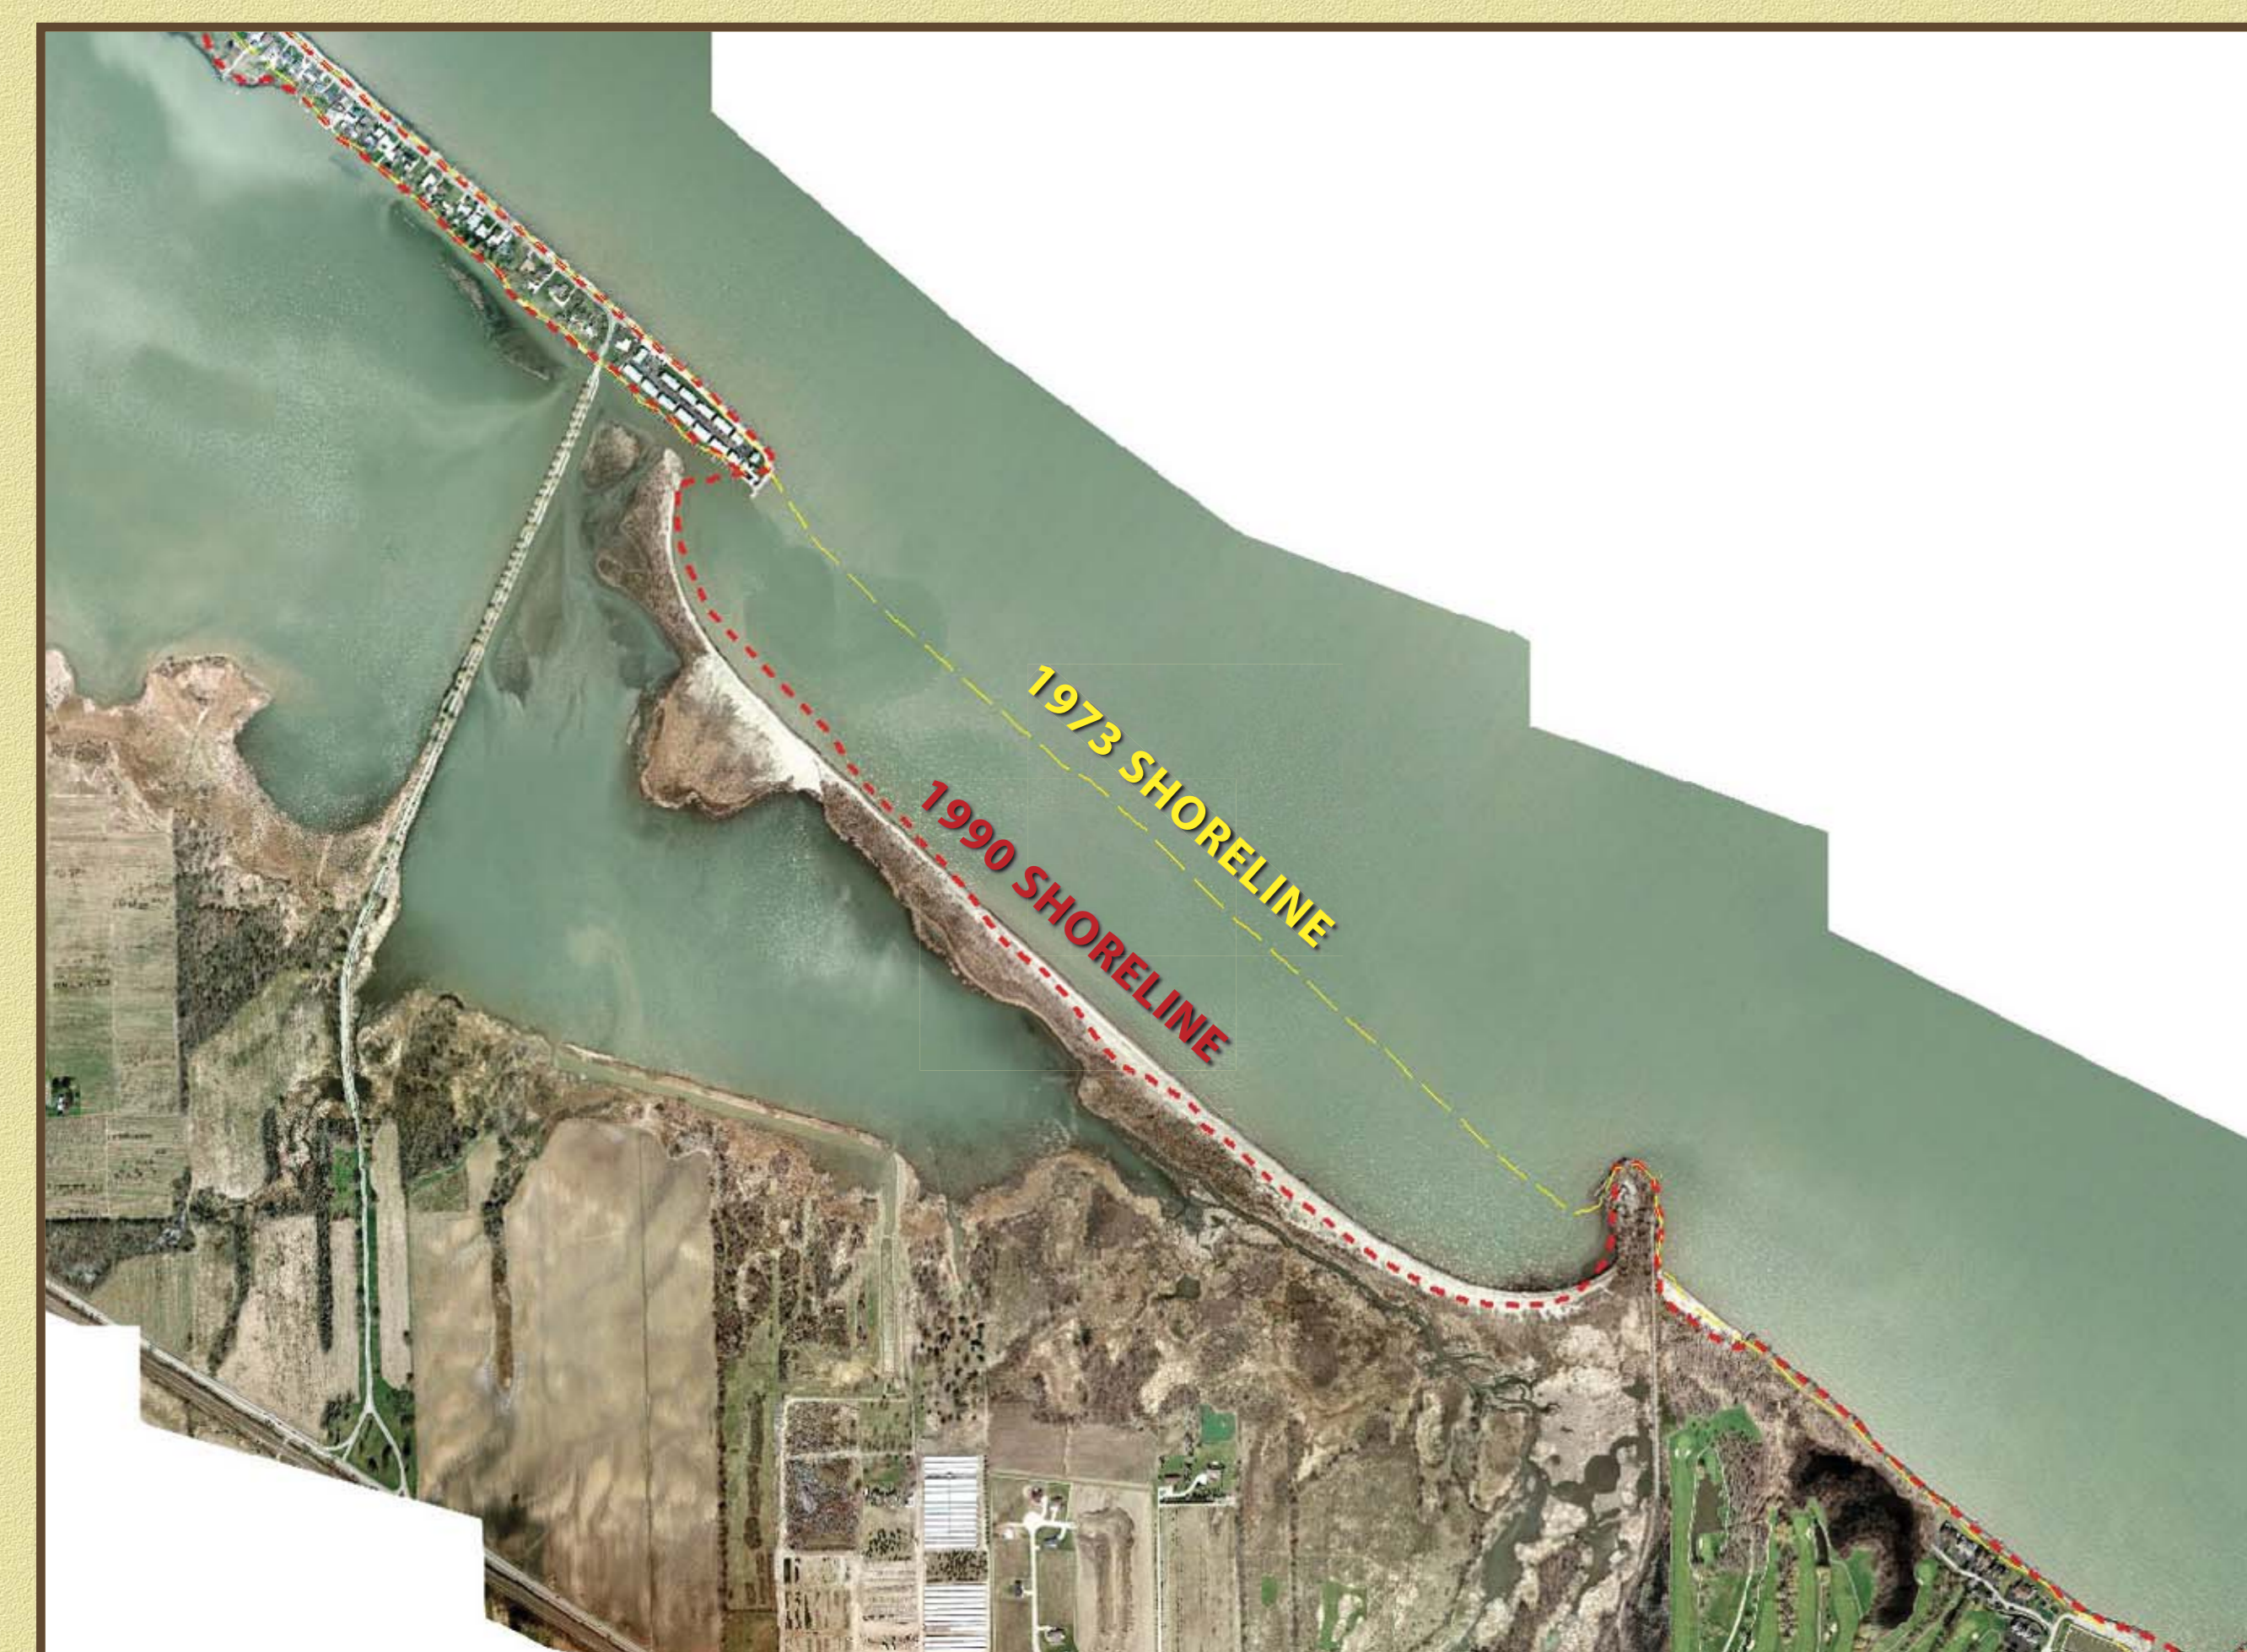
FIGURE 2.—The Sheldon Marsh barrier island has been retreating at a rate between 15 to 56 feet per year.

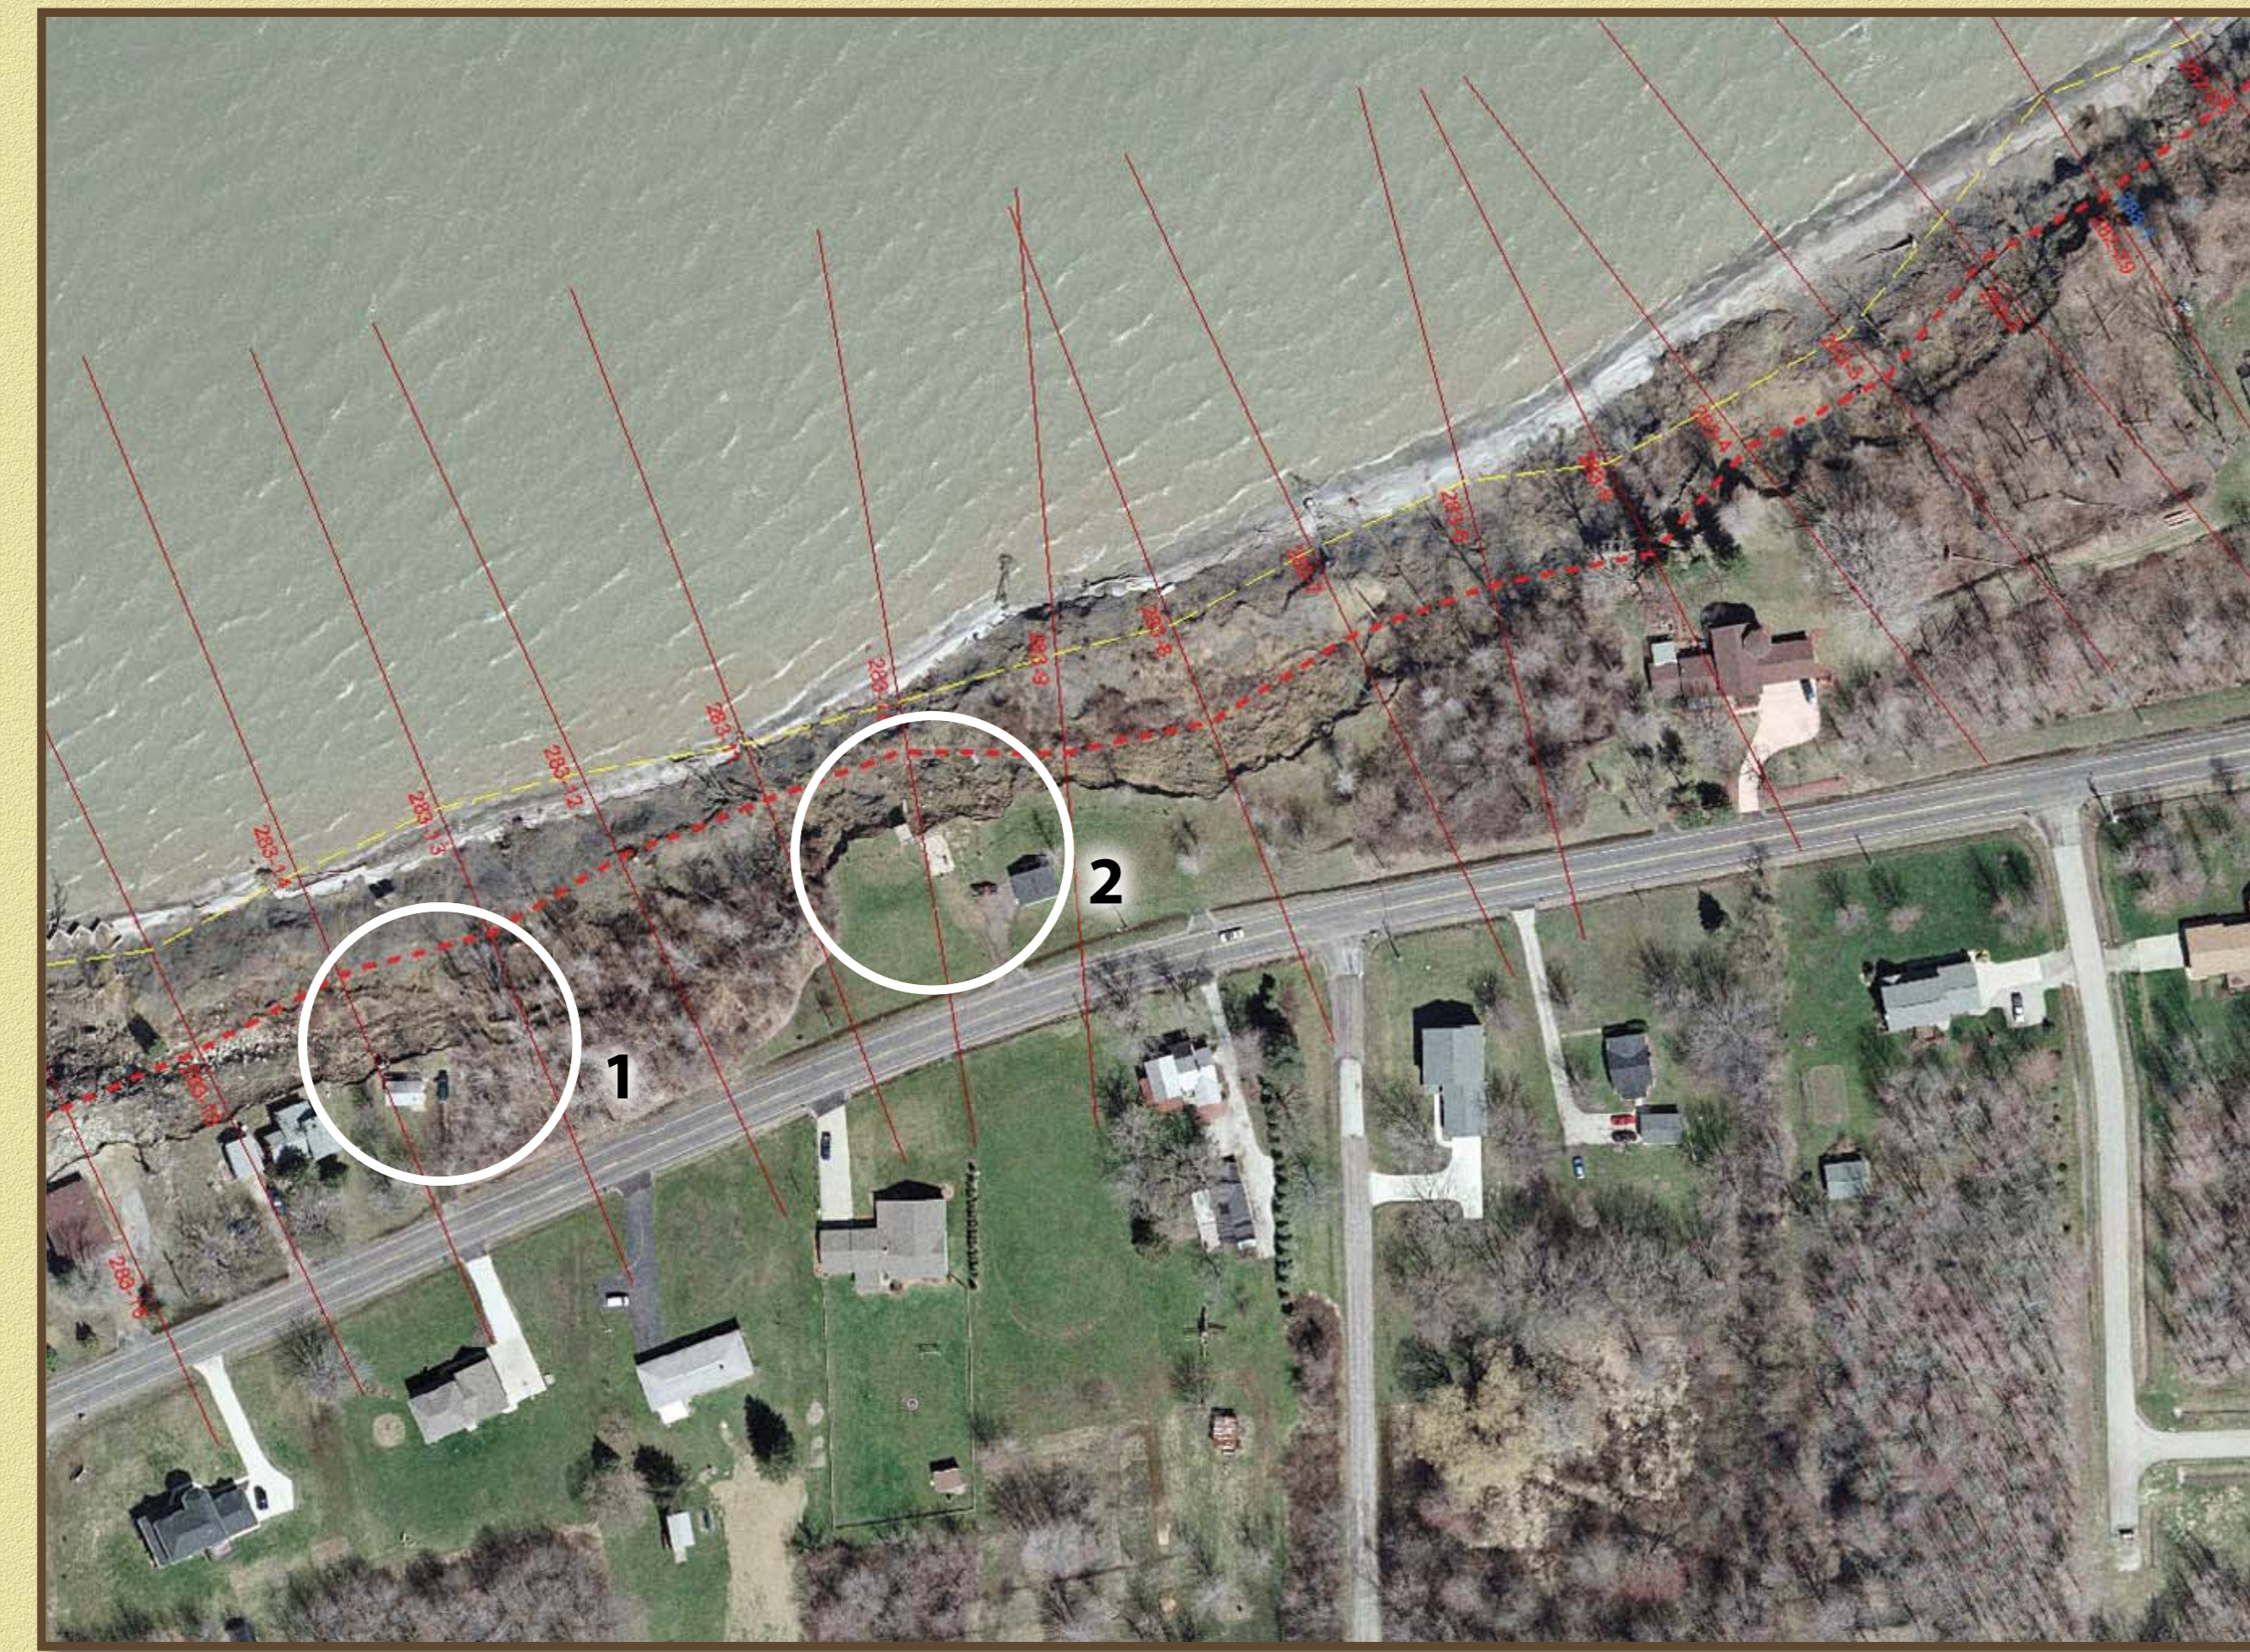
FIGURE 3b.—By 2004, the two houses (circled) have been lost to coastal erosion. Property (2) now has a garage.

More normal coastal erosion rates also erode bluffs and destroy properties. As a bluff recedes, buildings may be either physically moved back from the bluff or torn down before being destroyed or destroyed from the erosion. In Figures 3a, 3b, and 3c, two houses have disappeared and homeowners probably have moved into the garages. Geology, lake levels, prevailing winds, and shore protection affect coastal erosion rates. Between 1973 and 1990, average shoreline recession was 1.41 feet per year. Over the 17-year period the shoreline receded nearly 24 feet. In certain areas, recession has occurred at rates up to 56 feet per year (fig. 2). Ohio's Lake Erie coastline erosion significantly affects coastal residents.

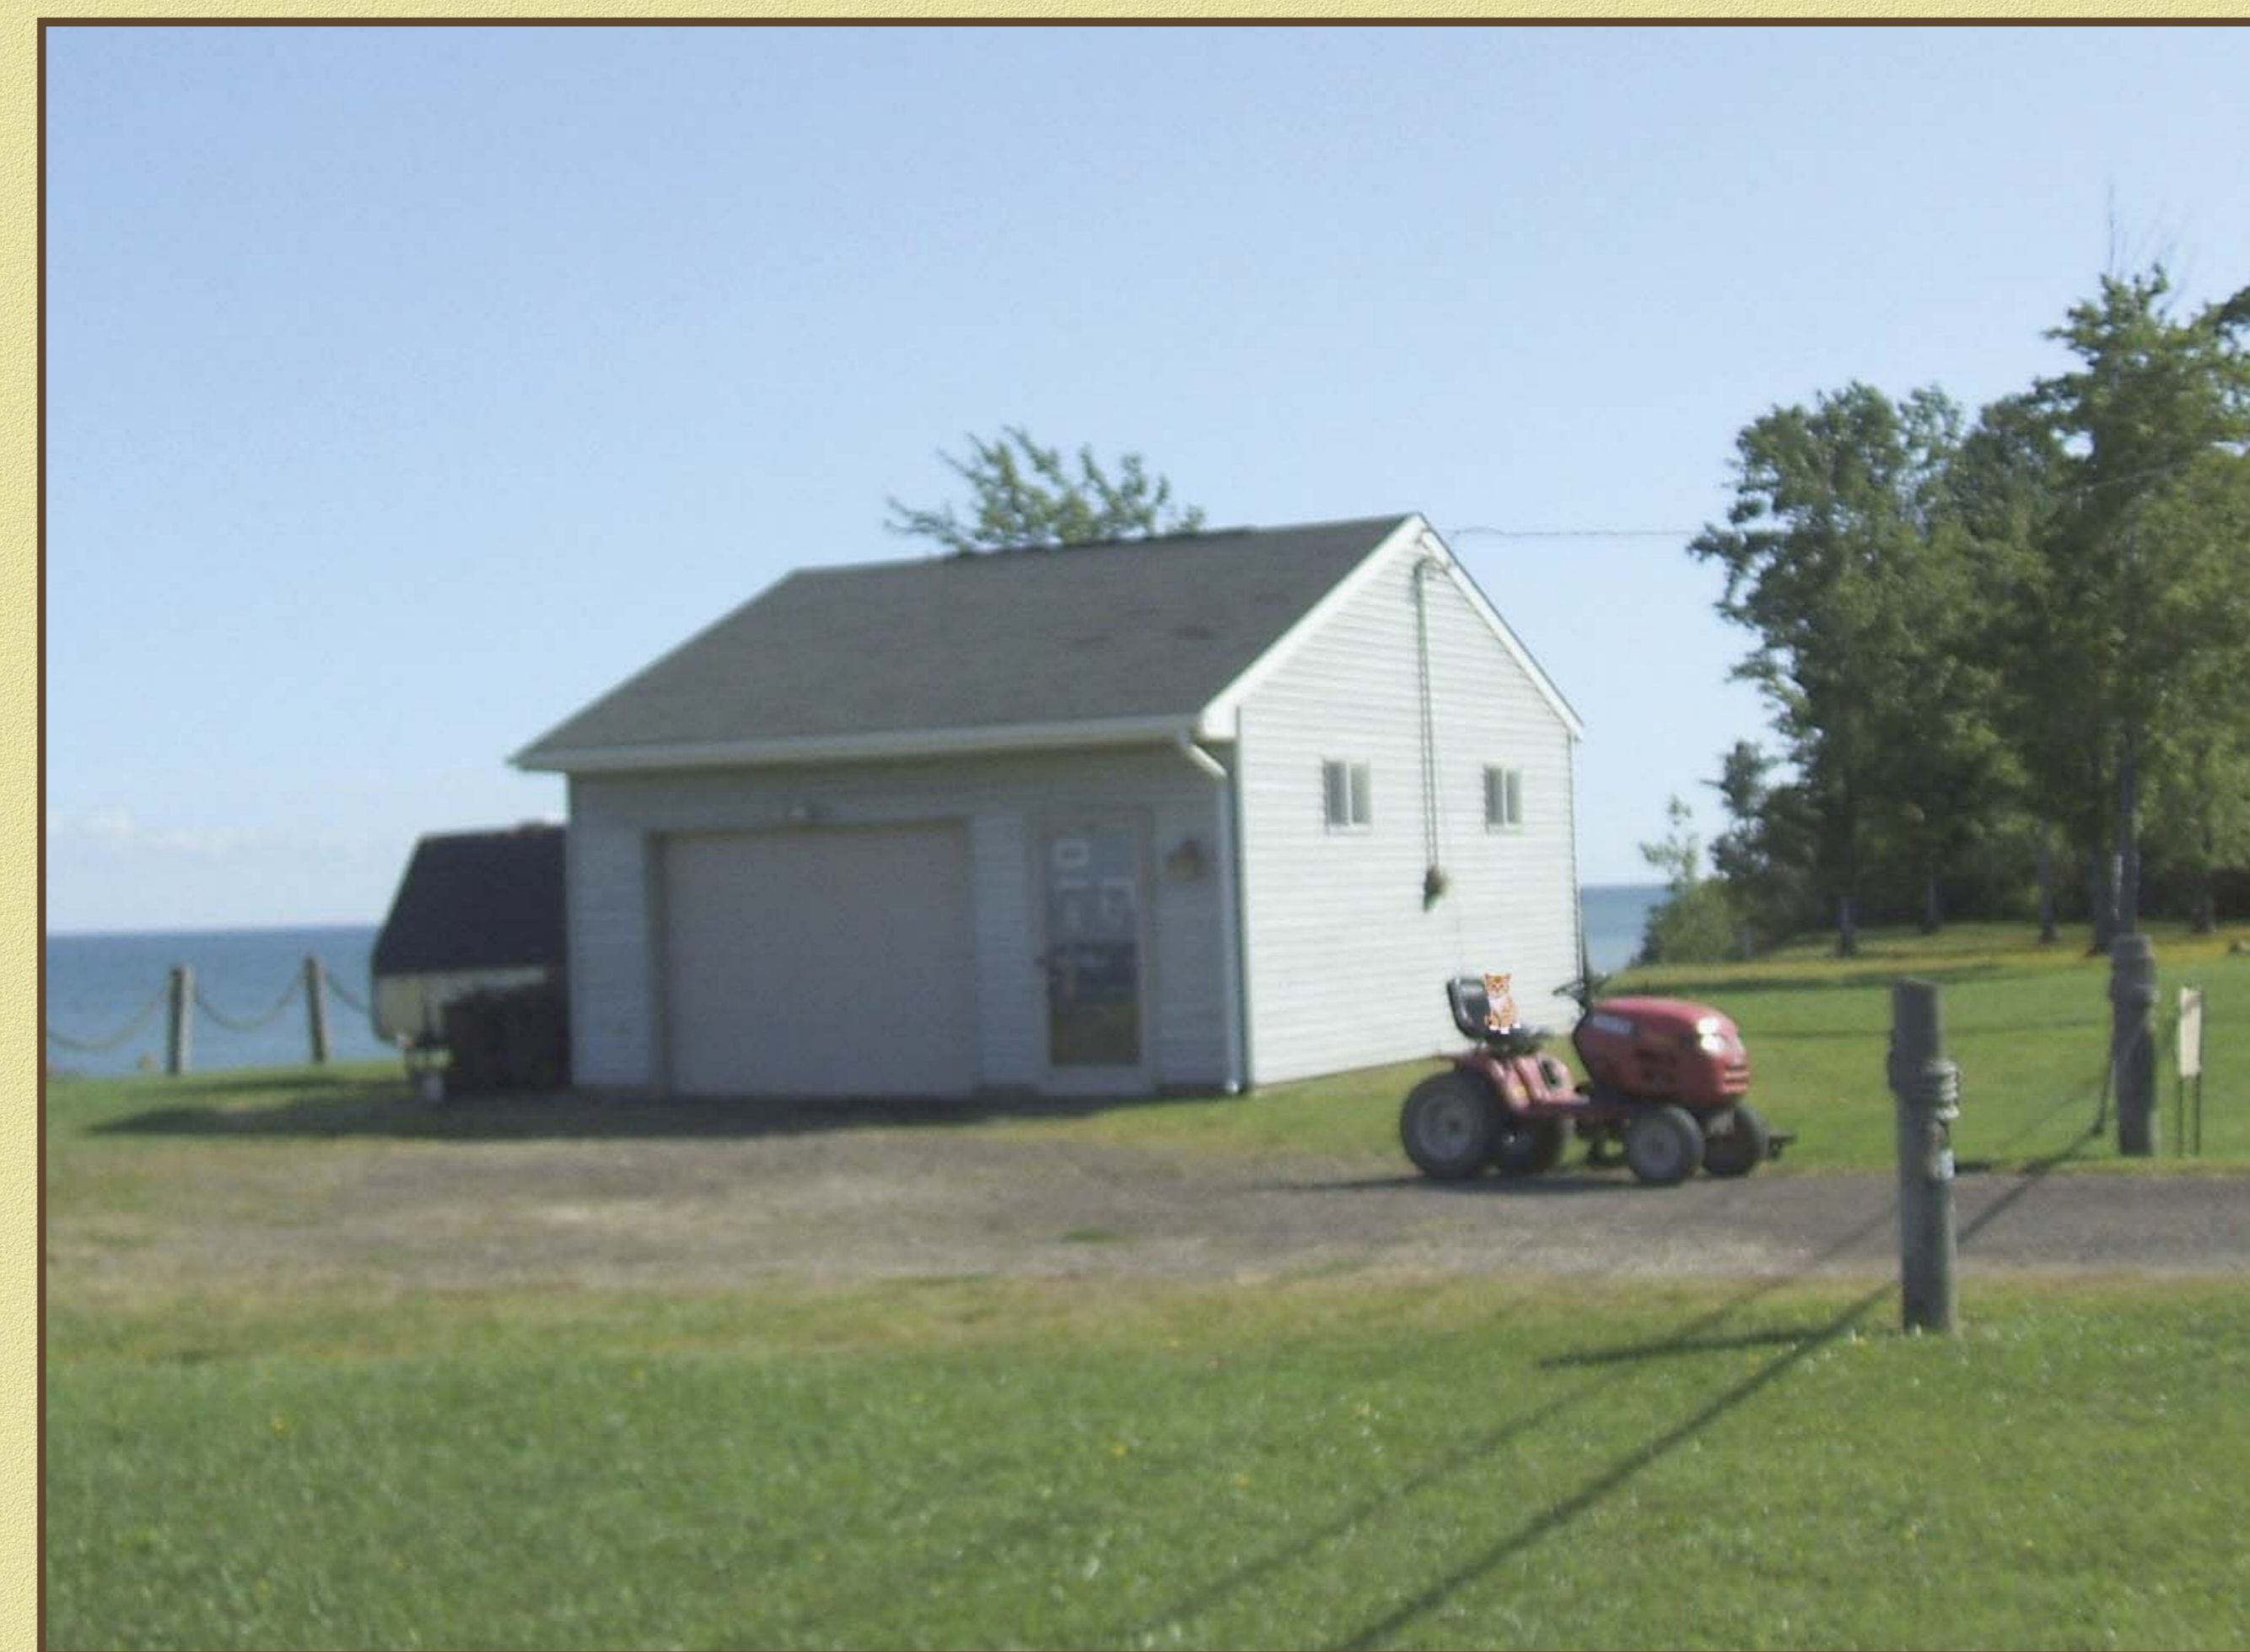
FIGURE 3c.—The property (2) owners probably have moved into the garage.
