The following was presented at DMT'10
(May 16-19, 2010).

INTRODUCTION

OMSIUA GIS APPLICATION

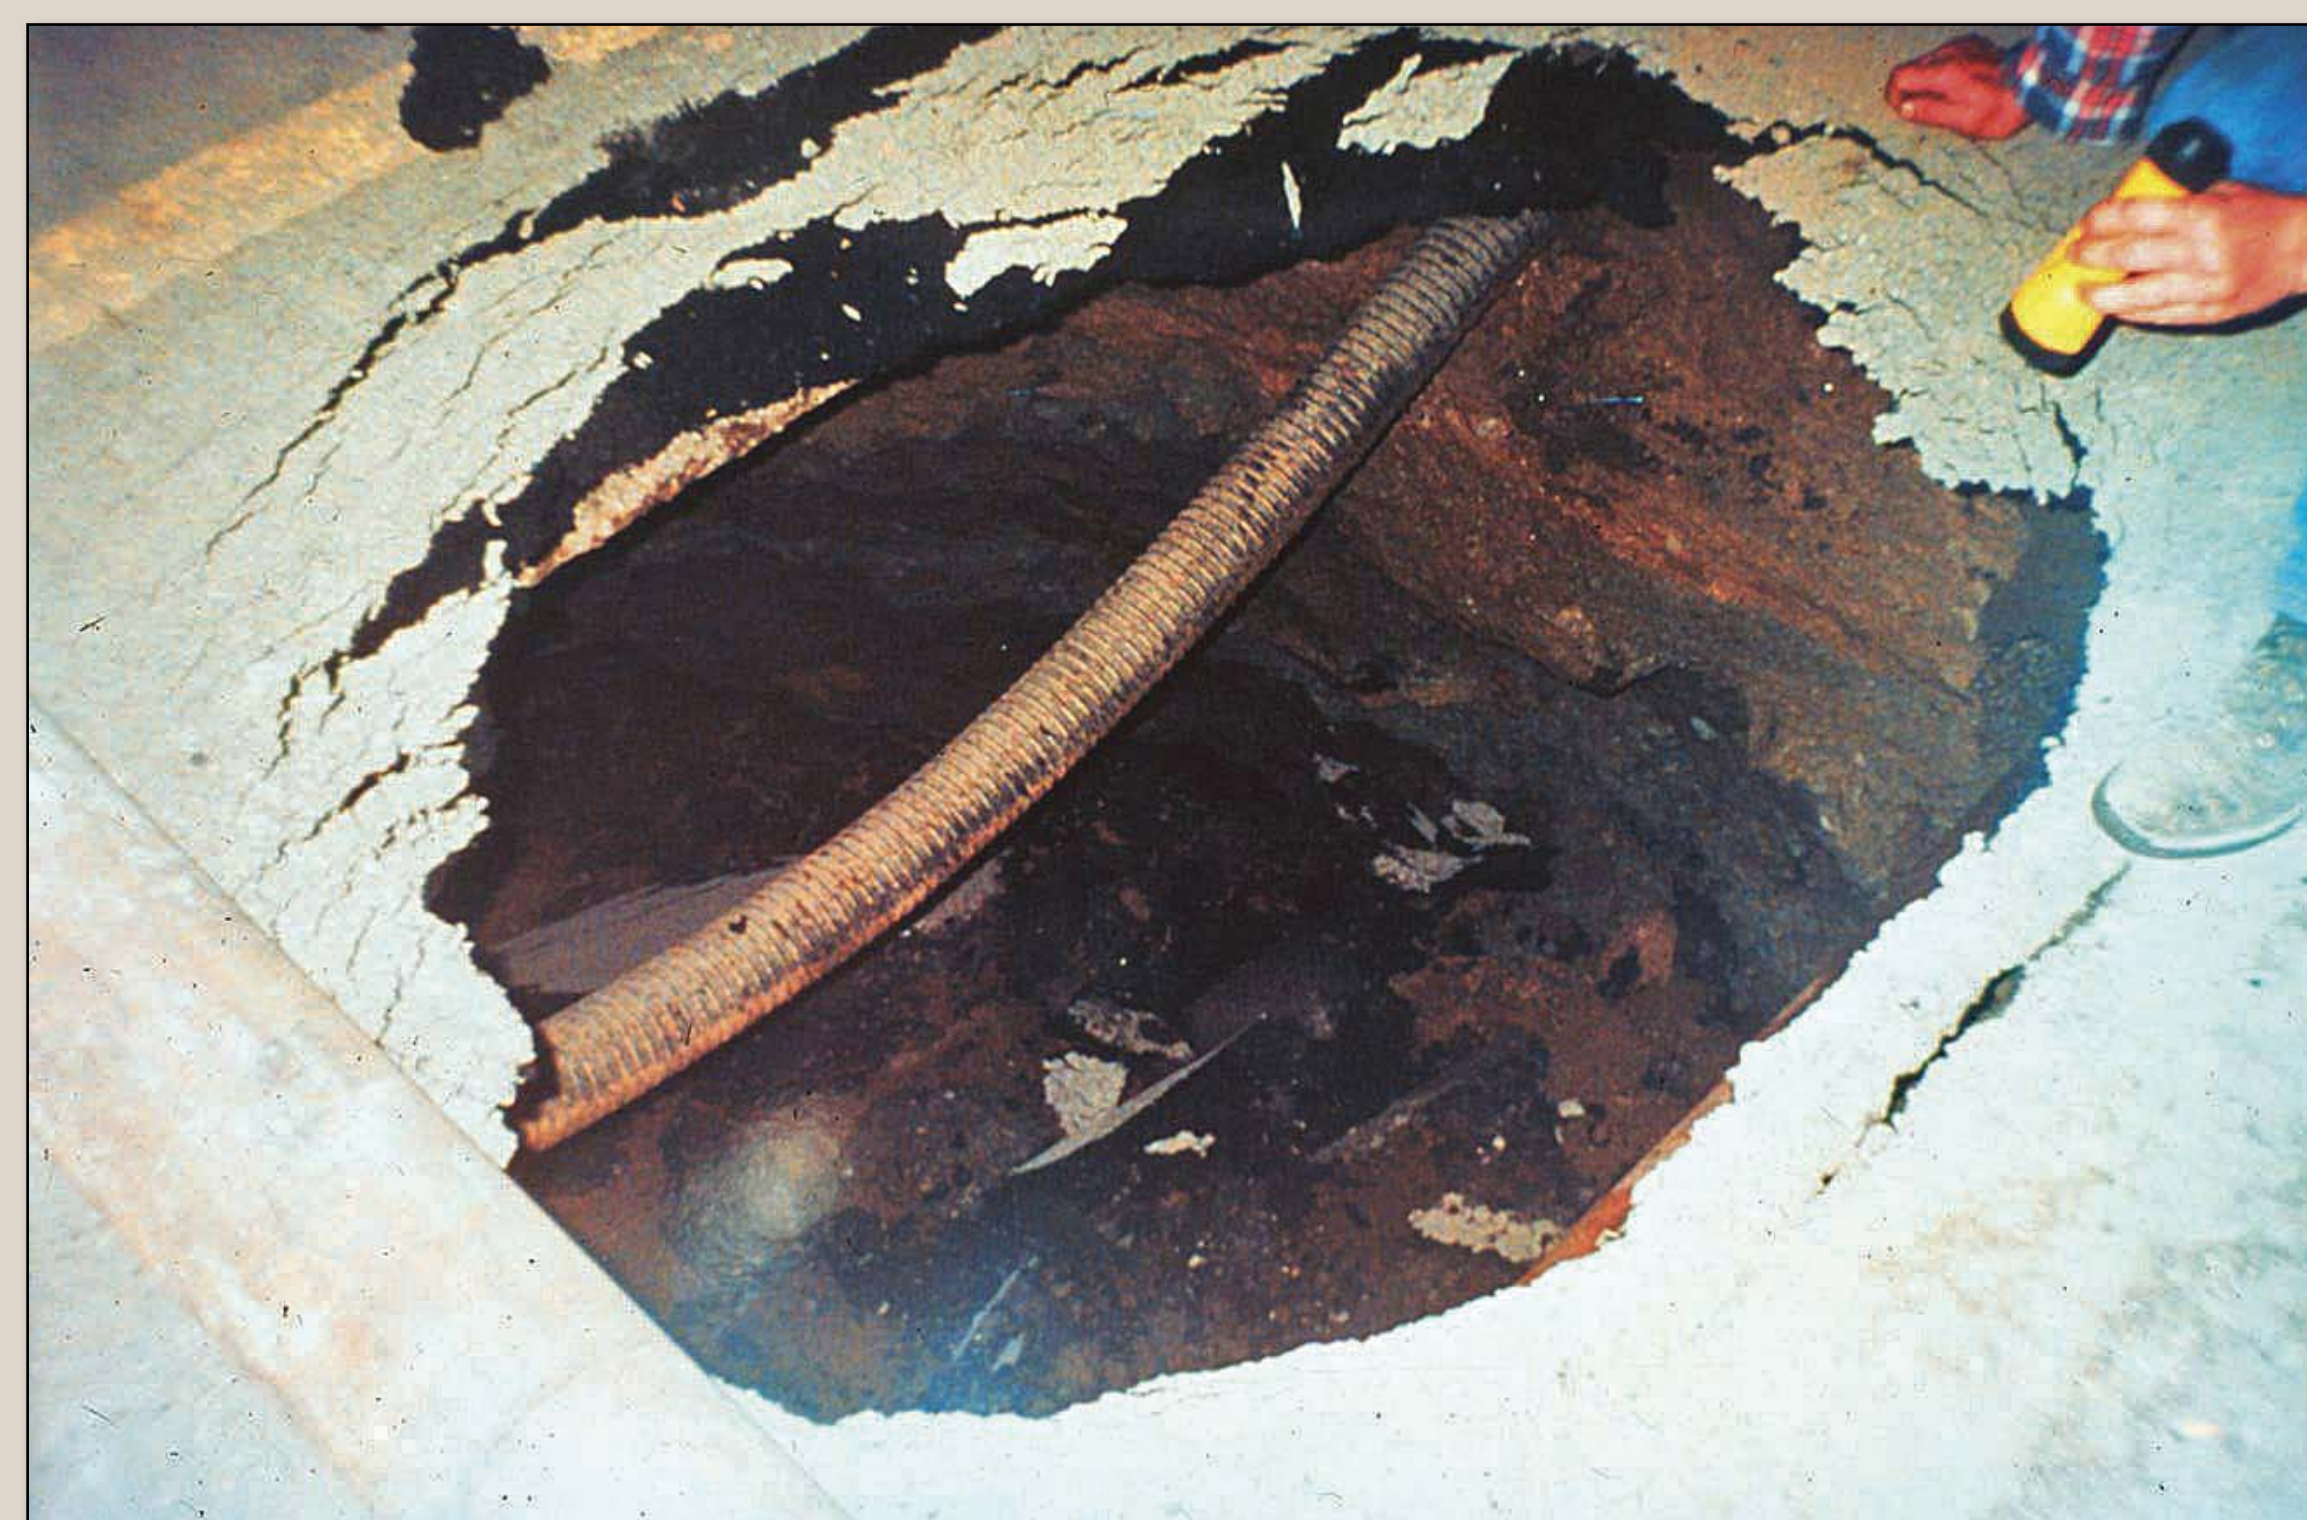
FIGURE 3.—Collapse of Interstate 70, near Cambridge, Ohio, caused by mine subsidence (Crowell, 1995).

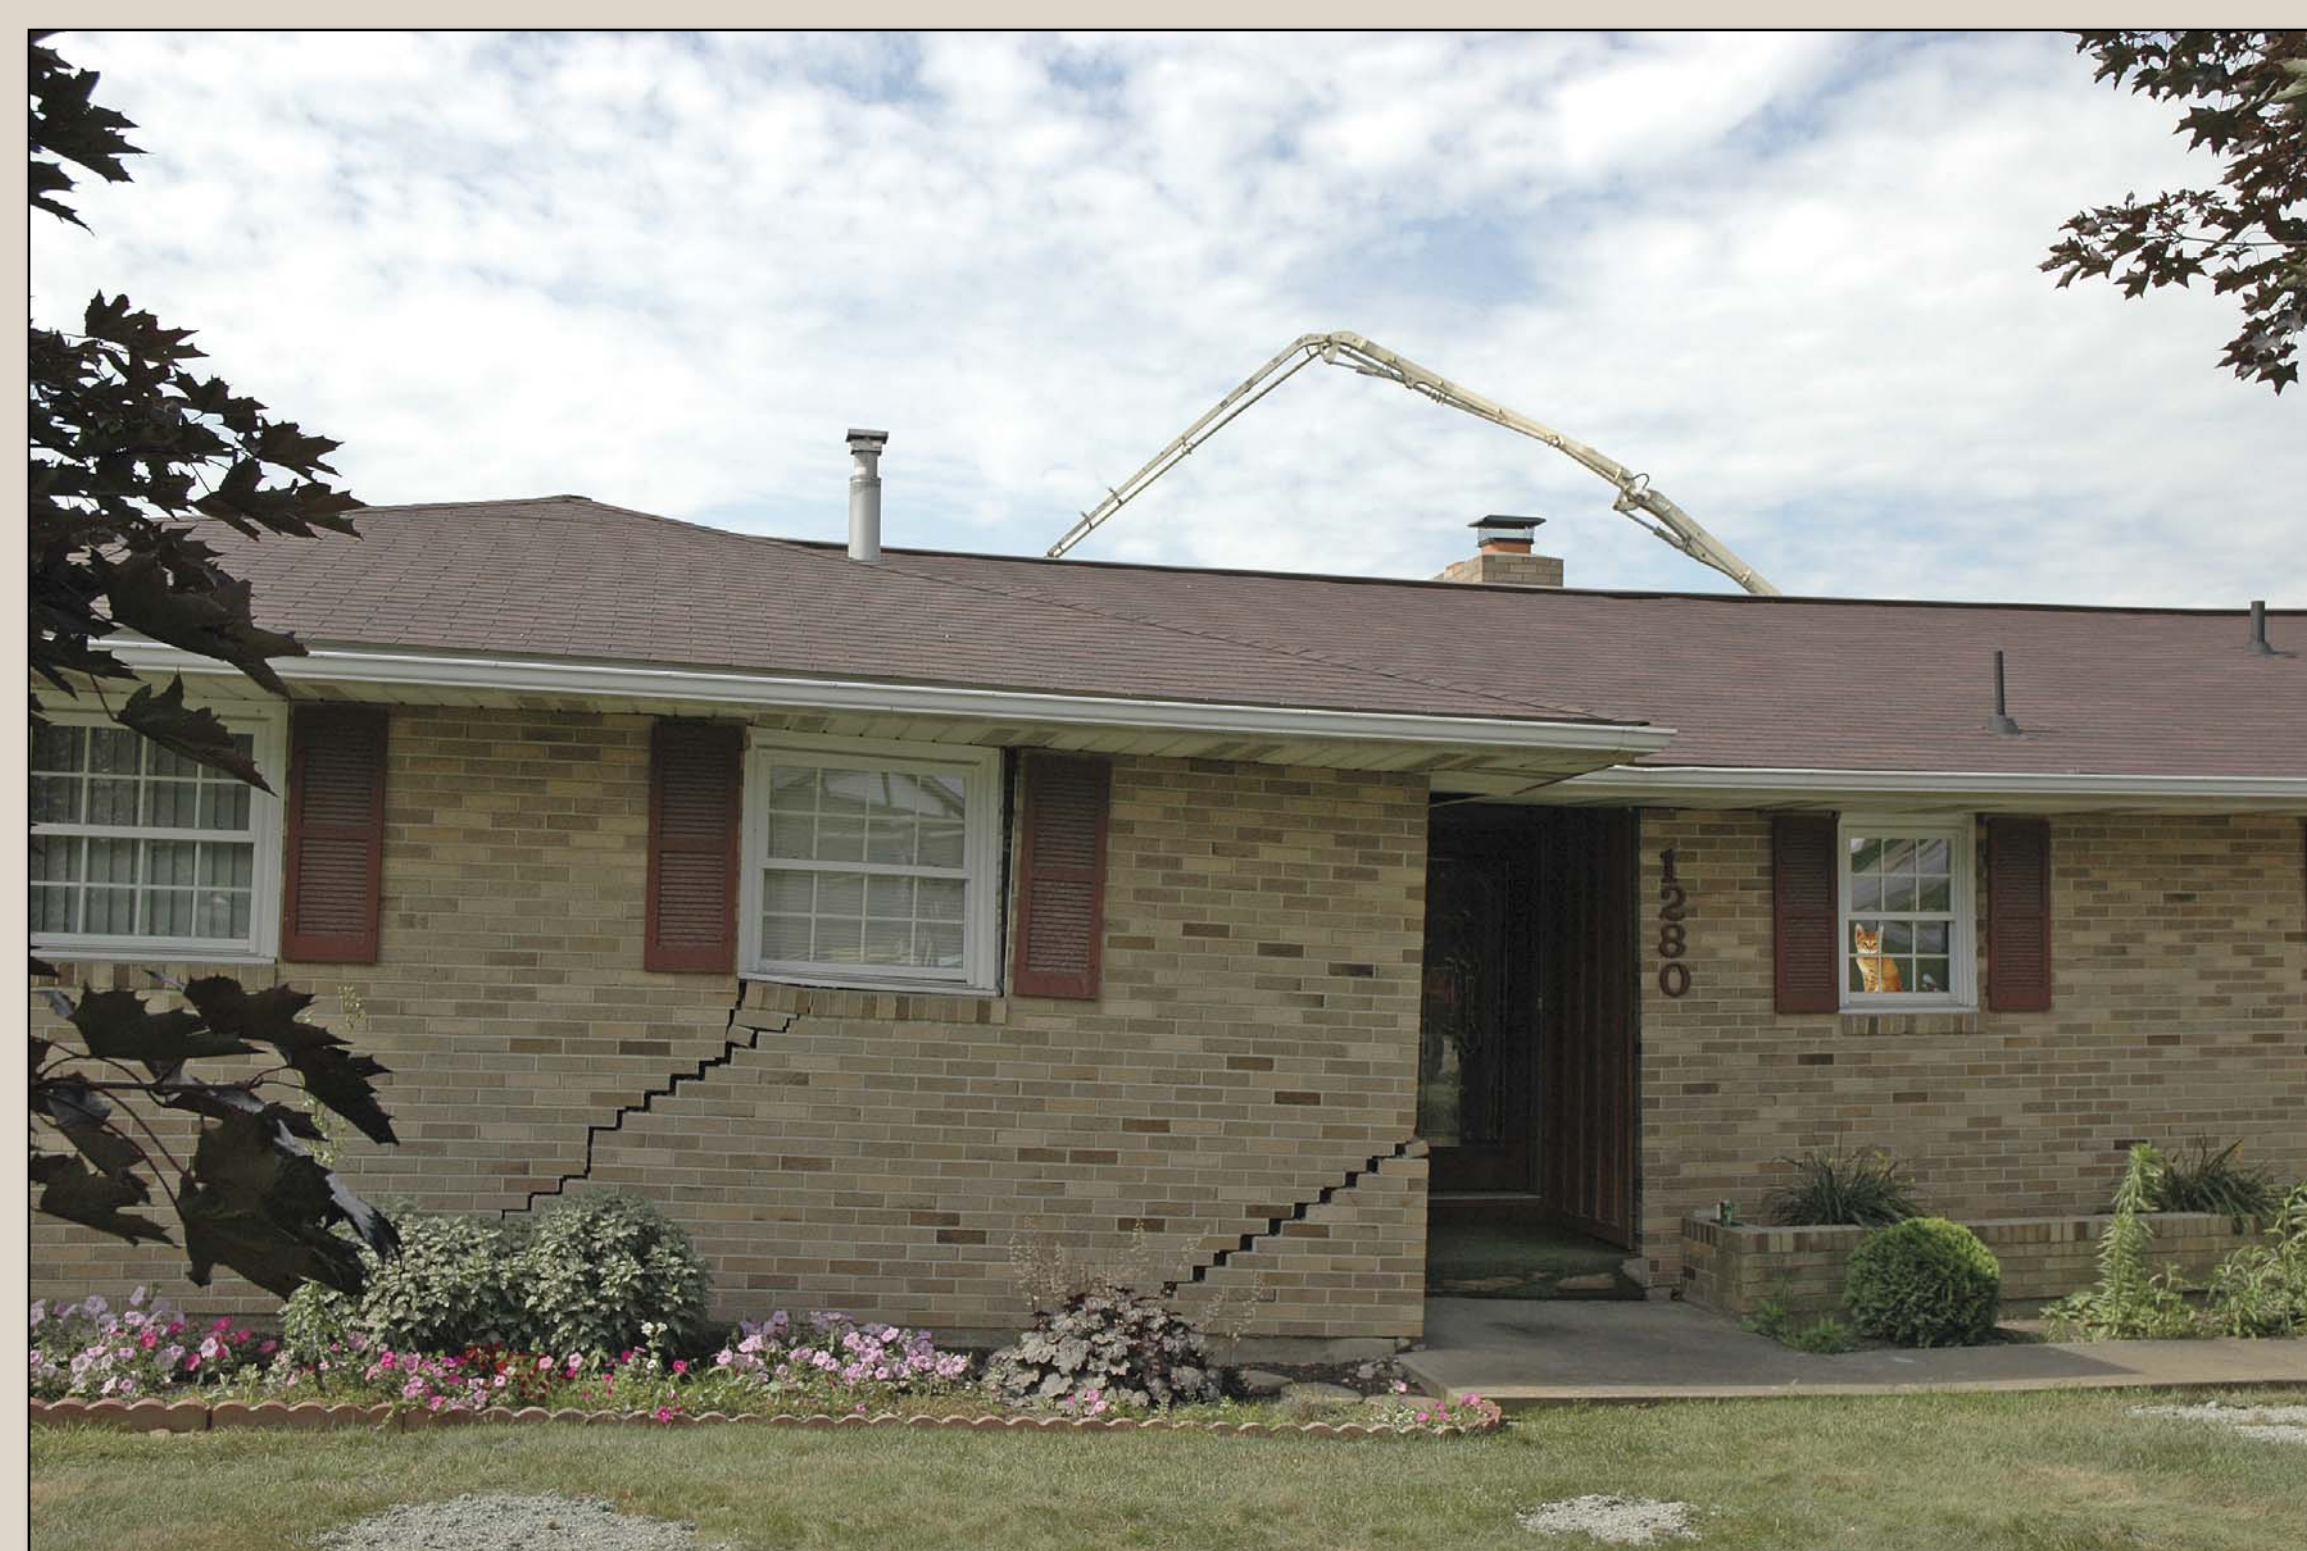
FIGURE 4.—A house damaged by mine subsidence. Sugarcreek Township, Tuscarawas County, Ohio.
