Inventory Mapping and Characterization of Landslides Using LiDAR: Kenton and Campbell Counties, Kentucky

Matt Crawford

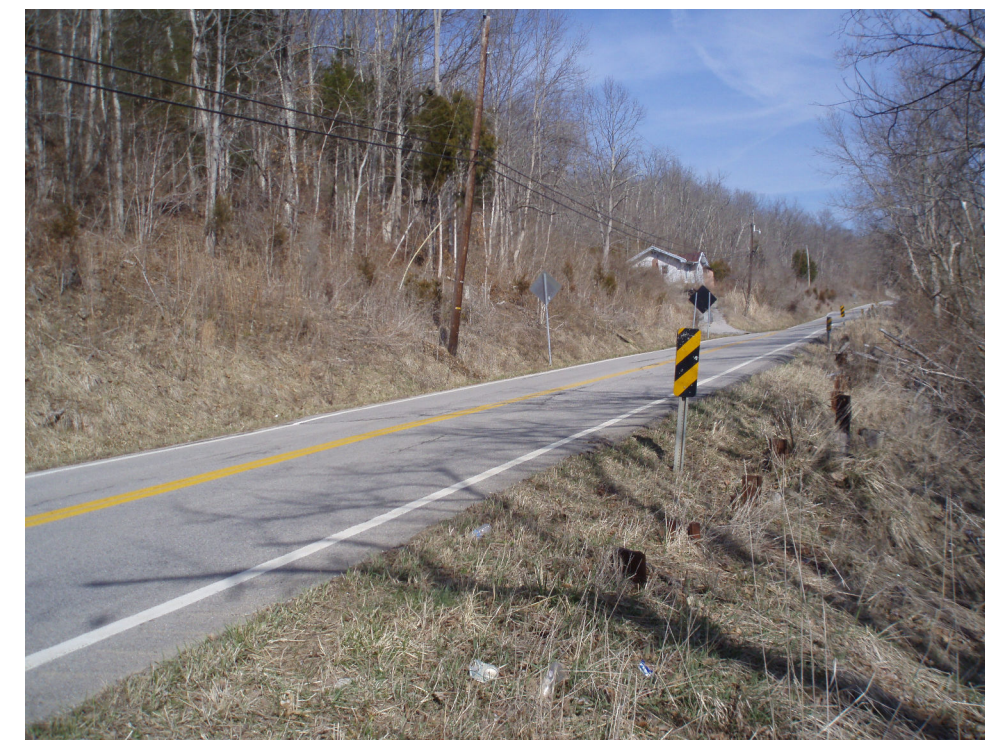
KY 177: Slide above and below road, note old retaining wall.

- Used Quick Terrain Modeler to create hillshade DEM's from the LAS files
- Imported DEM's to ESRI's ArcMap for visualization and spatial analysis
- Reexamined digitized landslides in Quick Terrain Modeler
- Performed field checking (example photos above)

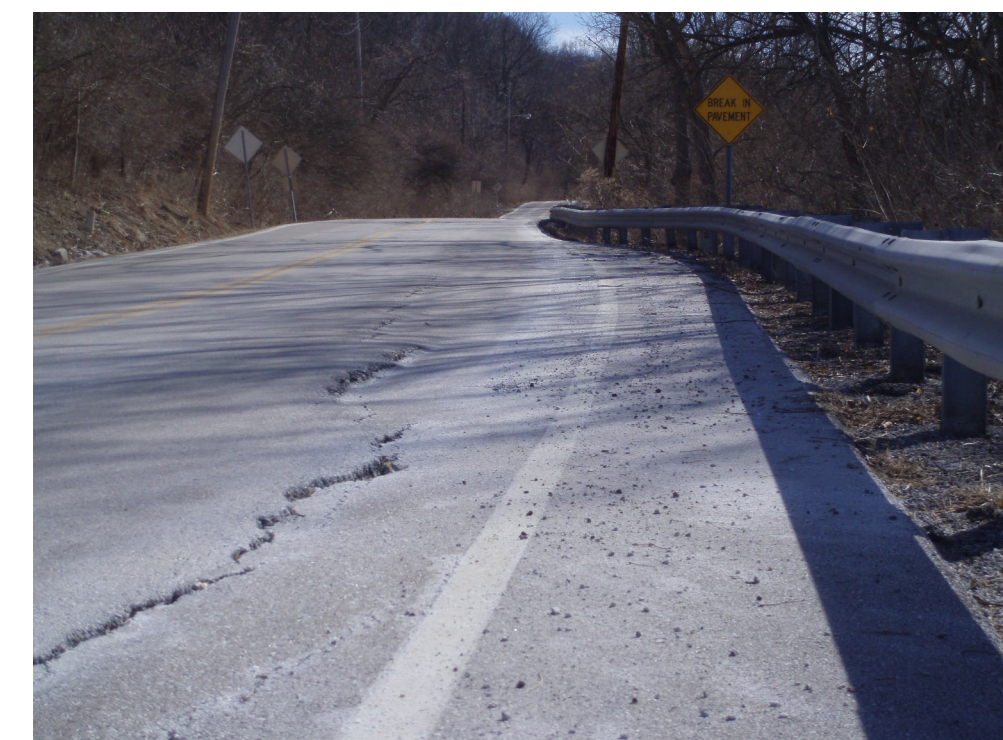
Licking Pike: Scarp and cracks in pavement, slide above and below road

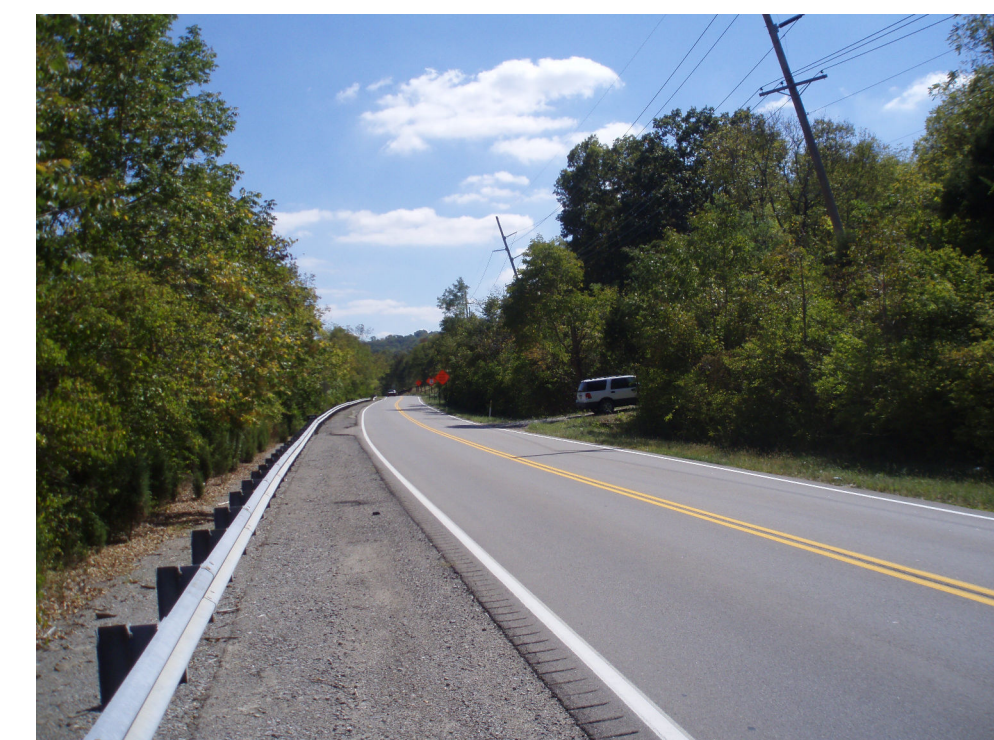
KY 8: Leaning telephone poles on large slide above and below road

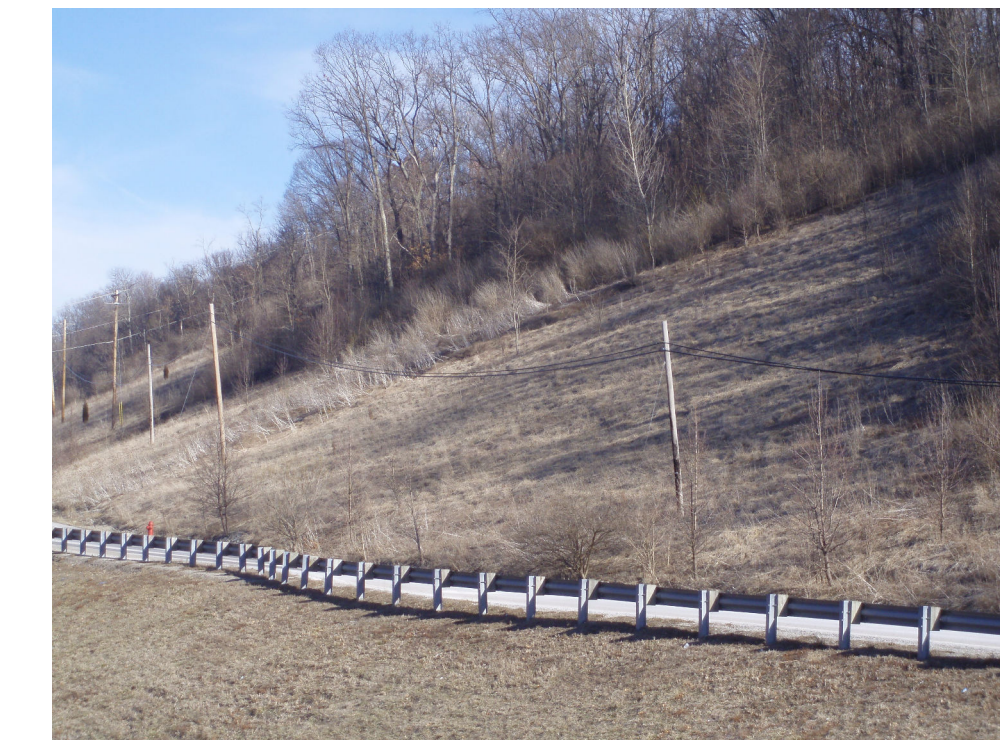
KY 1072: Old embankment failure
