MILITARY GEOLOGY OF SAIPAN, MARIANA ISLANDS

INTRODUCTION AND ENGINEERING ASPECTS

Prepared under the direction of the
Chief of Engineers, U. S. Army
by the
Intelligence Division, Office of the Engineer
Headquarters United States Army Forces Far East
and Eighth United States Army
with personnel of
The United States Geological Survey
1955

This study on Military Geology of Saipan, Mariana Islands, consists of three volumes: I, Introduction and Engineering Aspects; II, Water Resources; and III, Beach and Terrain Analysis.

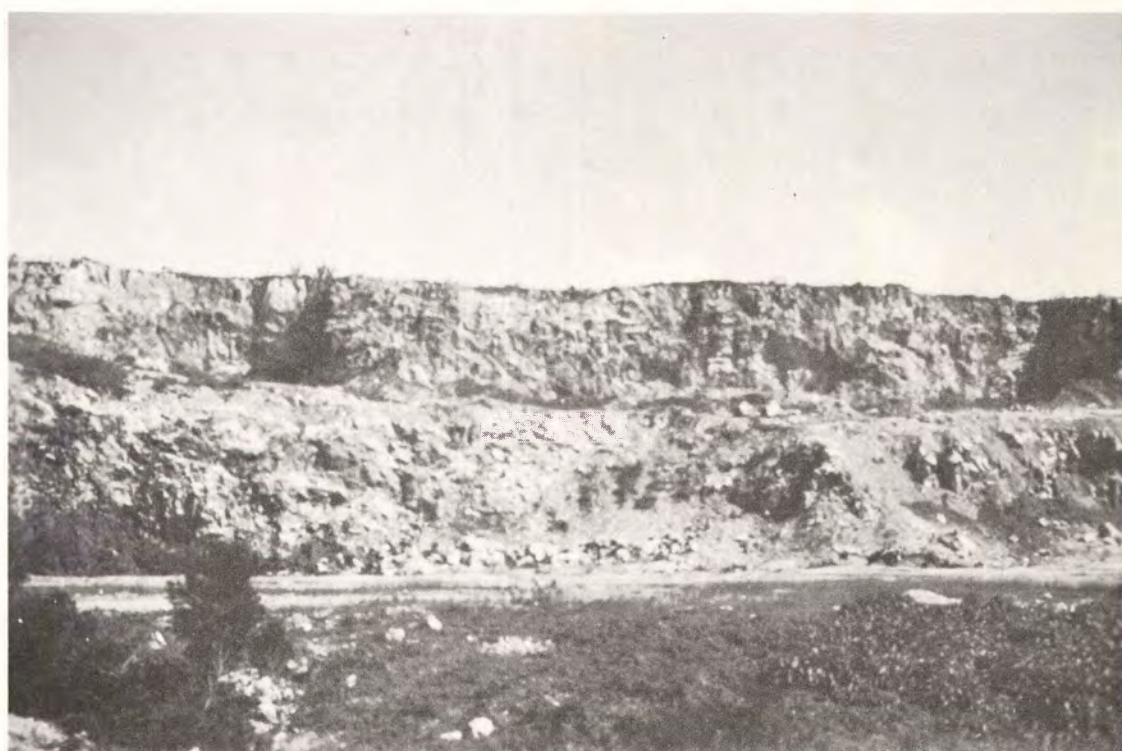
A. Unit No. 1 Very compact limestone. Quarry S-25 at Laderan Dago, south-central Saipan. Sample site No. 2.

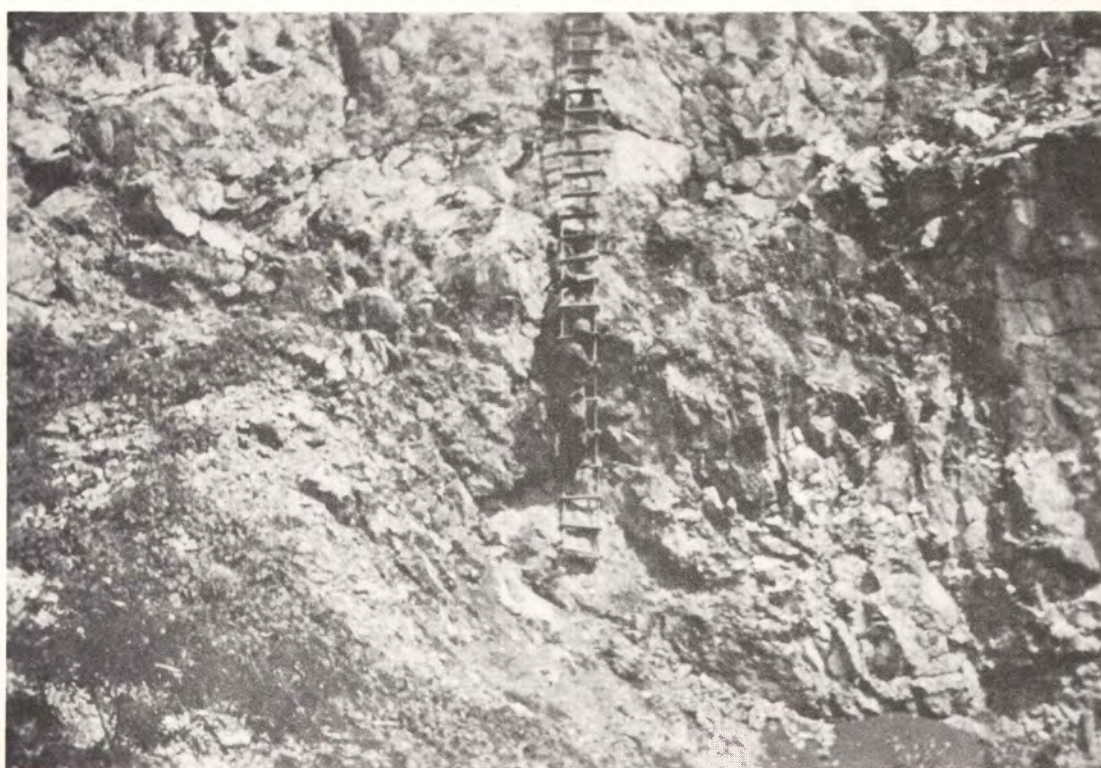
B. Unit No. 1 Very compact limestone. Quarry S-25 at Laderan Dago, south-central Saipan. Sample site No. 2.

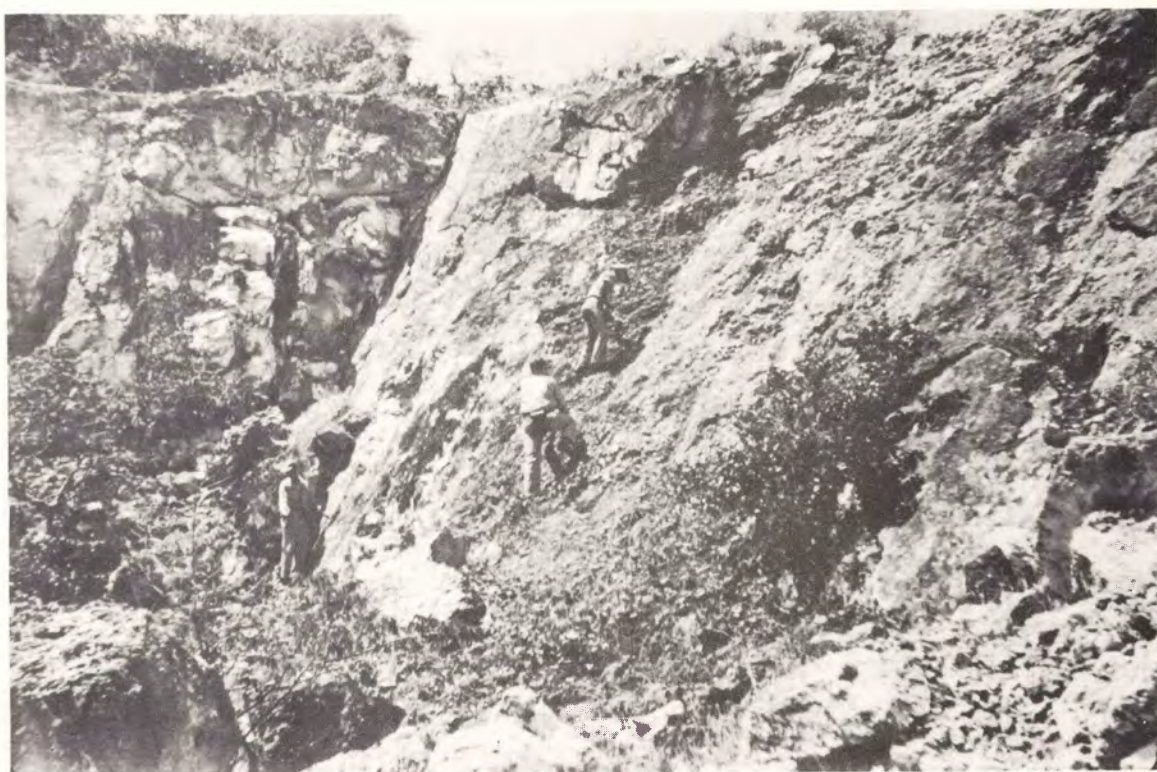
A. Unit No. 1 Very compact limestone. Quarry S-2 at south side of Laderan Laguna, northeast Saipan.

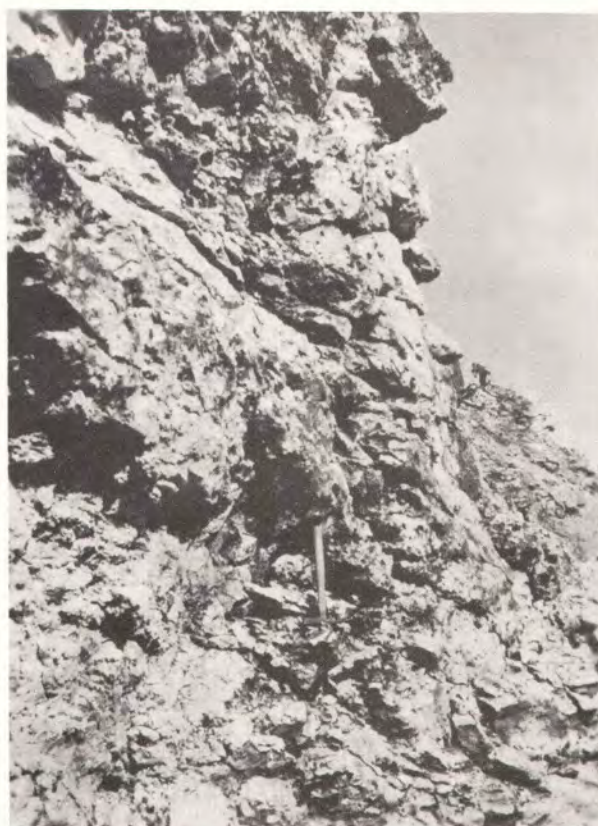
B. Unit No. 2 Firm, porous limestone. Quarry at Laderan Dandan, southeast Saipan.

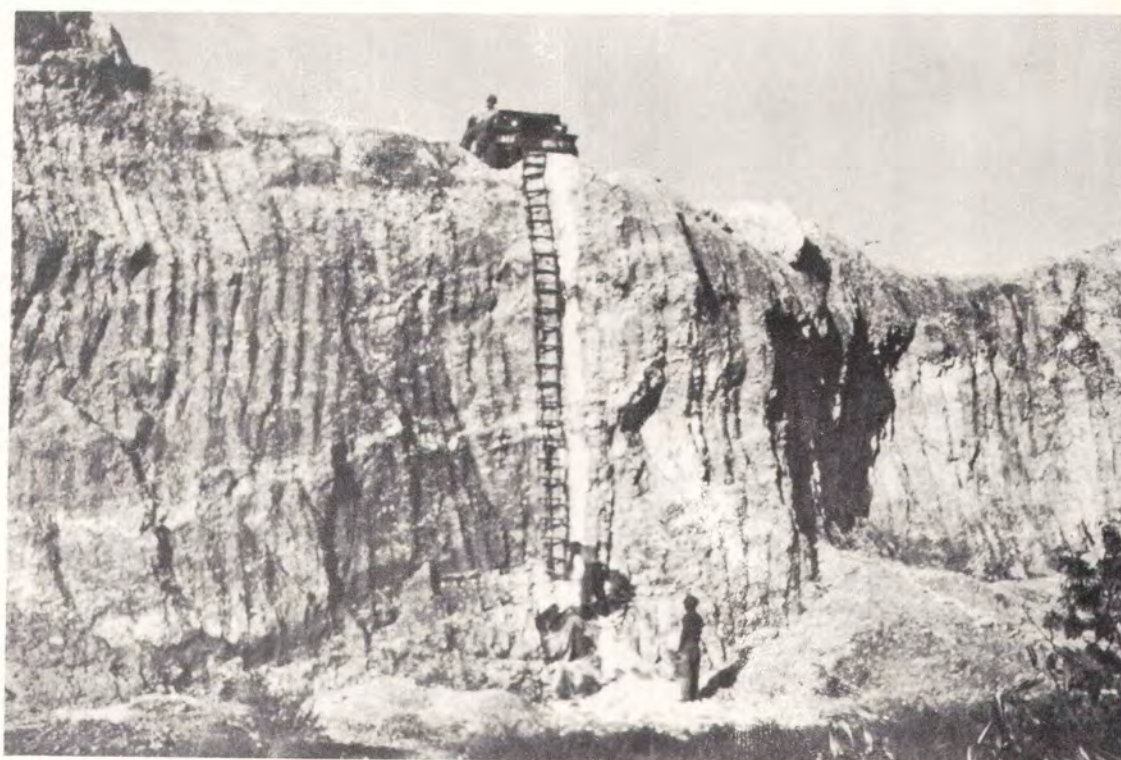
A. Unit No. 3 Coralline rubble. Quarry in southern part of district of As Matuis, northern Saipan. Sample site No. 2.

General description: The rock is a loose, rubbly, brecciated or fractured, clastic limestone, containing angular particles of semi-indurated to chalk-like limestone in a matrix of fine limy sand, and locally, some clay. Individual particles are commonly up to several inches in diameter; masses larger than one foot are uncommon. Its color is ordinarily white or light tan; exposed surfaces are discolored gray by algae and similar vegetation. Typical exposures are shown in plates 8A, 8B, 9A, 9B, 10A, and 10B.

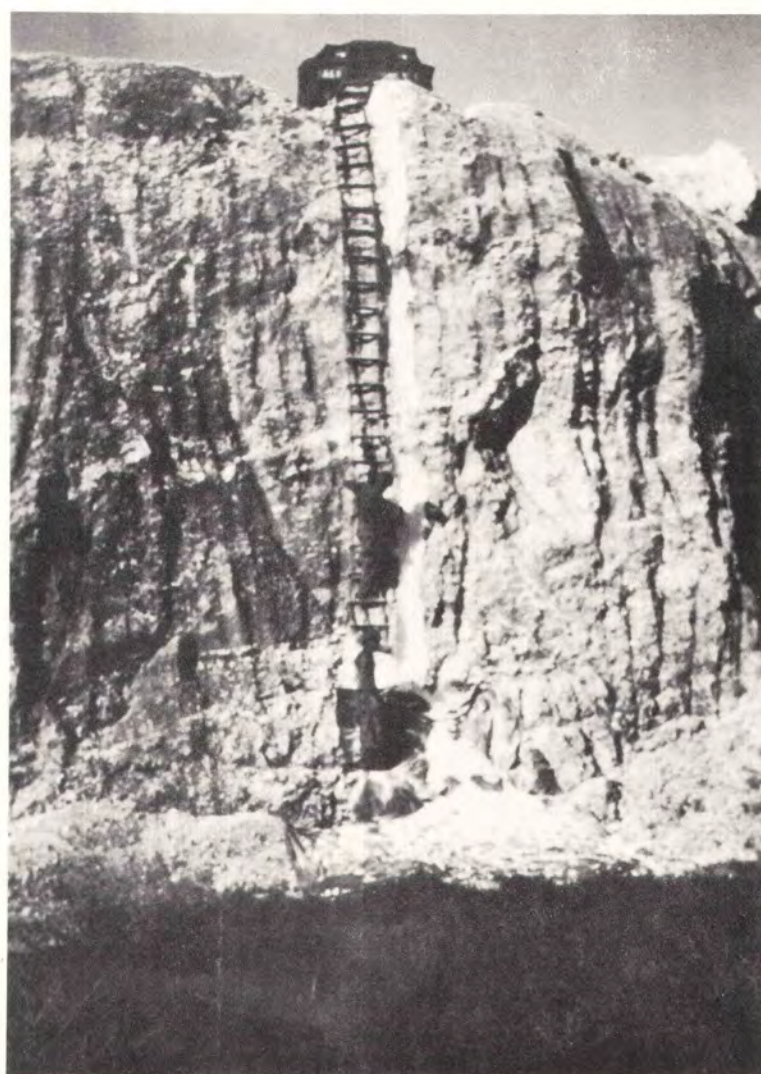
B. Unit No. 3 Coralline rubble. Quarry in southern part of district of As Matuis, northern Saipan. Sample site No. 2.

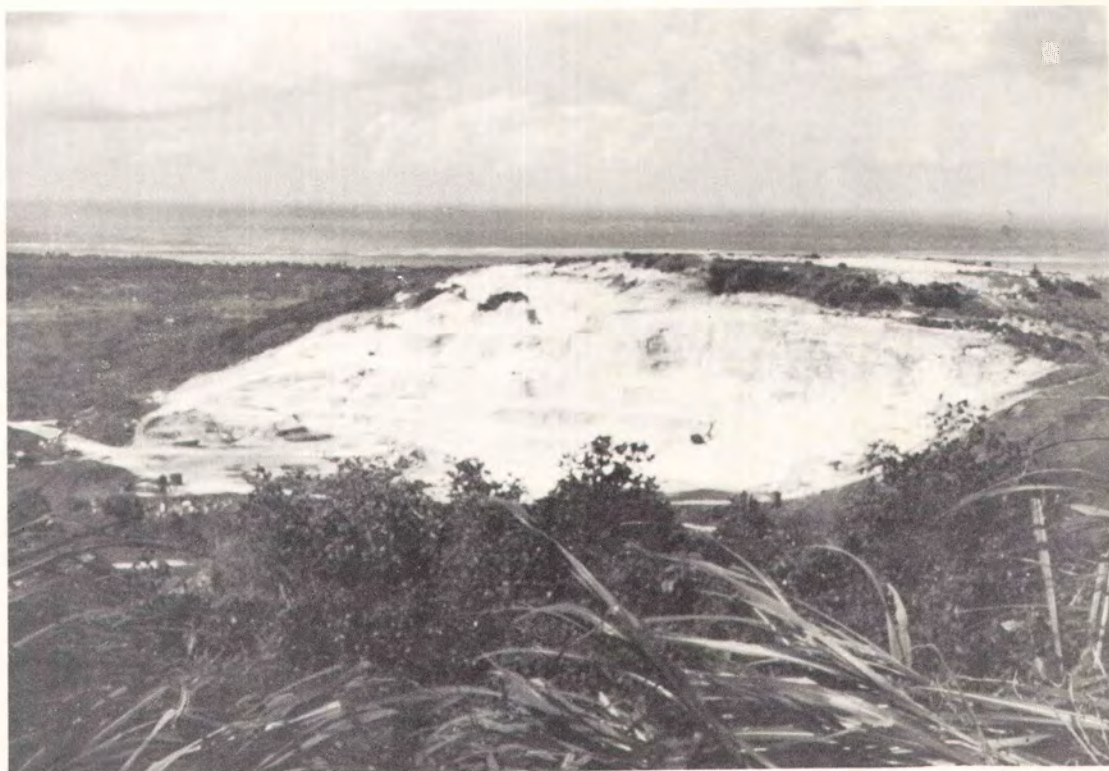
A. Unit No. 3 Coralline rubble. Distant view of Quarry S-16 at Laderan Dandan, south-central Saipan. Sample site No. 1.

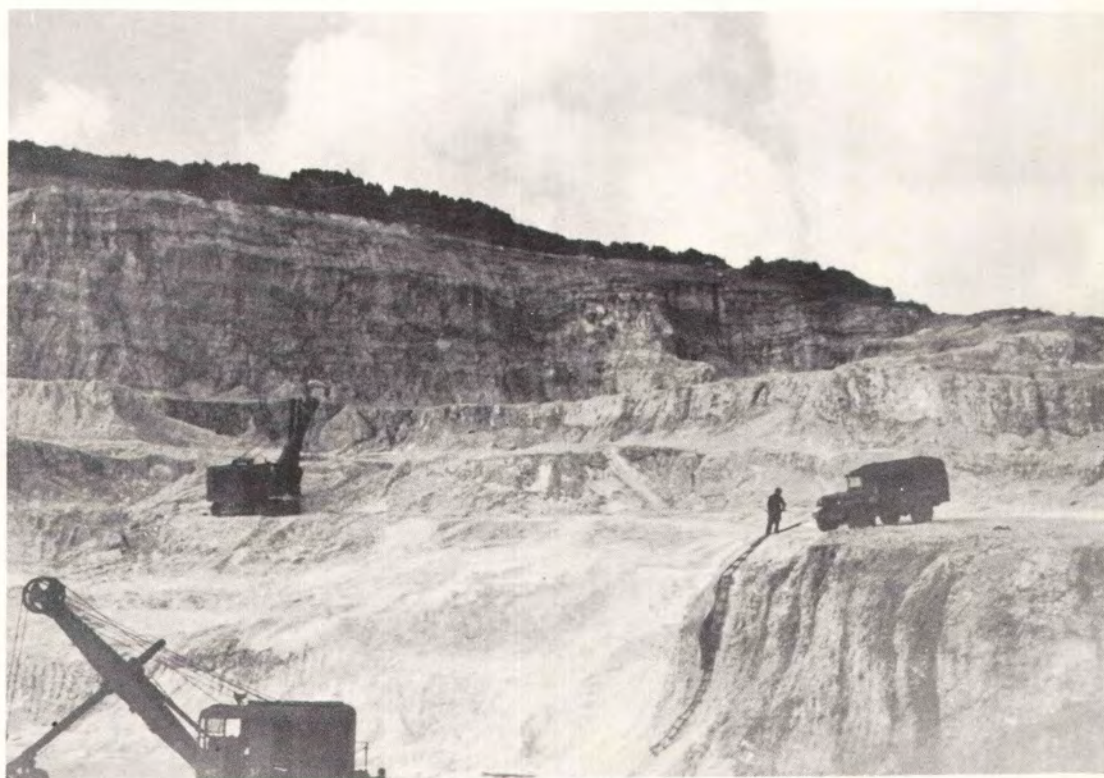
B. Unit No. 3 Coralline rubble. Close-up view of quarry S-16 at Laderan Dandan, south-central Saipan. Sample site No. 1.

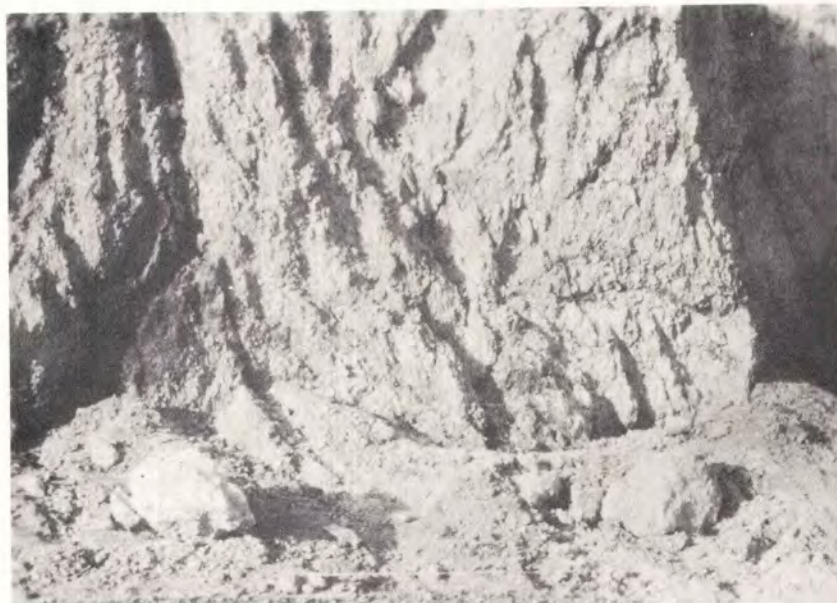
A. Unit No. 3 Coralline rubble. Quarry S-16 at Laderan Dandan, south-central Saipan. Sample site No. 1.

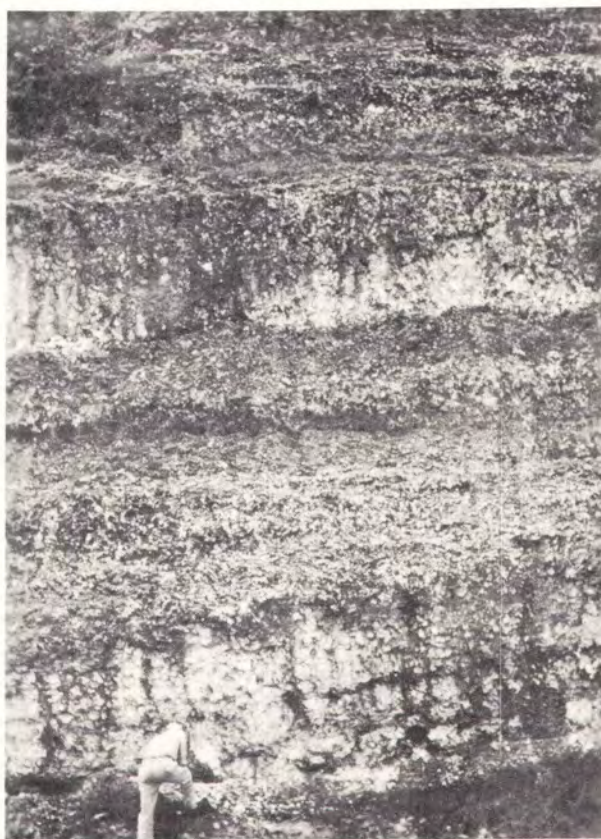
B. Unit No. 3 Coralline rubble. Quarry at base of Laderan I Agag, east-central Saipan.

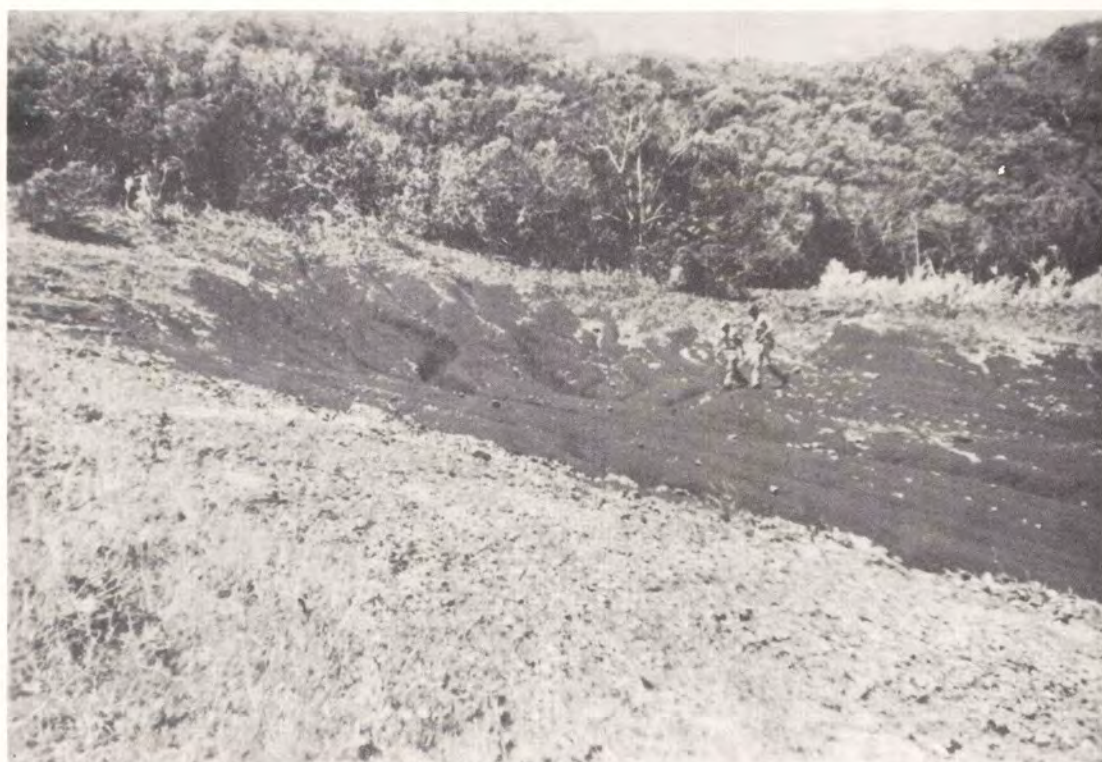
A. Unit No. 5 Red clay overlying limestone. At base of Laderan Kalabaran Katan, north Saipan.

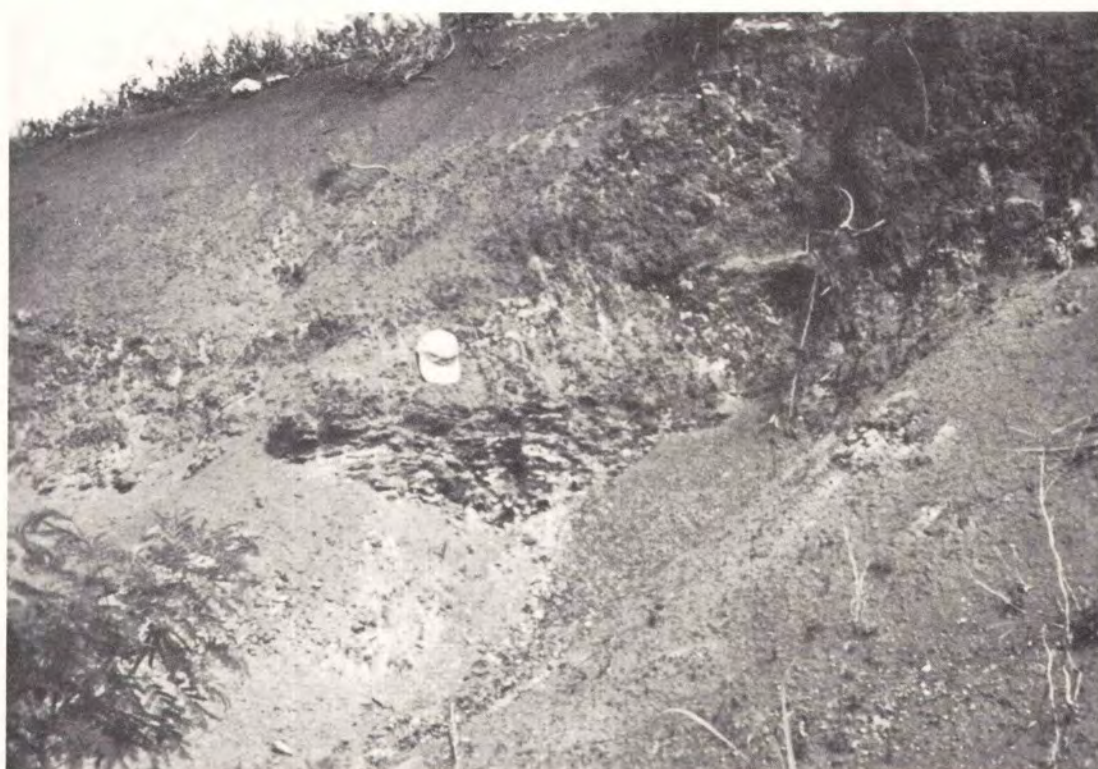
B. Unit No. 6 Brown clay. Cut along west side of Cross-Island Highway, district of Papago, east-central Saipan.

General description: This is a brown to yellowish clay, commonly containing pea-sized concretions of manganiferous and ferruginous composition, some sand, and limestone fragments. Valley deposits of the clay are gravelly. The clay is weakly to highly plastic; commonly loose when dry, but very sticky when wet. Thickness averages perhaps 5 feet or more and may reach as much as 25 feet locally. Underlying beds are not ordinarily exposed, but in most places they are limestone. A typical exposure is shown in plate 11B.

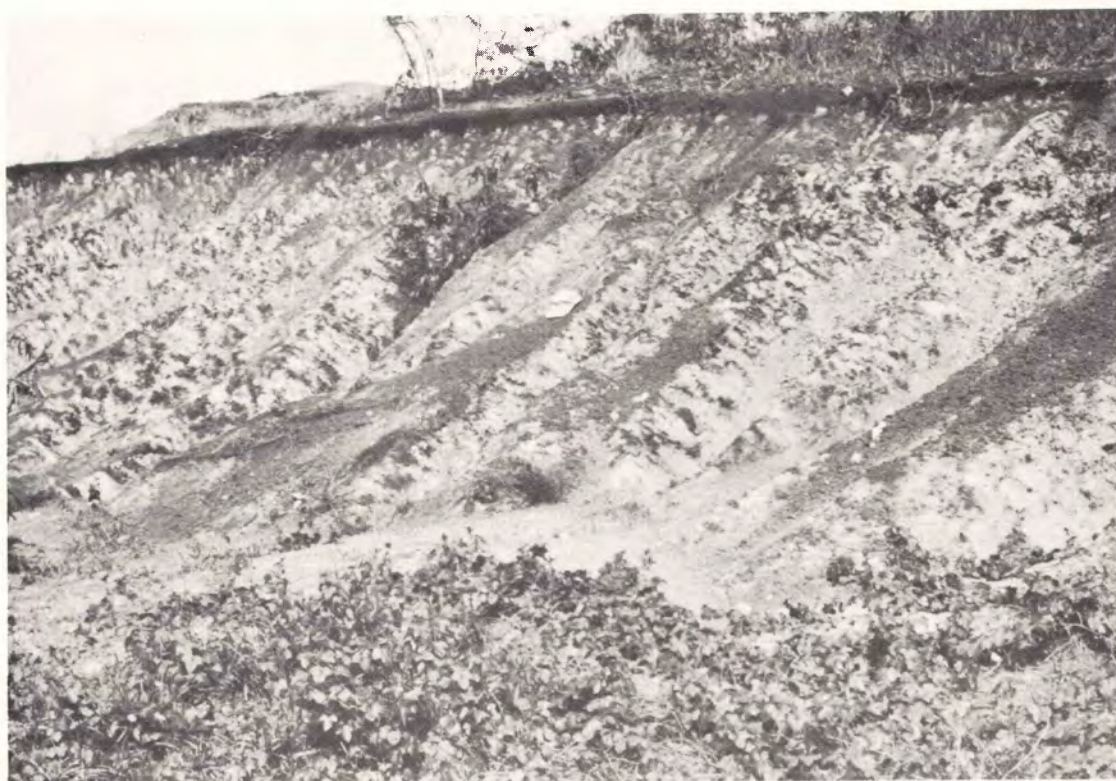
A. Unit No. 7 Mottled clay. Base of Laderan I Agag, east-central Saipan.

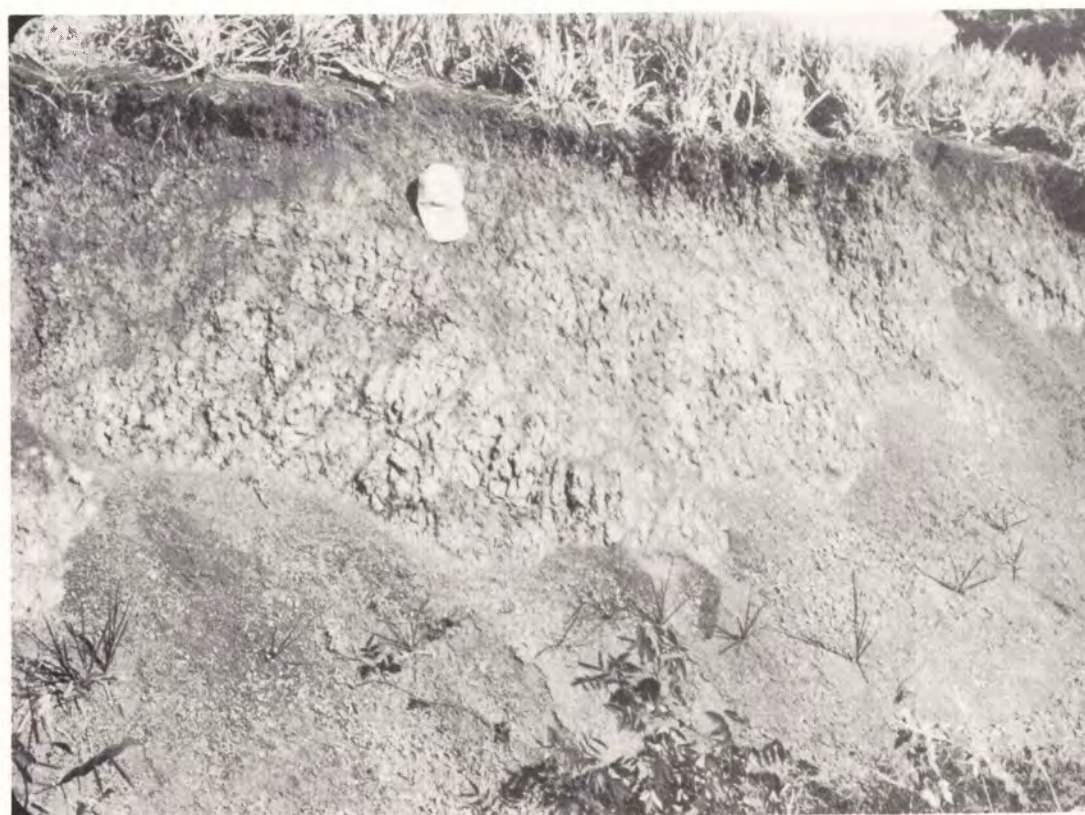
B. Unit No. 7 Mottled clay. About 100 feet northeast of As Perdido Road, district of Fina-sisu, southwest Saipan.

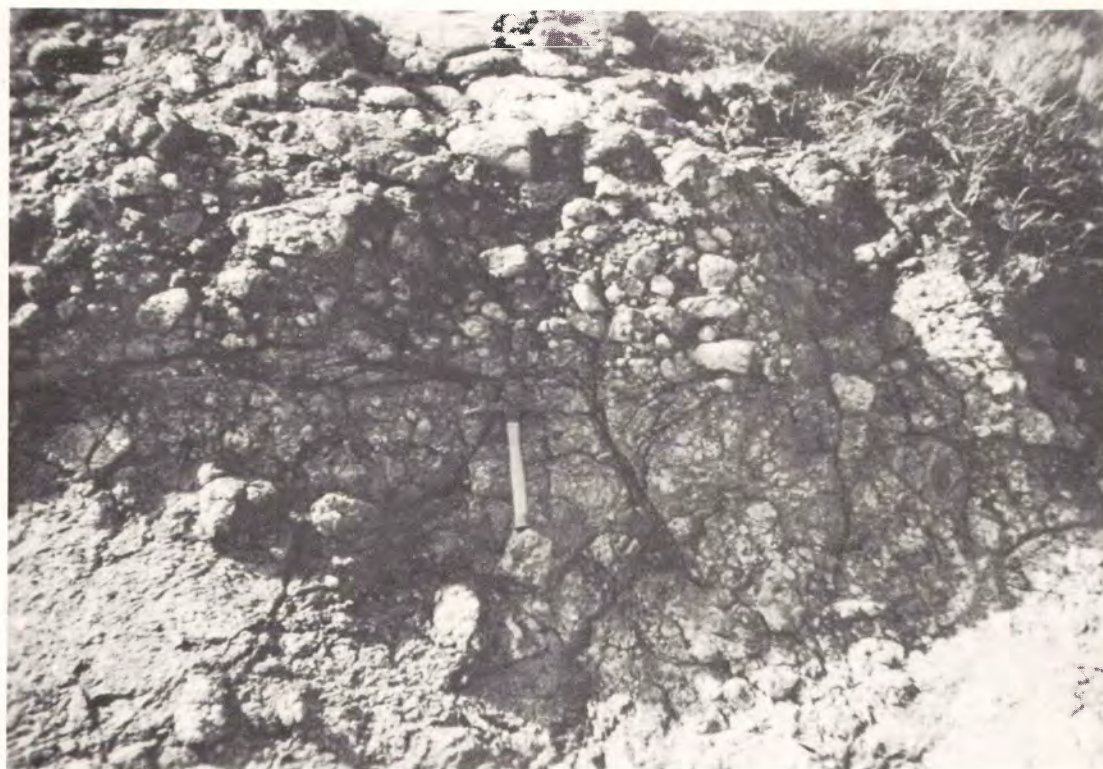
A. Unit No. 8 Weathered andesitic conglomerate and breccia.
District of Talofoto, northeast Saipan.

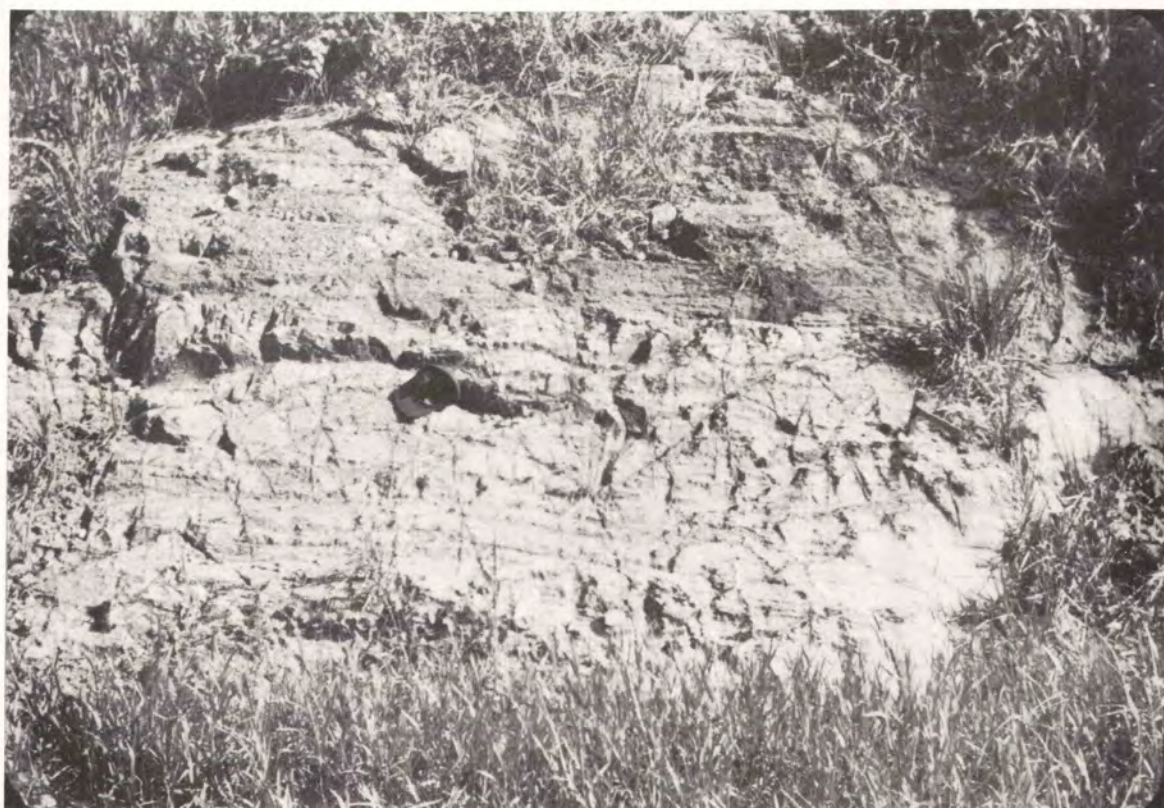
B. Unit No. 8 Weathered andesitic conglomerate and breccia. Cut
along west side of Cross-Island Highway, district of Papago, east-
central Saipan.

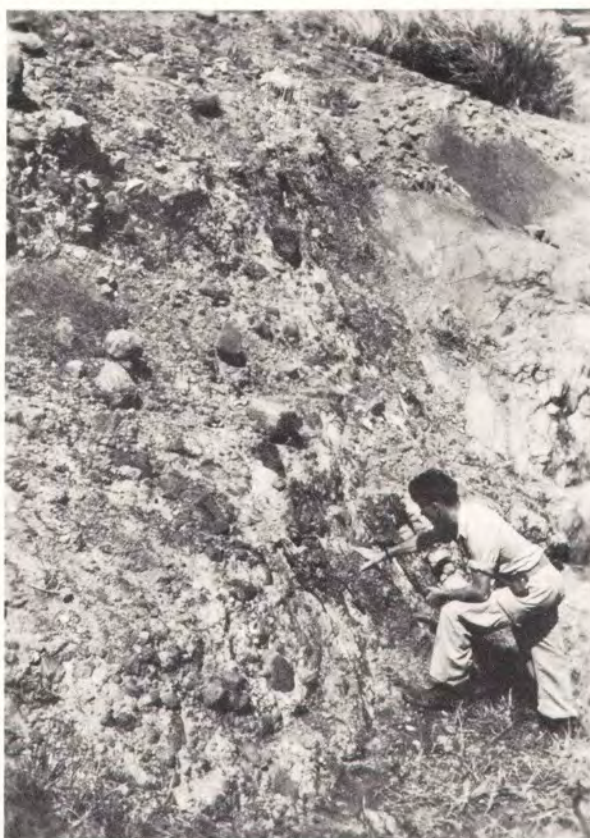
A. Unit No. 9 Partly weathered andesitic conglomerate and sandstone. Road cut at Laderan Hagman, eastern Hagman Peninsula, east-central Saipan. Sample site No. 1

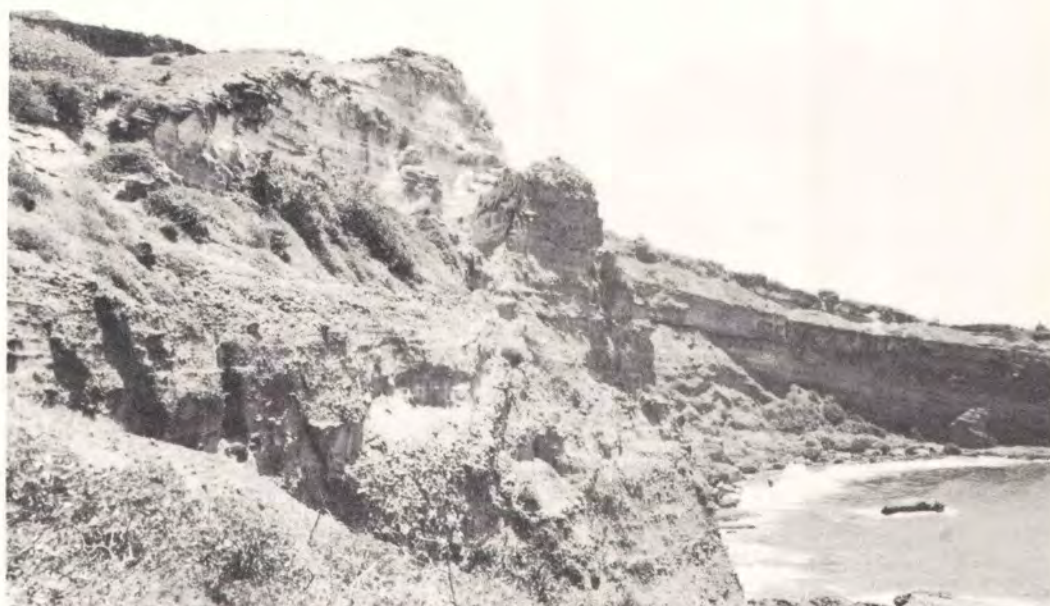
B. Unit No. 9 Partly weathered andesitic conglomerate and sandstone. Bluffs above Unai Hagman, eastern Hagman Peninsula, east-central Saipan.

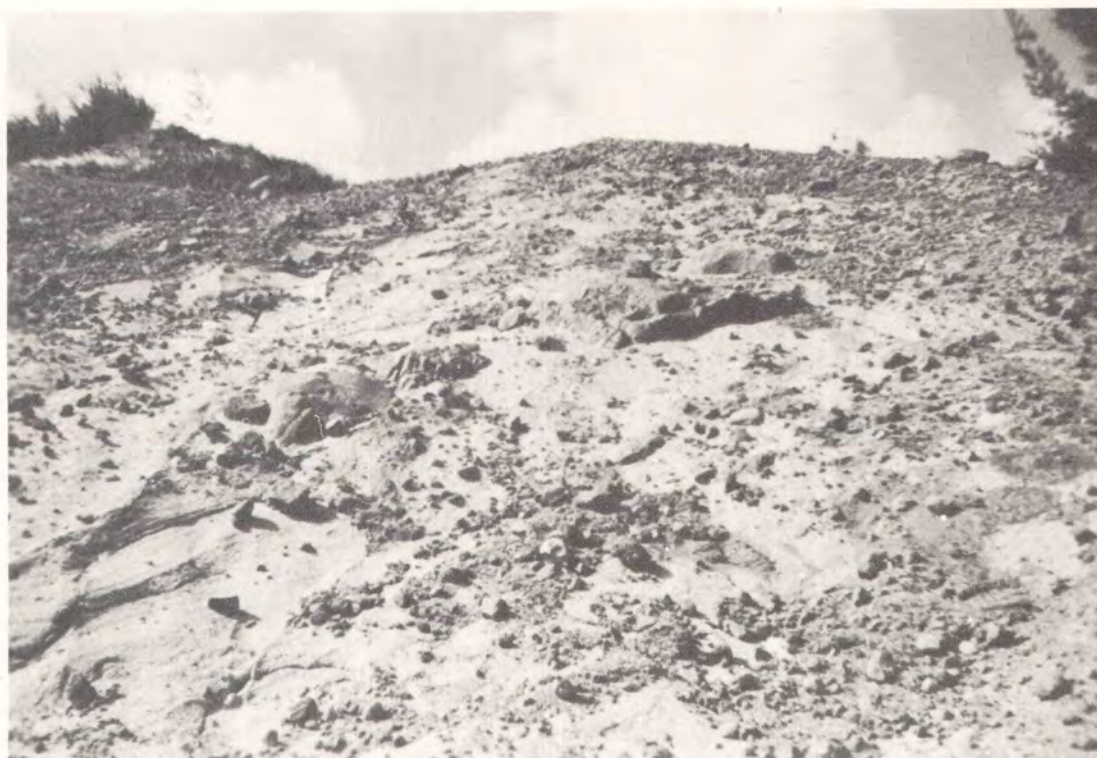
A. Unit No. 9 Partly weathered andesitic conglomerate and sandstone. East slope of Laderan Hagman, eastern Hagman Peninsula, east-central Saipan.

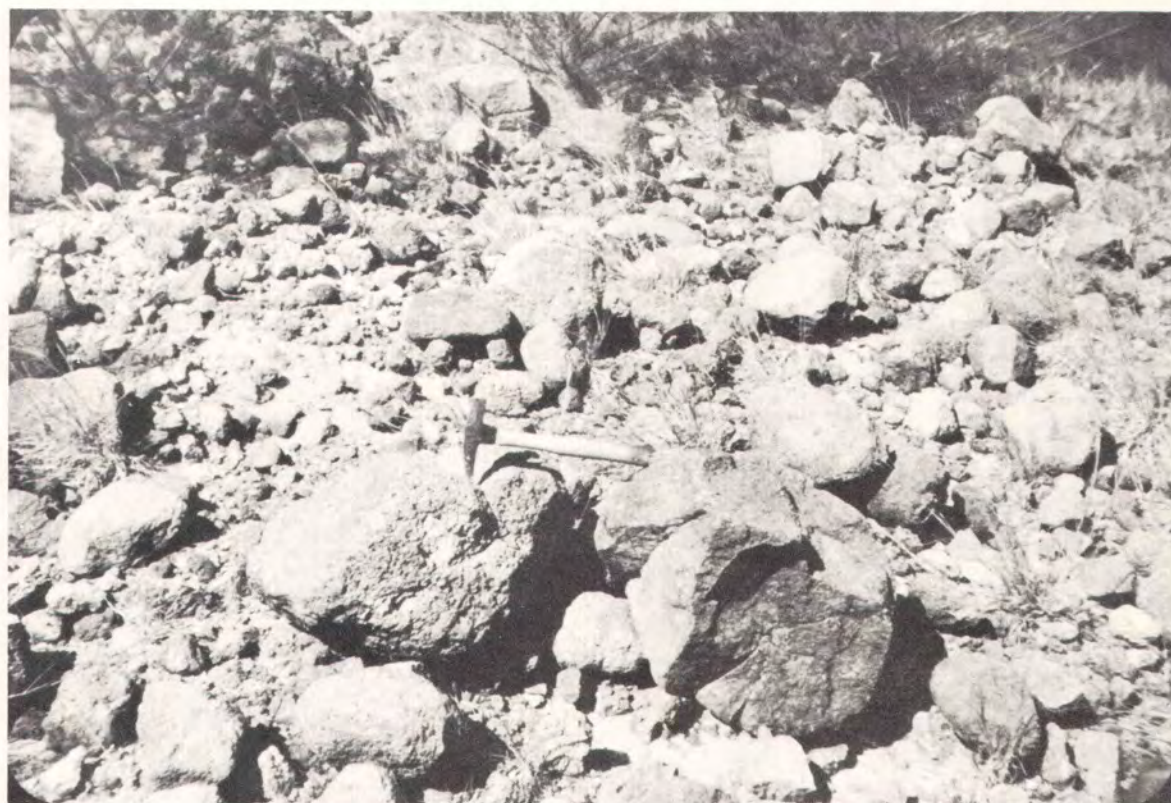
B. Unit No. 9 Partly weathered andesitic conglomerate and sandstone. Fresh andesite boulders and cobbles on surface. East slope of Laderan Hagman, eastern Hagman Peninsula, east-central Saipan.

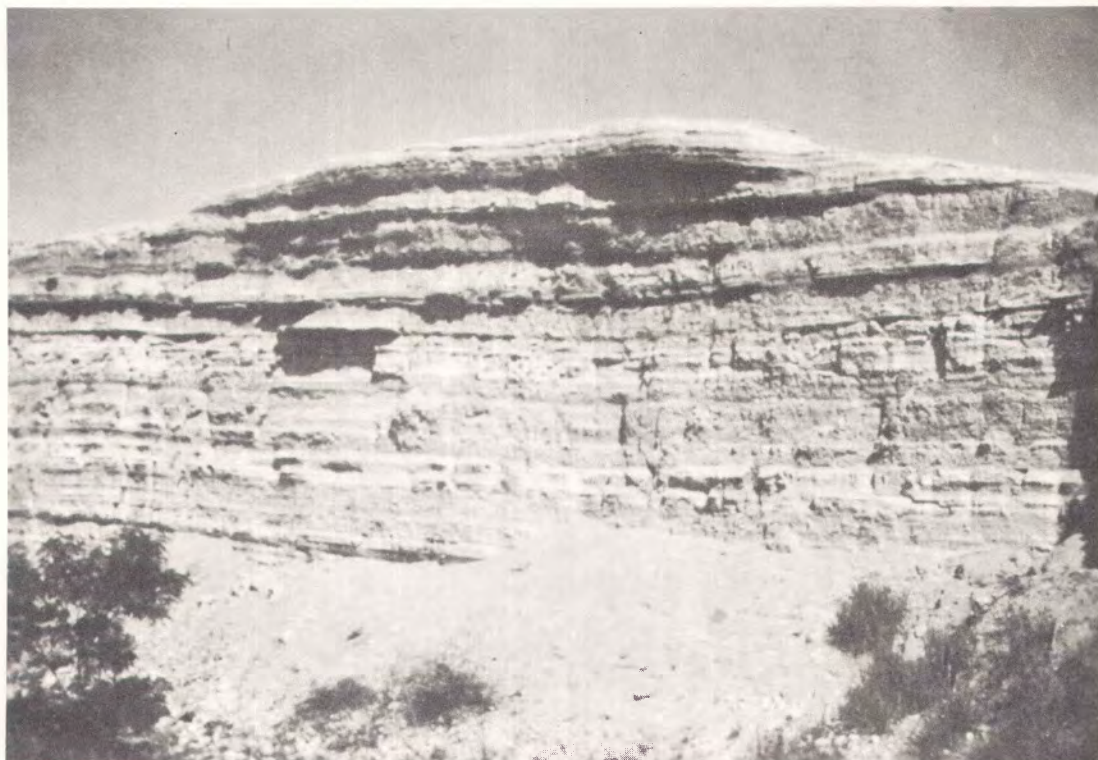
A. Unit No. 10 Clayey volcanic sediments. Quarry at Laderan Dago, about 800 feet east of Isley Entrance Road, south-central Saipan. Sample site No. 2.

General description: Stratified layers of silt, silty clay, sandy clay, marl, and weakly-cemented, calcareous, tuffaceous sandstone; silt and clay layers predominate. Maximum thickness of this unit is approximately 200 feet. Individual beds range from a few inches to several feet in thickness and are various shades of brown, green, gray, and red; they are inclined generally eastward at moderate angles, and in some areas are gently folded, deeply incised, and eroded. Some beds are partly bentonitic, and swell when wet. Textural and compositional differences between beds, undulations caused by folding, and erosion account for exposure of dissimilar layers at different locations within the unit. Typical exposures are shown in plates 16A and 16B.

Quarries: Extremely limited development. The only observed excavation is near Isley Field, at the north end of Laderan Dago, in south central Saipan, at the site from which a test sample was taken.

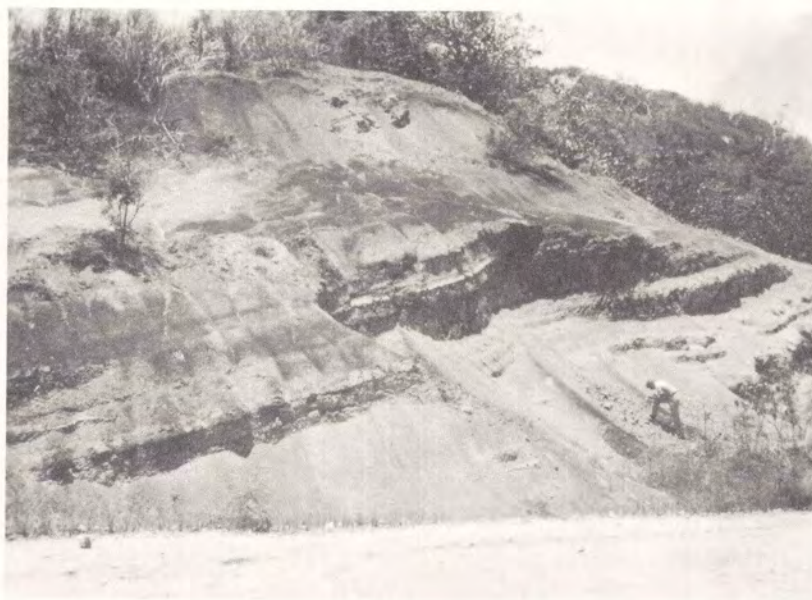
B. Unit No. 10 Clayey volcanic sediments. Cut along East Coast Highway, district of I Hasngot, northeast Saipan.

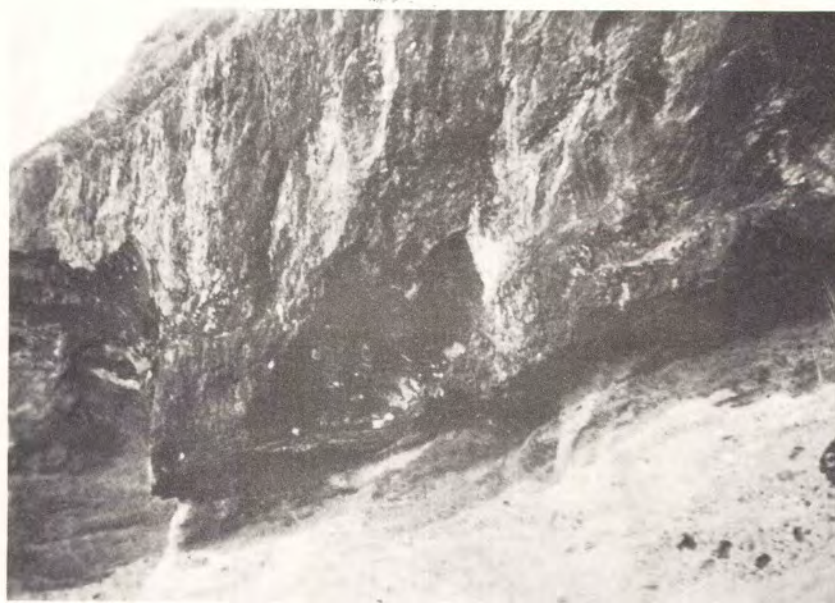
A. Unit No. 11 Compact dacite in upper part. Unai Fanunchuluyan, northeast Saipan.

General description: Fairly hard, massive, compact, glassy, porphyritic dacite rock; closely jointed and fractured. Contains extremely hard, but brittle, siliceous zones. Commonly intercalated with and overlain by unit 12. Typical exposures are shown in plates 17A, 17B, and 18A.

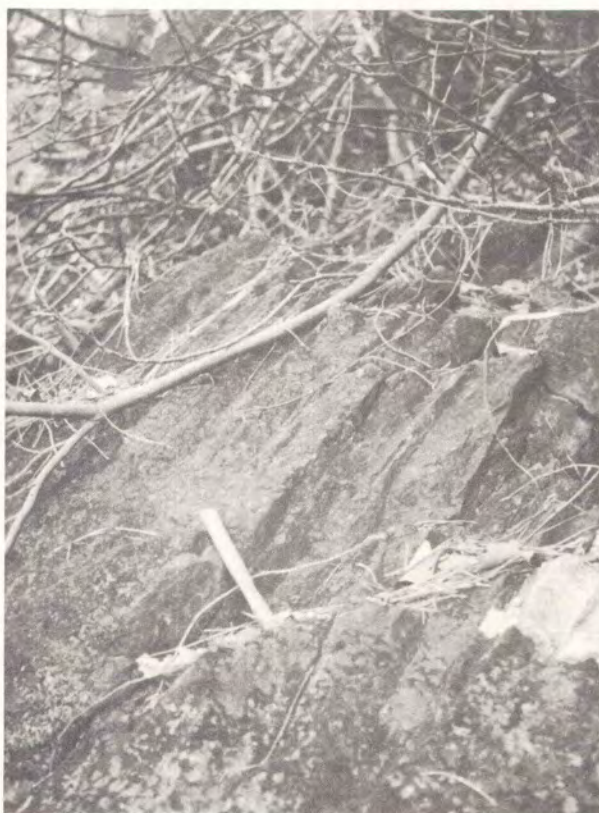
B. Unit No. 11 Compact dacite. In valley on southwestern flank of Ogso Achugau, northeast-central Saipan.

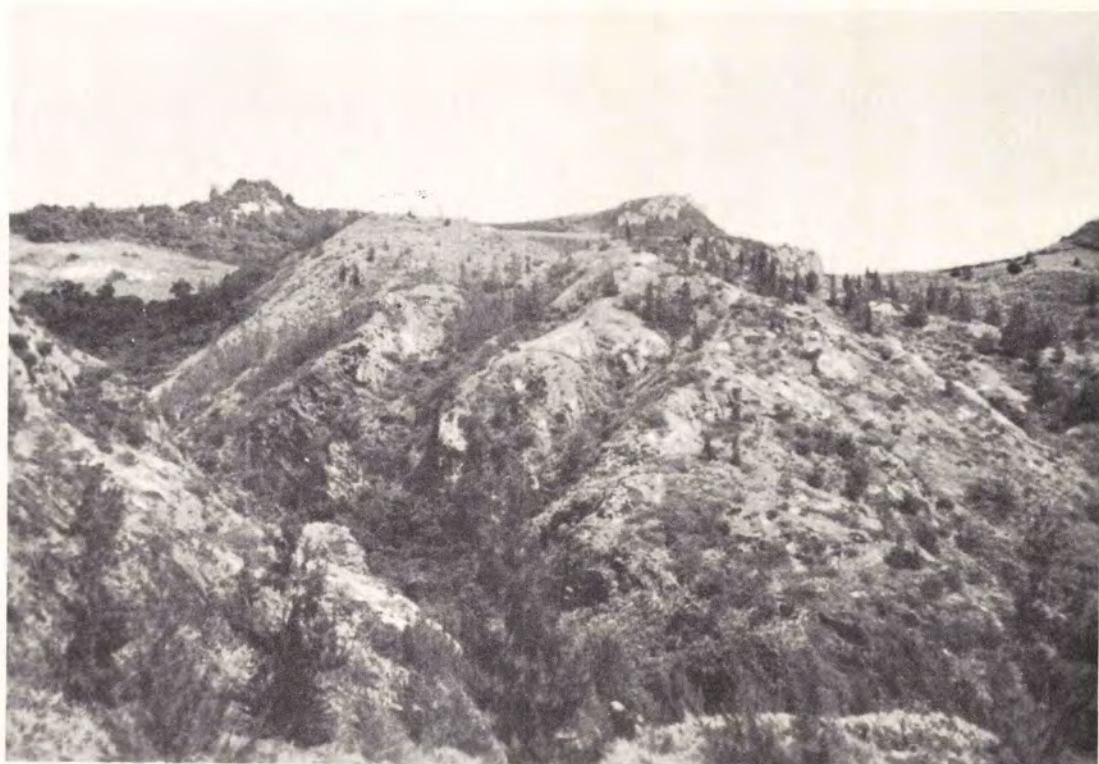
A. Units No. 11 and 12 Compact dacite, and friable dacitic breccia and tuff. Achugau district, northeast-central Saipan.

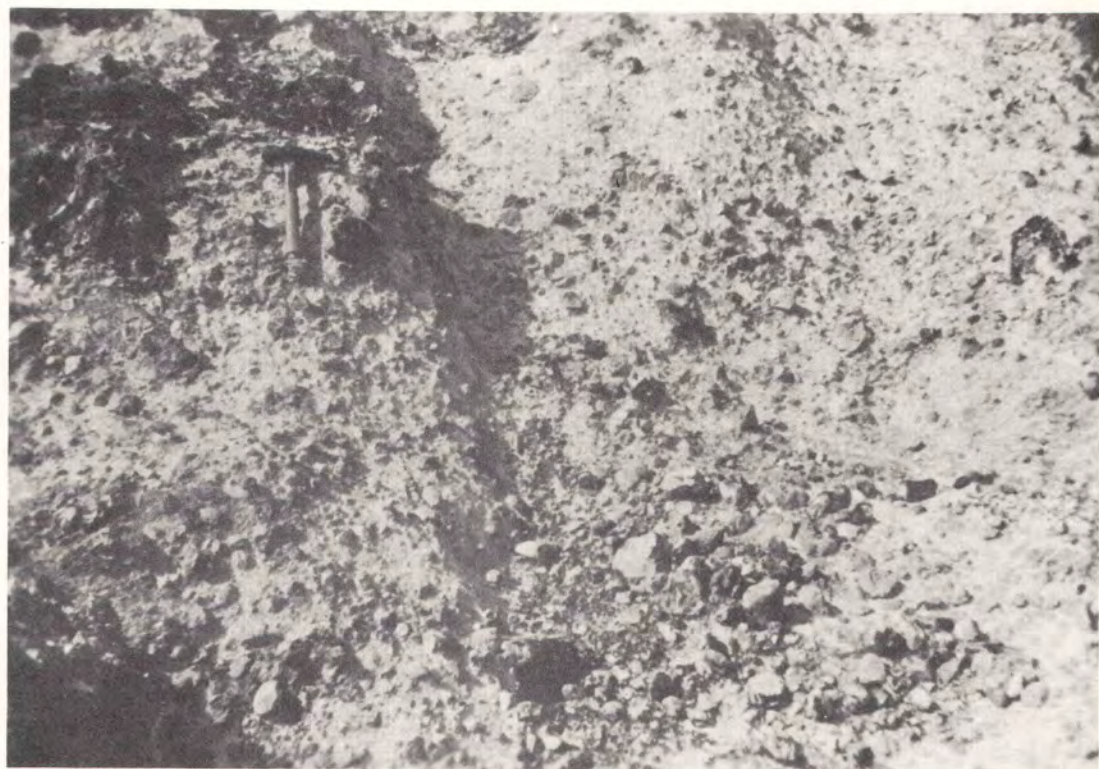
B. Unit No. 12 Friable dacitic breccia. Southeast slope of Ogso Achugau, northeast-central Saipan.

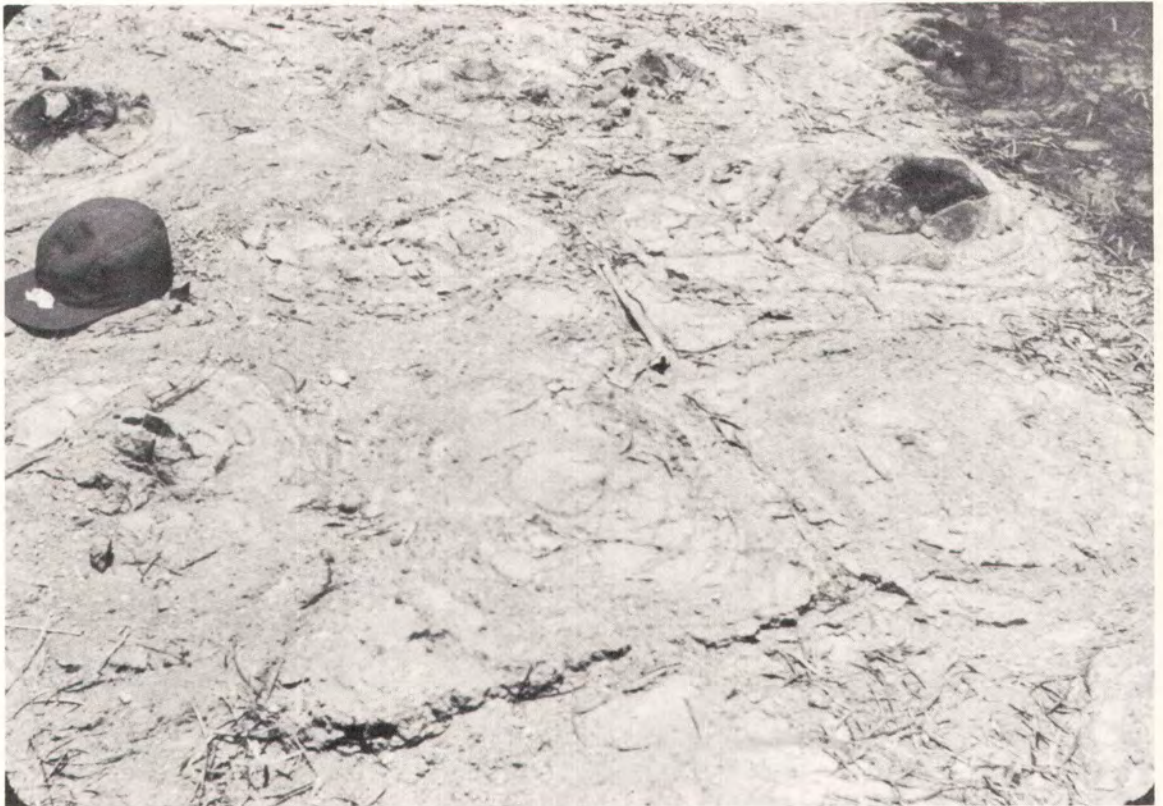
Unit No. 13 Compact andesite. About 1000 feet northeast of As Perdido Road, district of Fina-sisu, southwest Saipan.
