## **A Desktop Screen Analysis for Wind Farm Siting**

By Mark Zellman, Chris Hitchcock, Ranon Dulberg, and David Slayter

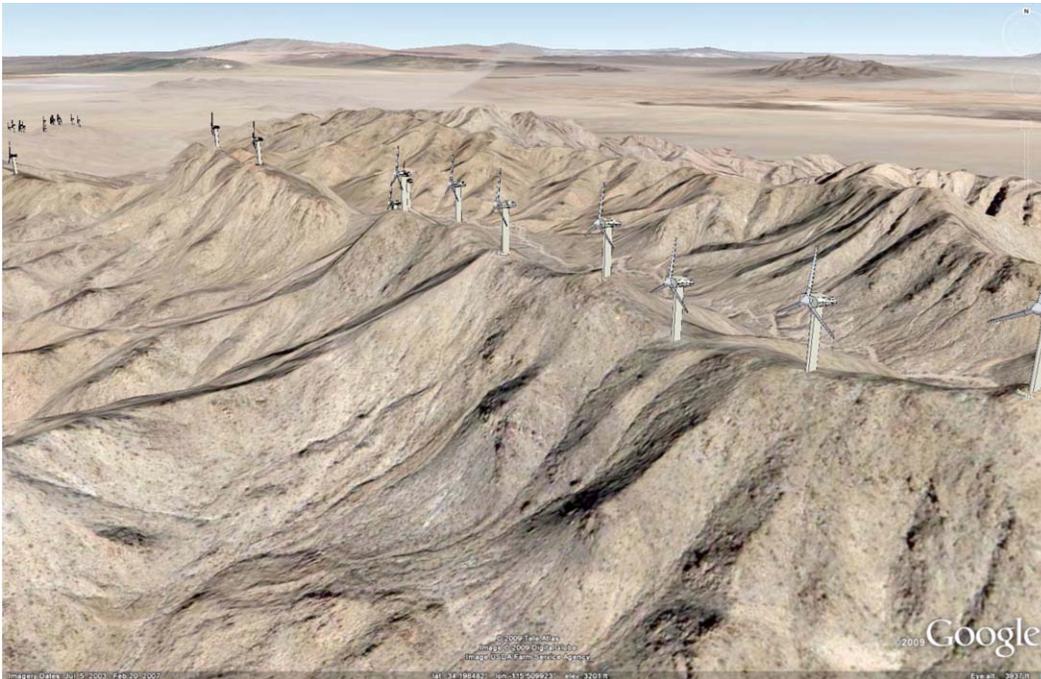
Figure 2. 3D scene of Site 2 taken from Google Earth with simulated wind turbines created in Google SketchUp.

Another tool which proved to be very helpful in site analysis and presentation was Google Earth. Shapefiles representing roads, wind turbines, geology, and soil were exported as KML (Keyhole Markup Language) format from ArcGIS and opened within Google Earth. Wind turbine icons were created using Google SketchUp and placed over proposed wind turbine sites (Figure 2). This process aided in the visual evaluation of site road conditions and slope. 3D screen images were also exported and used to demonstrate site conditions during presentations to the client.
